Bulletin No.: 28030B
Date: May 2016

PRODUCT SAFETY RECALL

SUBJECT: Driver Airbag Abnormal Deployment

MODELS: 2016 Chevrolet Colorado, Malibu
2016 GMC Canyon

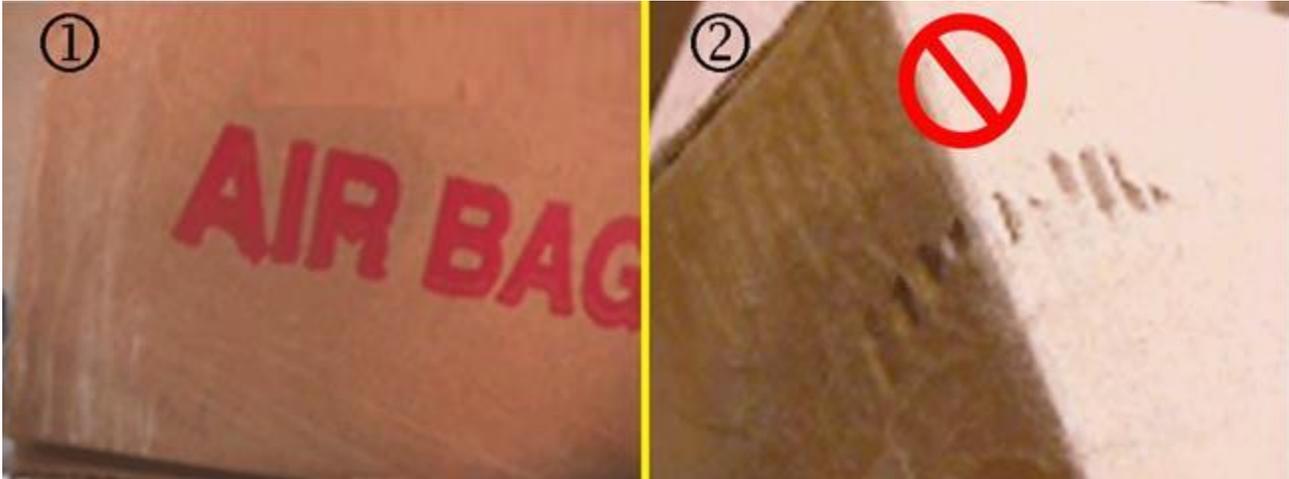
3961561

Hazardous materials packaging damages can be classified into one or more of the following different types. They include:

- **Abrasions:** Abrasions result from sliding the package against a rough surface (e.g. concrete floors). Major abrasions (2) are NOT acceptable. Note the flutes are visible.

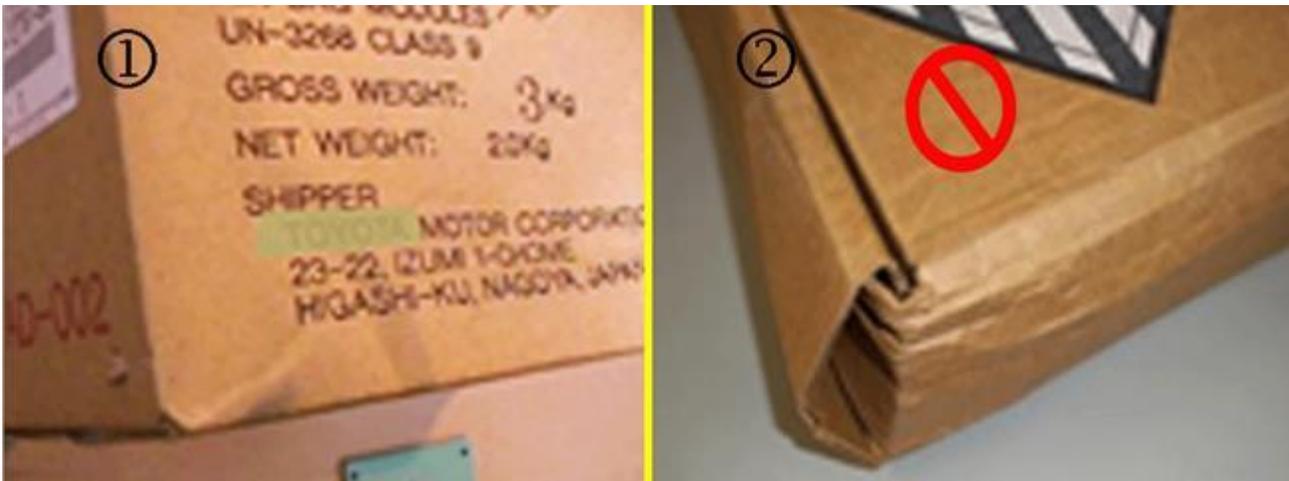
3961563

- **Compressions:** Compressions result from superimposed weights (e.g. stacked too high) or from dropping the packages. Small dimples (1) are acceptable.

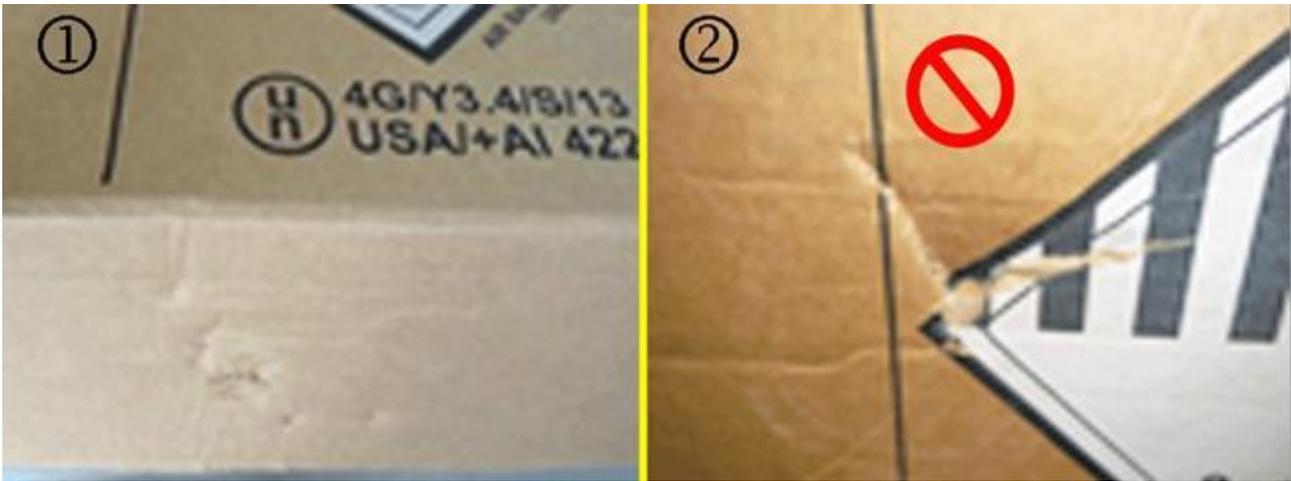
3961564

- **Dents:** Minor dents (1) occur through normal handling and picking (e.g. pulling from bin locations) and are acceptable. Major dents (2) result from impacts with others objects (e.g. pallet impacts).

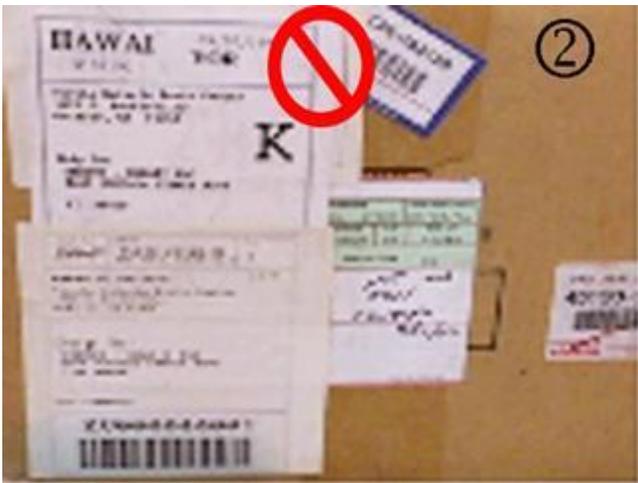
3961566

- **Labeling:** Packages with excessive labeling are NOT acceptable, particularly if the labels obscure other required marks and labels.

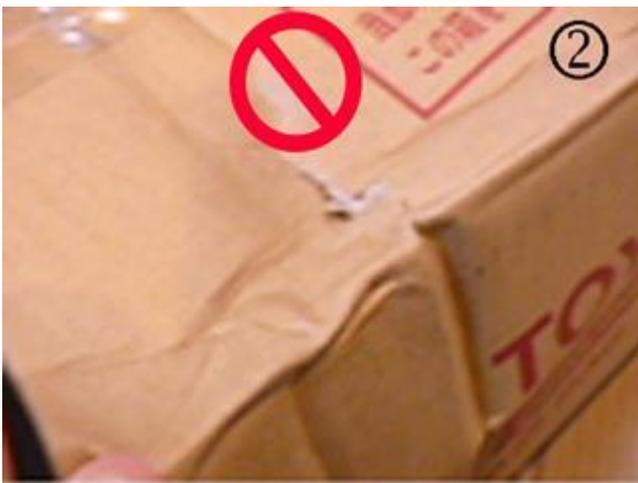
3961567

- **Other Damages:** Multiple damages, such as those shown above, may affect the integrity of the packages, and are NOT acceptable. Others that are not as severe may be acceptable. If questionable, repackage the material.

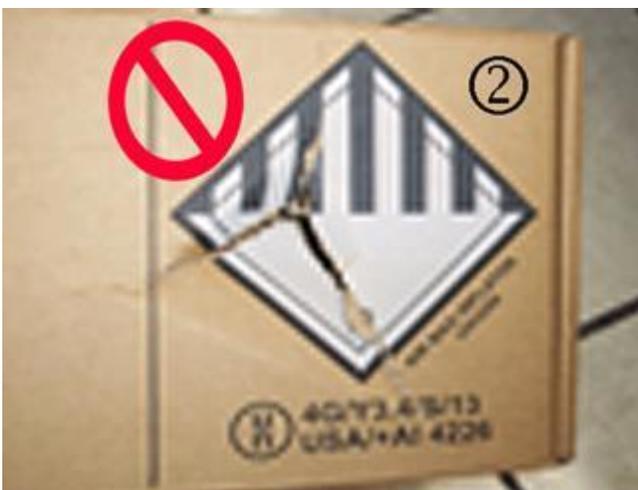
3961568

- **Punctures:** Any punctures, even minor ones, are NOT acceptable.

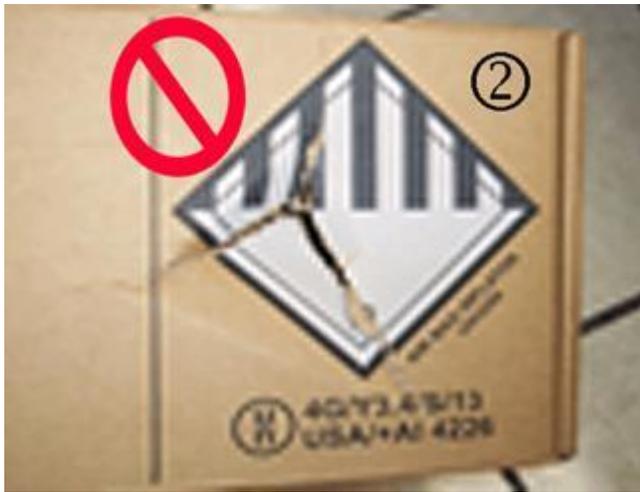
3961568

- **Tears:** Minor tears will not generally affect the structural integrity of the packaging and are considered to be normal "wear and tear", however, large tears or rips are NOT acceptable.

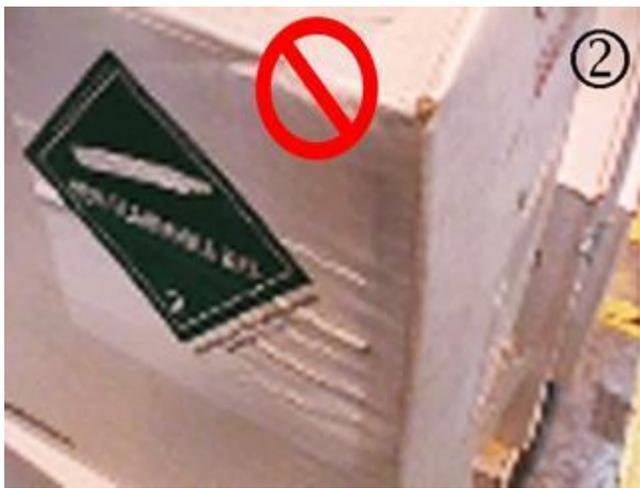
3961569

- **Water Damages:** Water Damages, such as the example shown above, are NOT acceptable. Water damages will affect the structural integrity of the packaging. These packages should be repacked in appropriate specification packages.

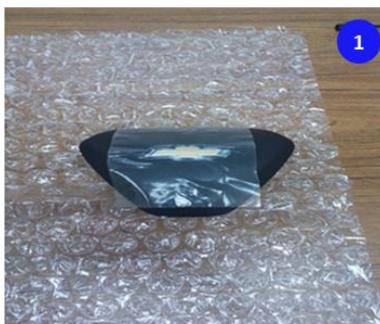
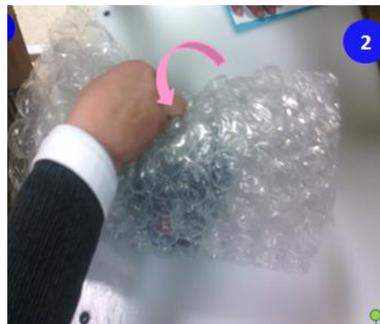
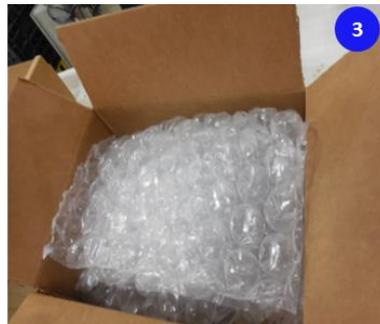
4481574

Note: The components required for the completed return package are dunnage (1) and foam (2), as shown in the graphic above.

1. **DO NOT DEPLOY THE AIRBAG.** Ensure that the box the replacement airbag arrived in is not damaged and place the steering wheel airbag in the box. Also, make sure to include a copy of the repair order in the box.
