1199 Superleggera Clutch
Models: Model Year 2014 1199 Superleggera (all country versions)
Recall Bulletin SRV-RCL-16-002

NHTSA Campaign I.D. Number: 16V339
Transport Canada Safety Recall I.D. Number: 2016-247

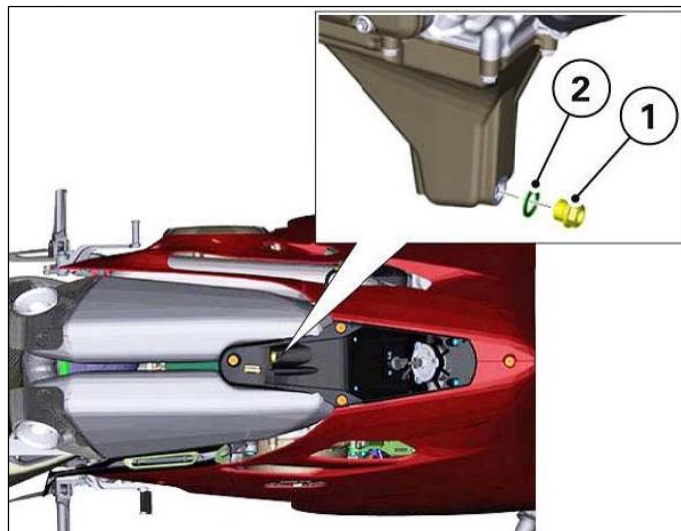
- 1) Set the motorcycle on the rear service stand.
- 2) Remove ignition switch cover (See "Section 05 – Fairing – Headlight fairing" of the Workshop Manual).
- 3) Remove carbon RH and LH side covers (See "Section 05 – Fairing – Headlight fairing" of the Workshop Manual).
- 4) Remove RH side fairing (See "Section 05 – Fairing – Headlight fairing" of the Workshop Manual).
- 5) Remove LH side fairing (See "Section 05 – Fairing – Headlight fairing" of the Workshop Manual).
- 6) Remove **drain plug M14x1.5 (1)** with **washer (2)** from oil sump and drain oil.

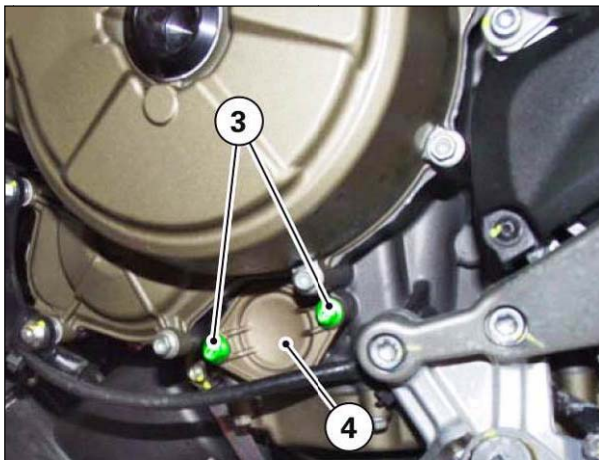
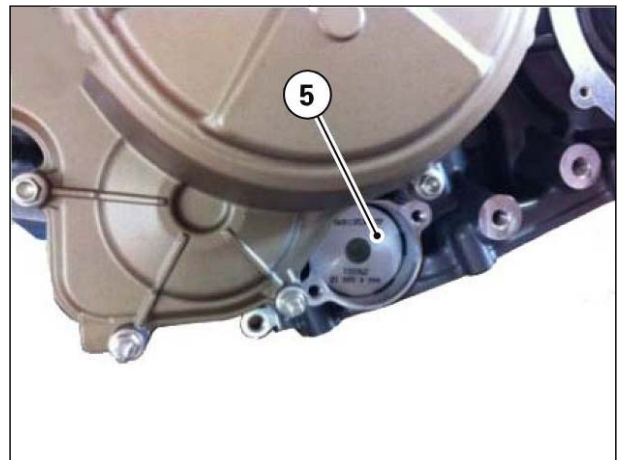
- 7) Remove the **2 screws M6X20 (3)** securing **oil filter cover (4)**.

Remove **oil filter cover (4)** and **oil filter cartridge (5)**.

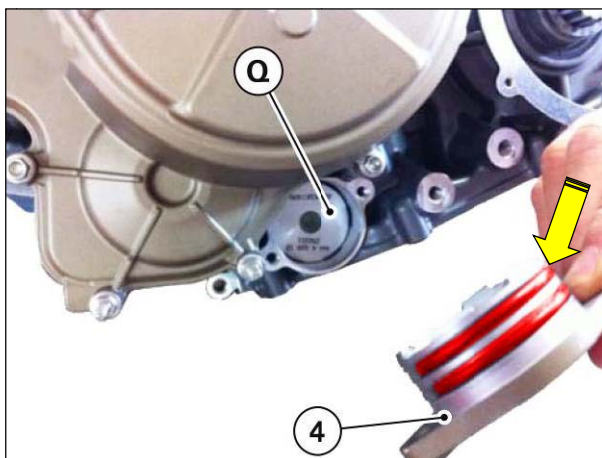
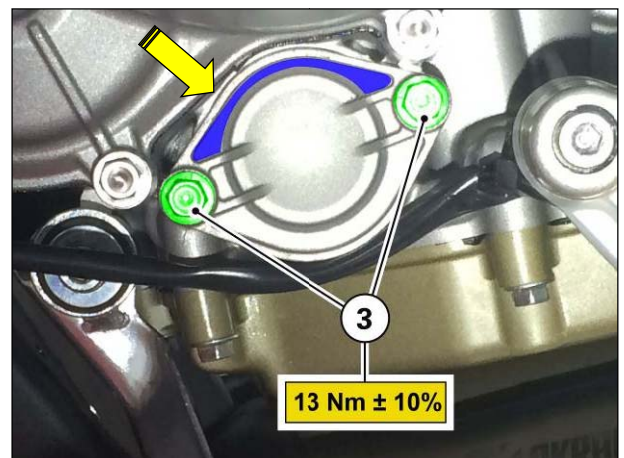
- 8) Install the new **oil filter cartridge Part no.44440312B** and fully secure.
9) Lubricate the 2 O-rings and fit **oil filter cover (4)** aiming it as shown in the figure.

Tighten the **2 screws M6X20 (3)** to a torque of **13 Nm ± 10%**.

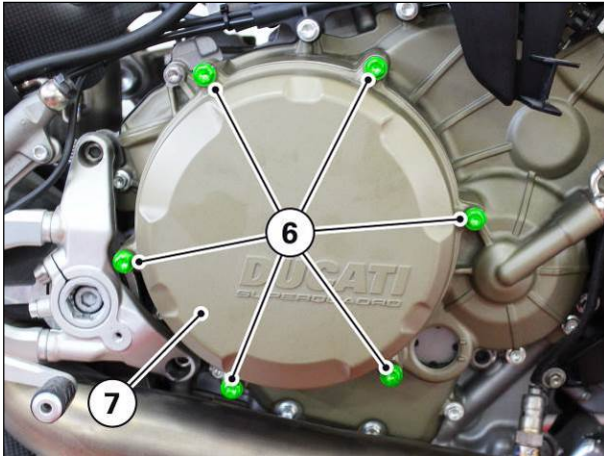
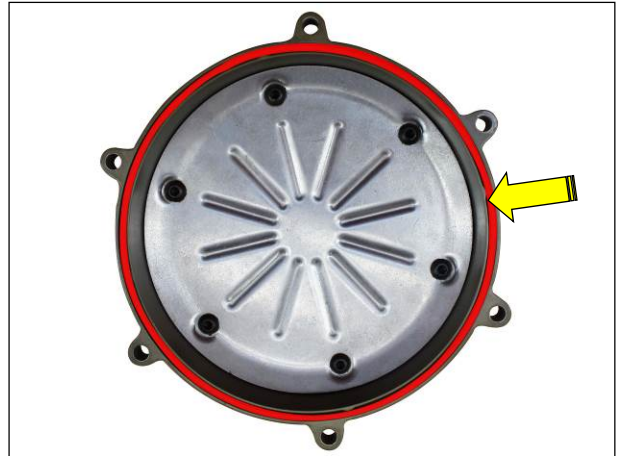
- 1) Loosen the **6 screws M6x25 (6)** and remove **clutch cover (7)** collecting the relevant O-ring.

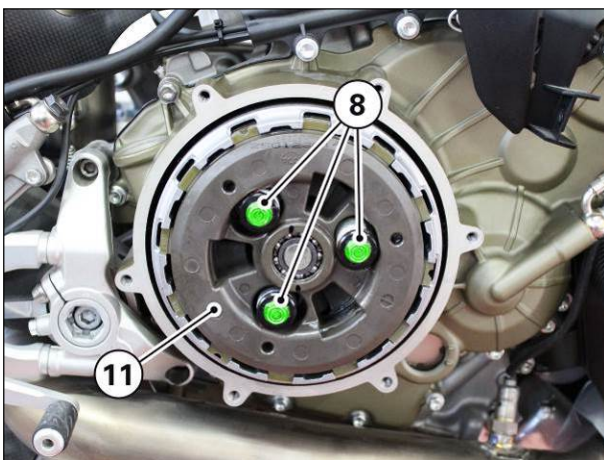
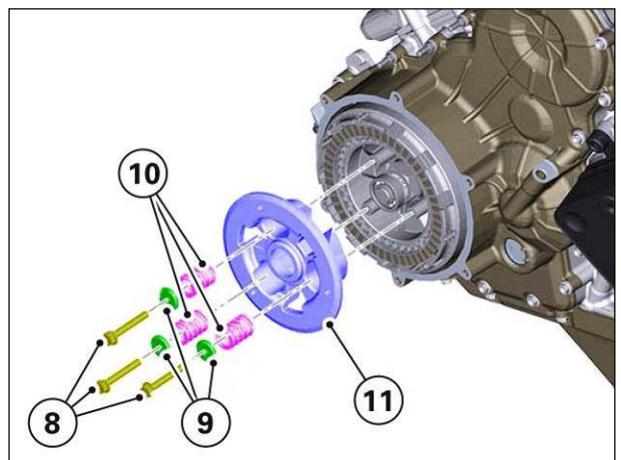
- 2) Remove the **3 screws M6x45 (8)** and take out the **3 caps (9)** and the **3 springs (10)** from **pusher plate (11)**.

Slide **pusher plate (11)** out.

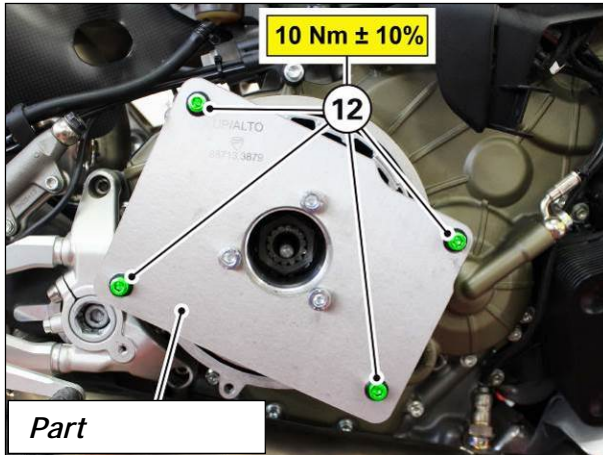
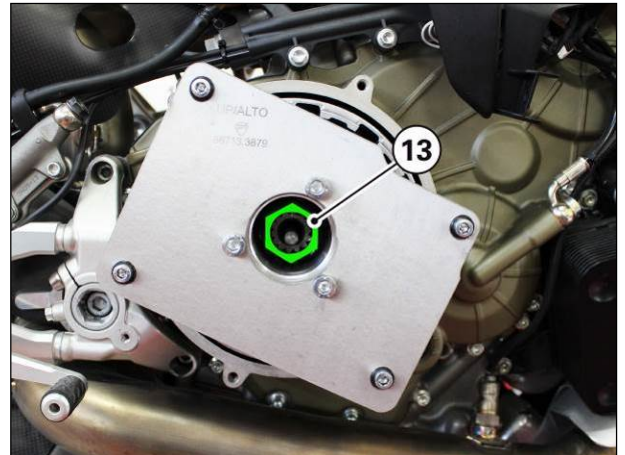
- 3) Lock plate holder hub with special tool Part no.887133879 and tighten the **4 screws (12)** to a torque of **10 Nm ±10%**.

Remove retaining **nut M25x1.5 (13)**.

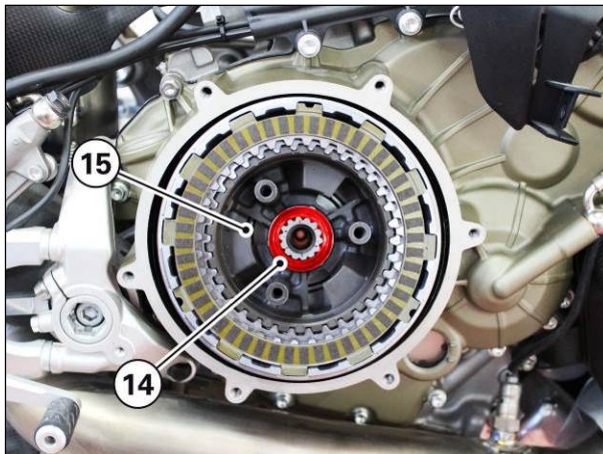
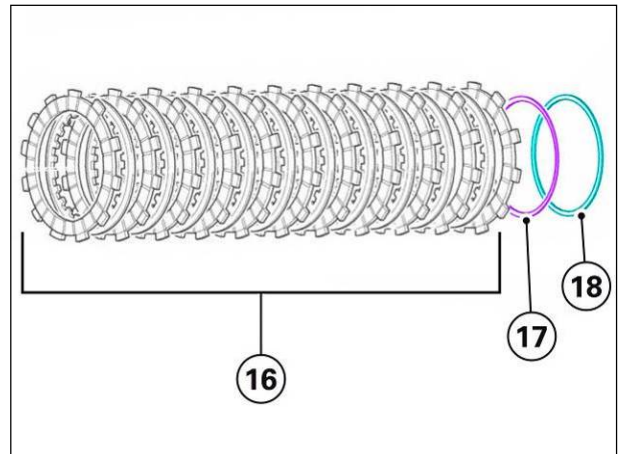
- 4) Slide out **lockwasher (14)** and **plate holder hub (15)** with the **clutch plate set (16)**.

Collect **belleville washer (17)** and **flat plate (18)**.

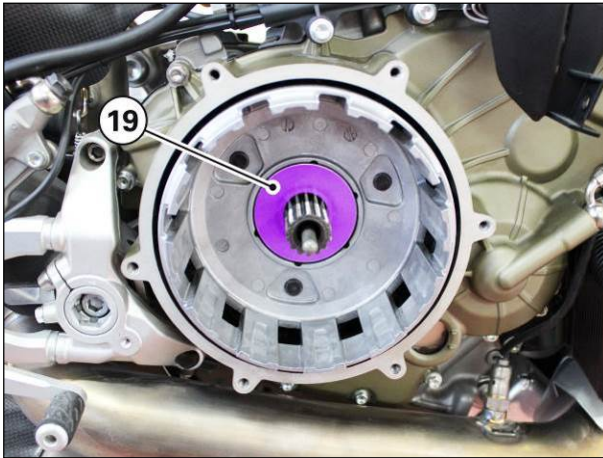
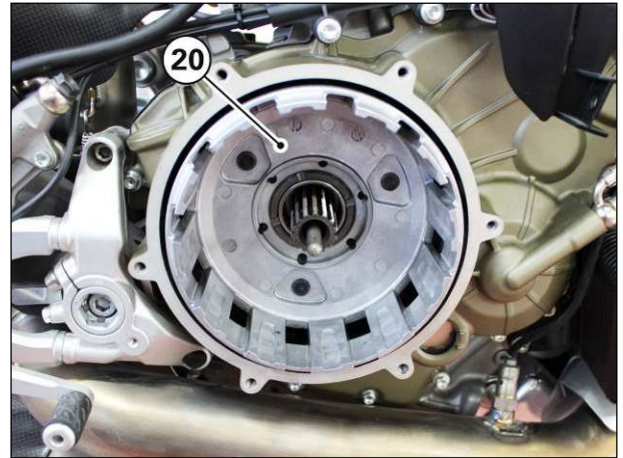
- 5) Remove *spacer (19)* and *clutch housing (20)*.

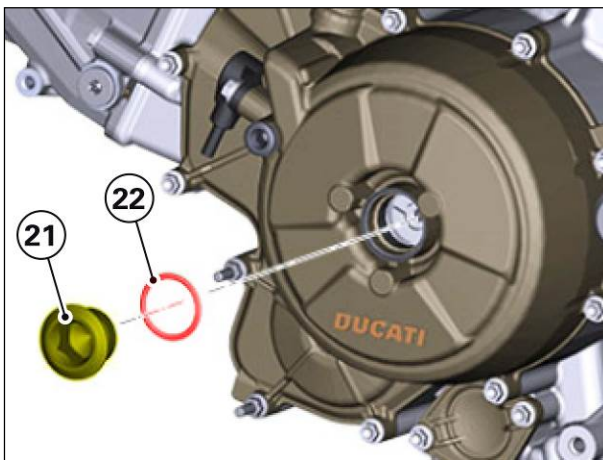
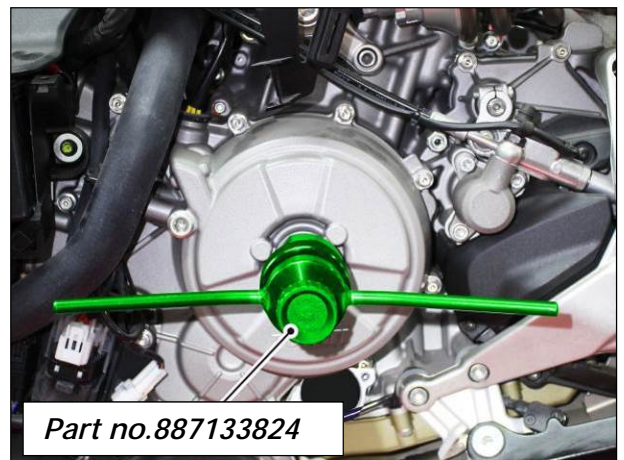
- 1) Remove *plug M27x1.5 (21)* from generator cover with the relevant *O-ring (22)*.

Fit special tool Part no. 887133824

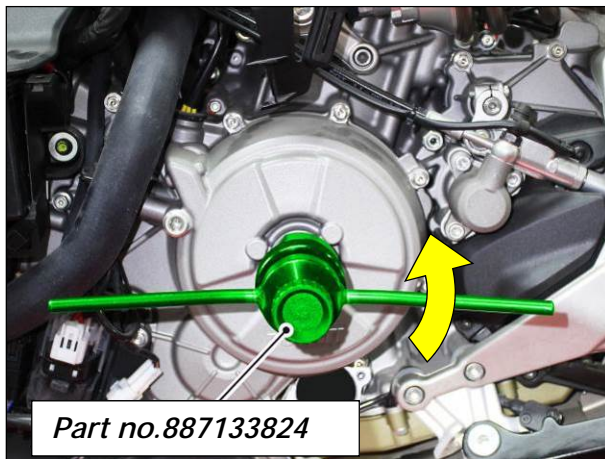
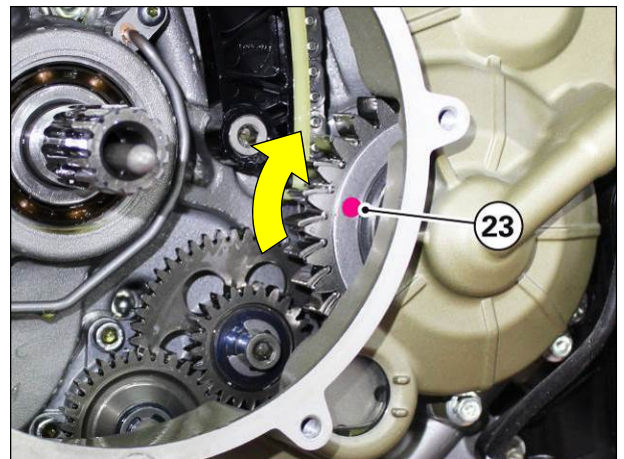
- 2) Using special tool Part no.887133824, turn engine counter clockwise until primary drive sprocket **hole (23)** is visible, as shown in the figure.

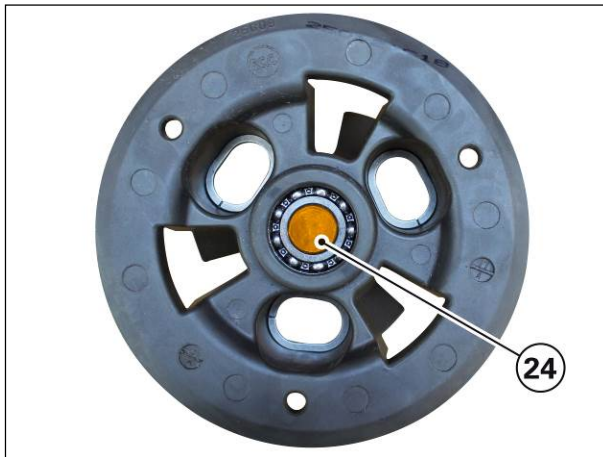
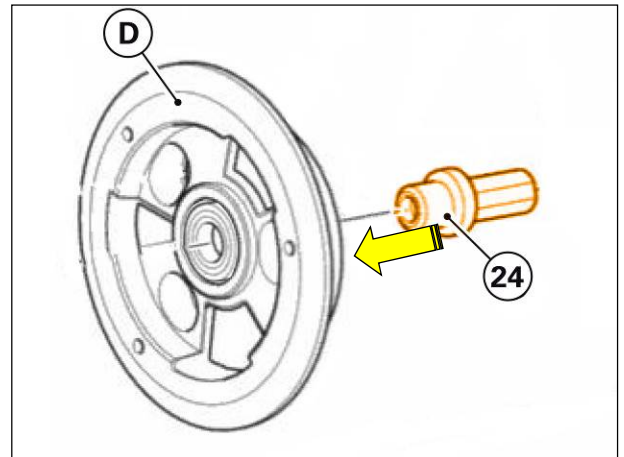
- 3) Collect **clutch plate pin (24)** from **pusher plate (11)** of the old clutch assembly.

Insert **clutch plate pin (24)** inside **pusher plate (D)** of the new clutch assembly Part no.18920344A, driving it fully home inside bearing.

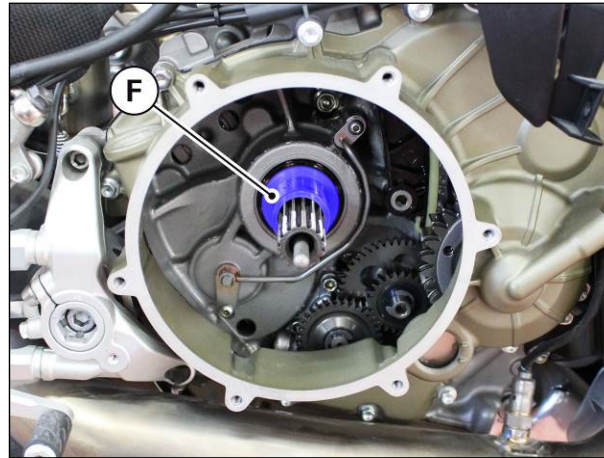
- 4) Fit the new **bushing (F)** on gearbox primary shaft.

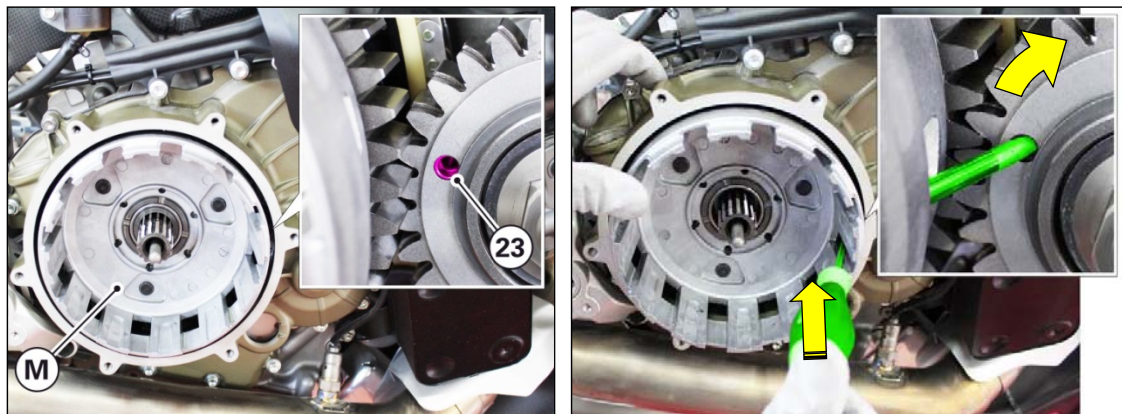
Fit **clutch housing (M)** on gearbox primary shaft, driving teeth fully home on those of primary drive sprocket.

Insert a screwdriver inside primary drive sprocket **hole (23)** working from inside clutch housing.

Move screwdriver up until winning the force of primary drive sprocket twin disc teeth spring.

Then insert clutch housing assembly all the way down and remove screwdriver.

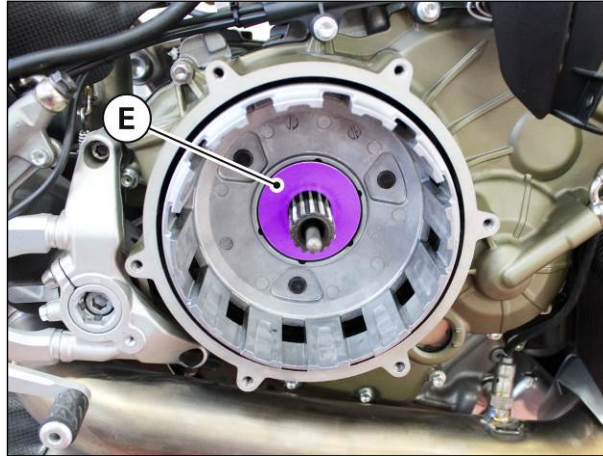
6) Fit *spacer (E)* on clutch housing (M).

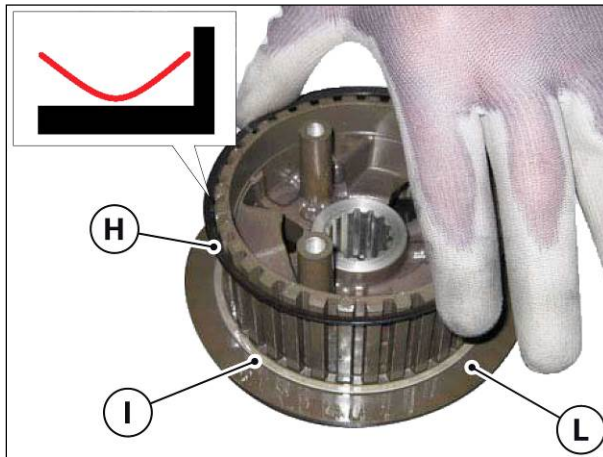
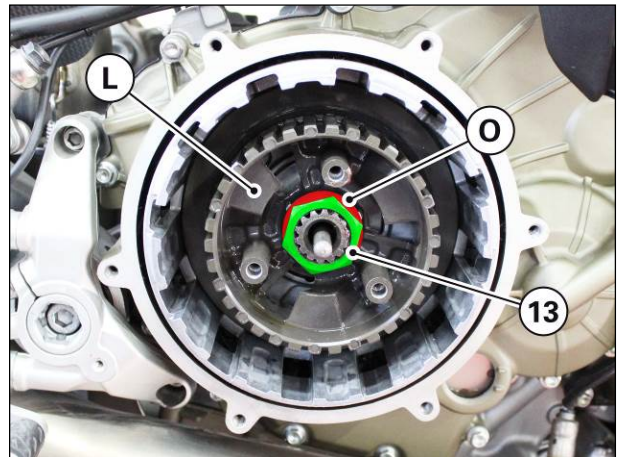
7) Position *flat plate (I)* and *belleville washer (H)* on *plate holder hub (L)* aiming it with the rounded side facing the drum.

Fit *plate holder hub (L)* and the NEW *lockwasher (O) Part no.85110201A* on gearbox primary shaft and start *retaining nut (13)*.

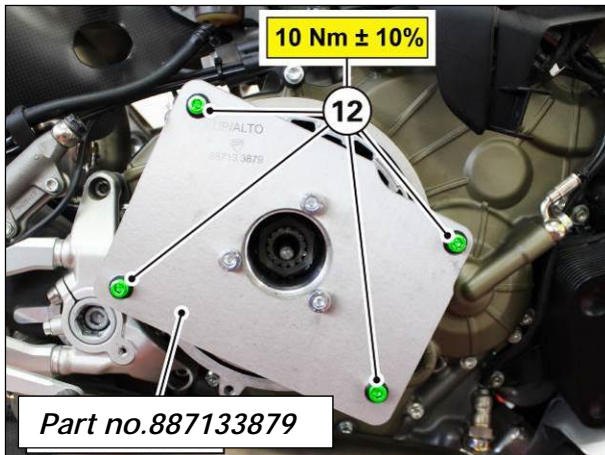
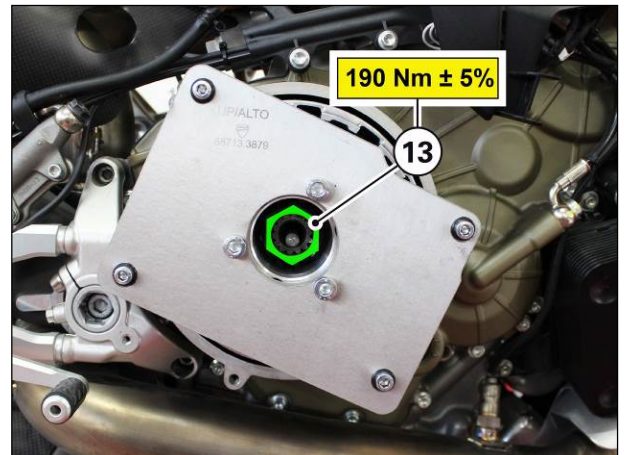
- 6) Lock plate holder hub with special tool Part no.887133879 and tighten the **4 screws (12)** to a torque of **10 Nm ±10%**.

Tighten retaining **nut M25x1.5 (13)** to a torque of **190 Nm ±5%**.

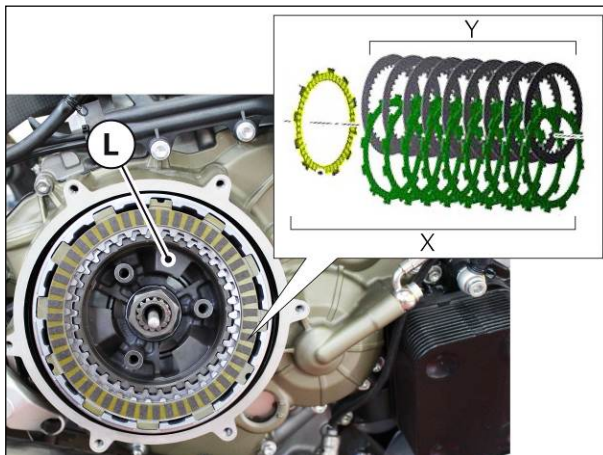
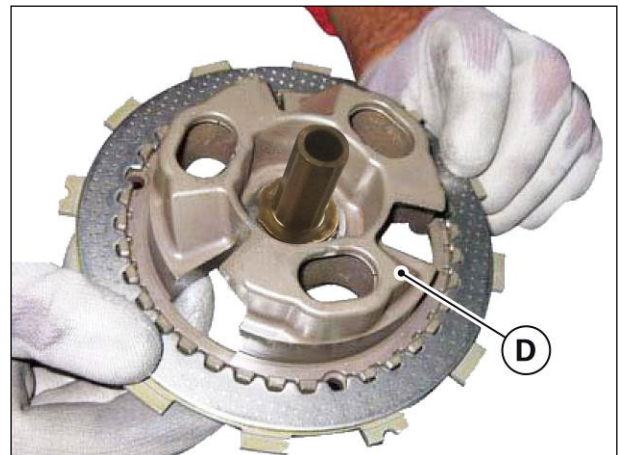
- 7) Fit the clutch plate set (G) in the following order:

- on **plate holder hub (L)**:
set of 10 driving plates (X) alternated with nine driven plates (Y) starting from driving plate (X).
- on **pusher plate (D)**:
1 driving plate (X);
1 driven plate (Y).

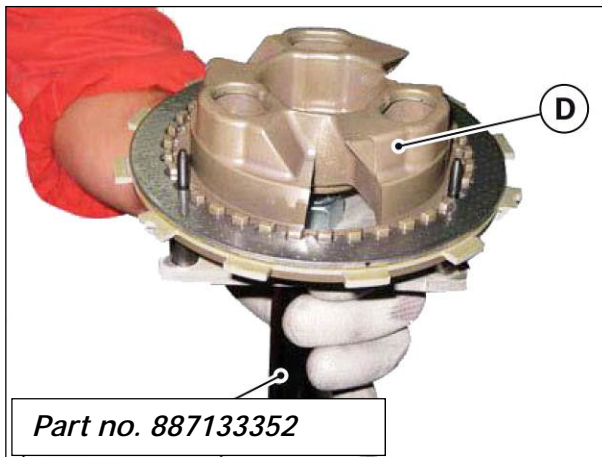
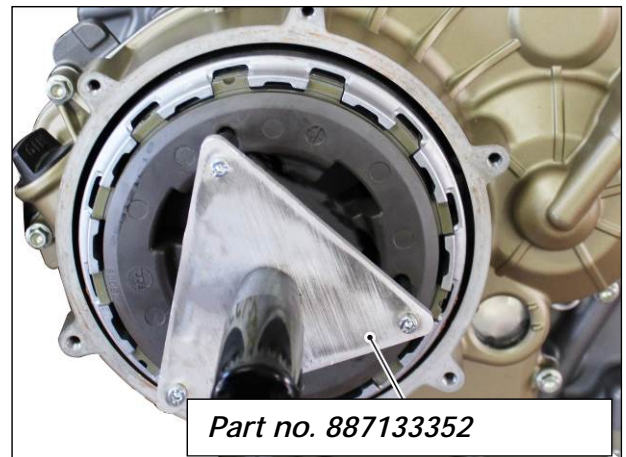
- 8) Position **pusher plate (D)** with the two plates on centering tool Part no.887133352 and fit it on plate holder hub (L).

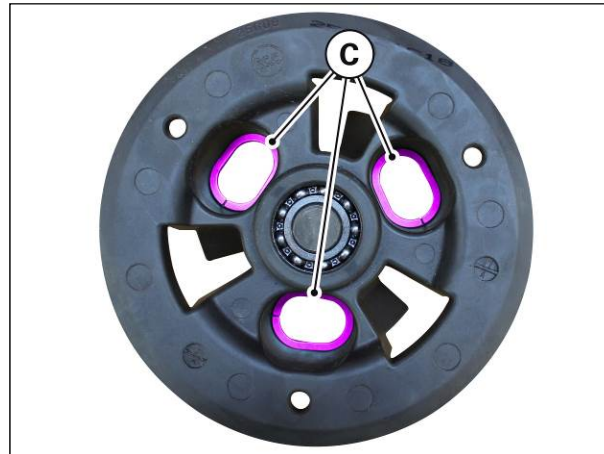
- 9) Ensure that the **3 shims (C)** are present on pusher plate.

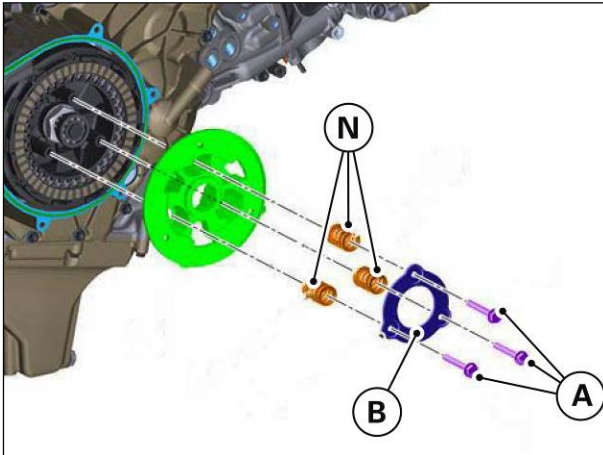
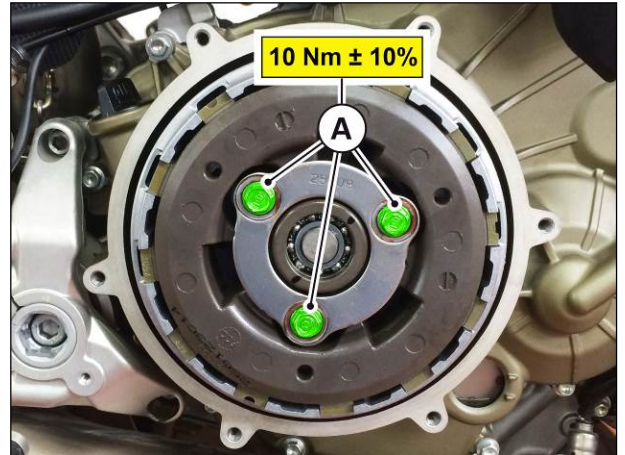
- 10) Fit the **3 springs (N) Part no.79710711A**, the **guide ring (B)** and start the **3 screws M6x45 (A)**.

Tighten the **3 screws M6X45 (A)** to a torque of **10 Nm ± 10%**.

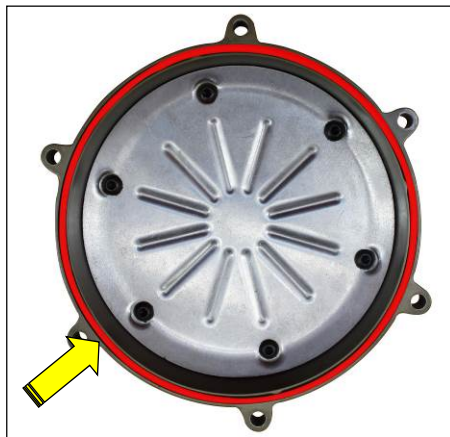
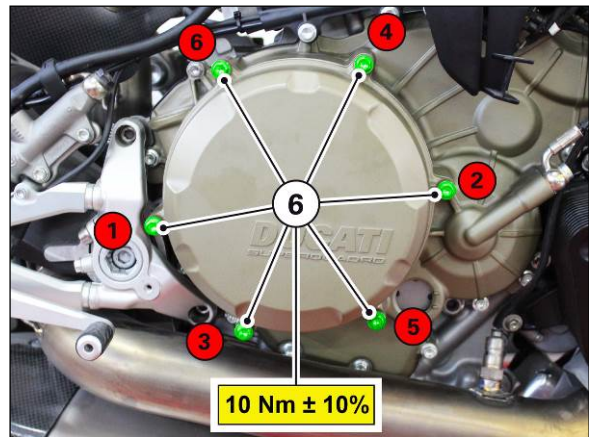
- 11) Fit clutch protection cover (7) by starting the **6 screws M6x25 (6)**.

Tighten the **6 screws M6X25 (6)** to a torque of **10 Nm ± 10%** following the indicated sequence.

Ensure that the O-ring is positioned inside its seat on clutch protection cover (7).

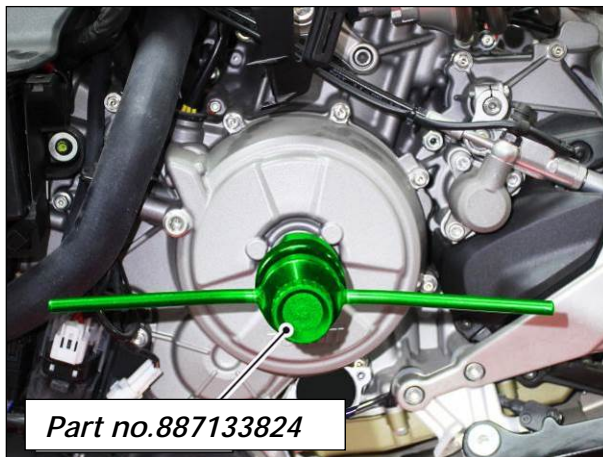
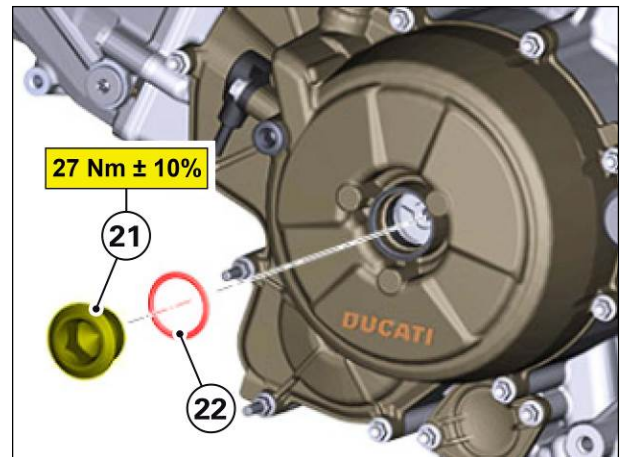
- 8) Remove special tool Part no.887133824 and tighten generator cover **plug M27x1.5 (21)** with the relevant **O-ring (22)** to a torque of **27 Nm ±10%**.

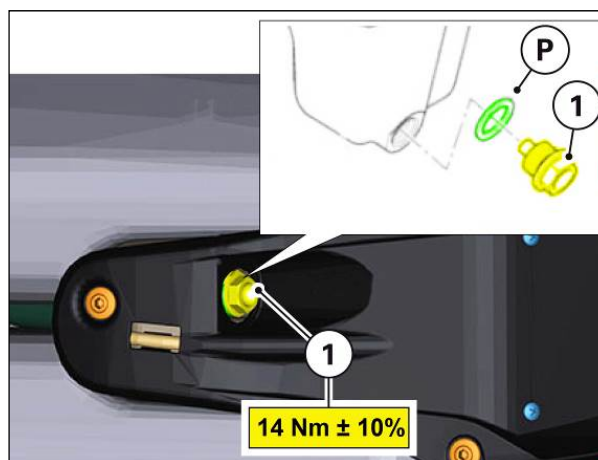
- 12) Before inserting the drain plug (1), you have to:
- dry the residual oil from inside the puller and perform a thorough cleaning;
 - ensure that there are no metal particles on drain plug magnetic end (1);
 - clean the whole threading of drain plug (1);
 - fit the **new washer (P) Part no.85250541A** aiming its flat surface towards the oil sump.
 - apply ThreeBond TB1215 along the whole threading of drain plug (1).

Tighten **drain plug M14x1.5 (1)** to a torque of **14 Nm ±10%**.

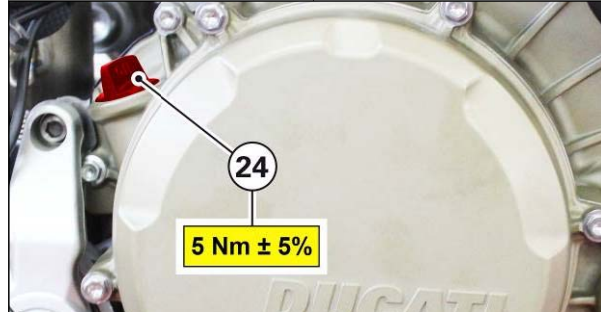
- 13) Remove **filler plug M20x2.5 (24)** and add **NEW oil** until reaching the required level.
Insert **filler plug M20x2.5 (24)** and tighten it to a torque of **5 Nm \pm 5%**.

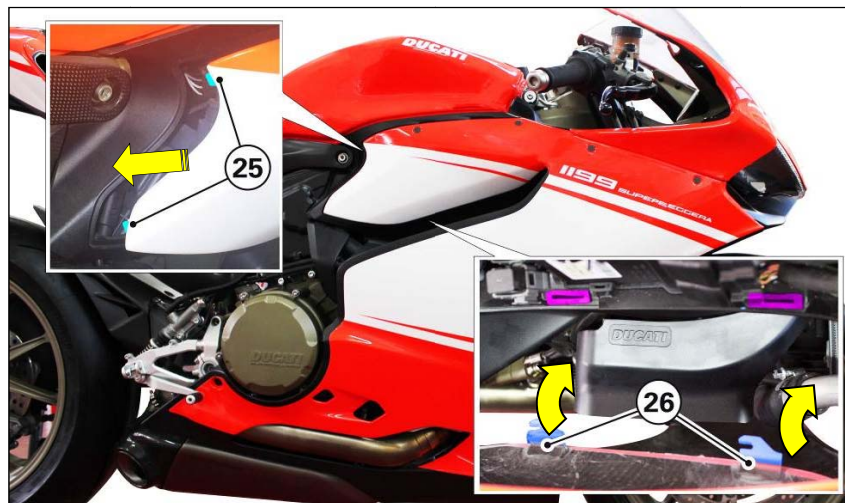
- 14) Fit right side fairing by inserting **teeth (25)** behind electrical component support profile and **tabs (26)** inside vibration damping pads.

Move the right fairing towards the rear side of the vehicle making sure that the front profile of the fairing fits on the front profile of the radiator support, as shown by the arrow.

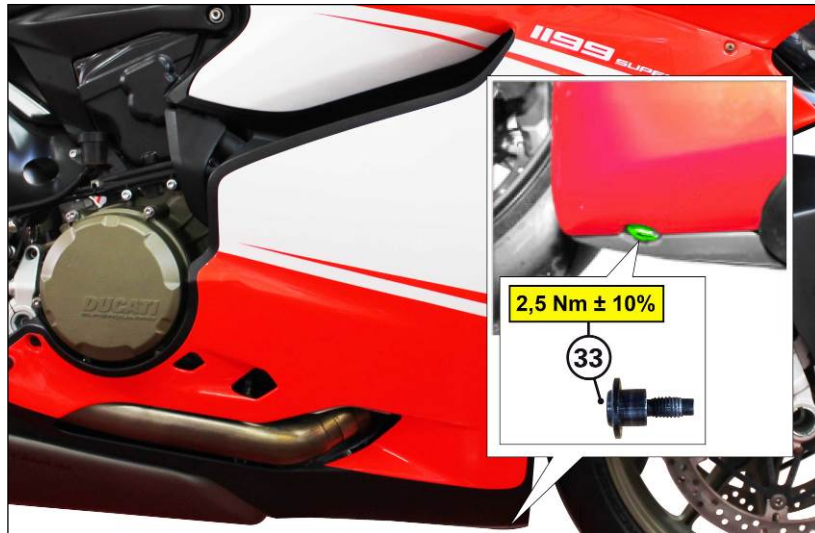
- 15) Repeat the same procedure for left side cover and tighten **screw M5x0.8 (33)** to a torque of **2.5 Nm ± 10%**.
