F/CMVSS Noncompliance Recall

50190 Up-Level Headlamp Incorrect Marking

Reference Number: N16205019
GWM Number: 2050190
Revision Description: This bulletin has been revised to include a copy of the customer notification letter. Please discard all copies of 50190.

Release Date: July 2016
Revision: 01

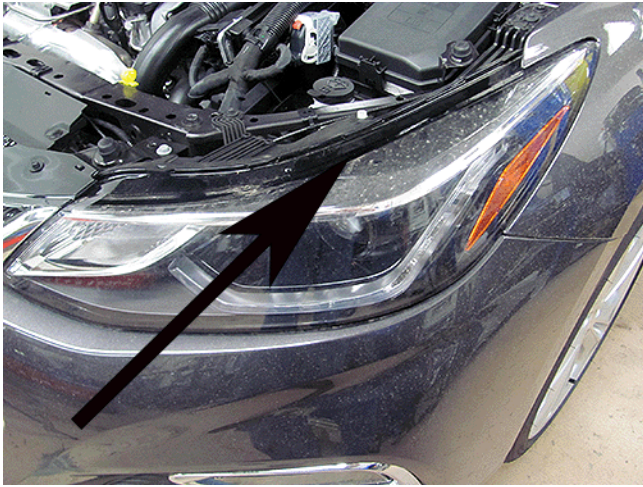
4549669

1. Open the vehicle hood.

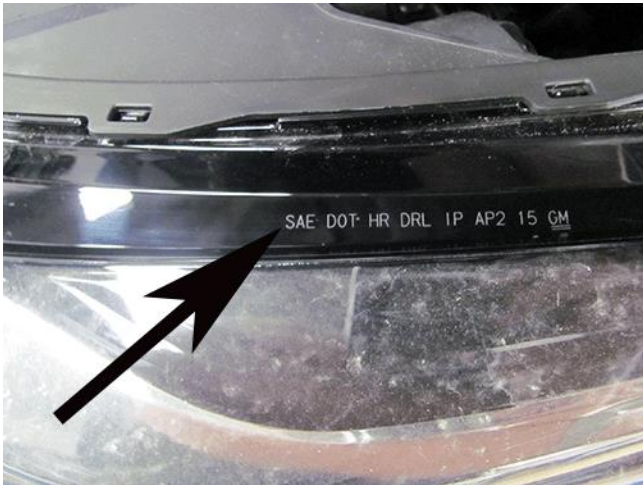
4549671

2. Locate the existing identification information etched into the top edge of both headlamp assemblies.
3. Using a soft dampened towel, clean the area inboard (center of vehicle) of the existing identification information. Use care to not scratch the surface.

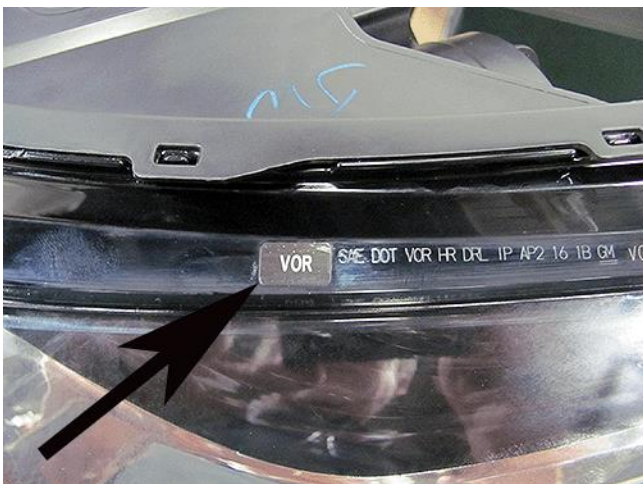
4549674

4. Peel the "VOR" label off of the backing paper and place it approximately 3mm inboard of the existing identification information. Repeat this process on both headlamps.

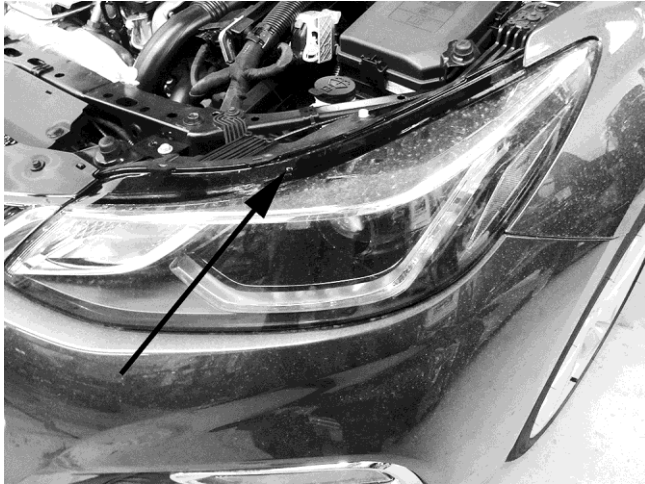
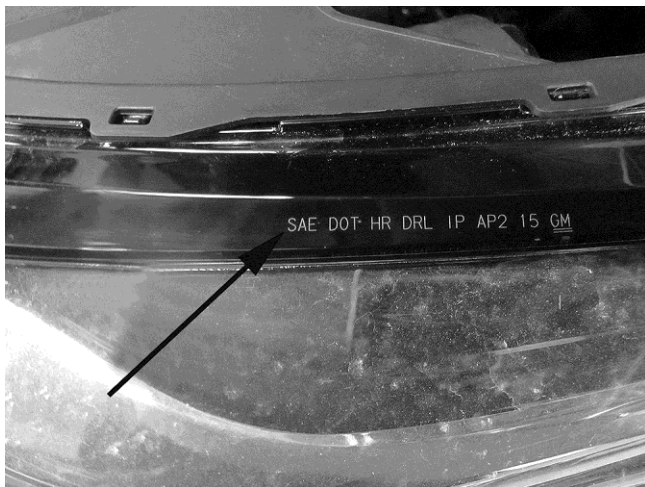
2. Locate the existing identification information etched into the top edge of both headlamp assemblies.
3. Using a soft dampened towel, clean the area inboard (center of vehicle) of the existing identification information. Use care to not scratch the surface.

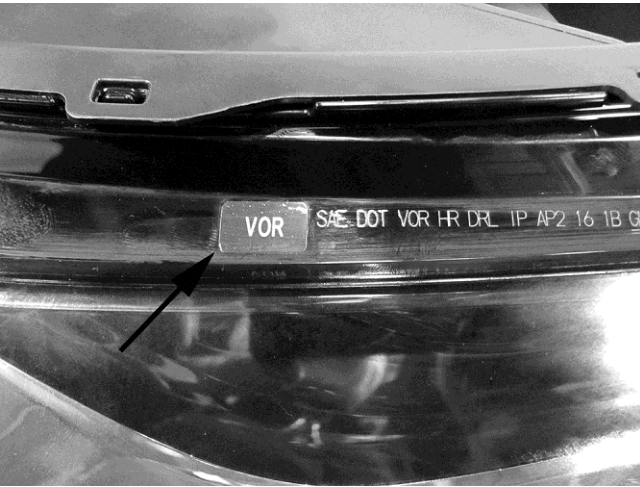
4549674

4. Peel the "VOR" label off of the backing paper and place it approximately 3mm inboard of the existing identification information. Repeat this process on both headlamps.
