Bulletin Type.....: Safety Recall

Bulletin No.....: TS-S112

Bulletin Name.....: Steel Rims Offset Improvement

Summary: This bulletin is prepared to replace the current steel rims of the drive axle with the new ones on TS45 vehicles.

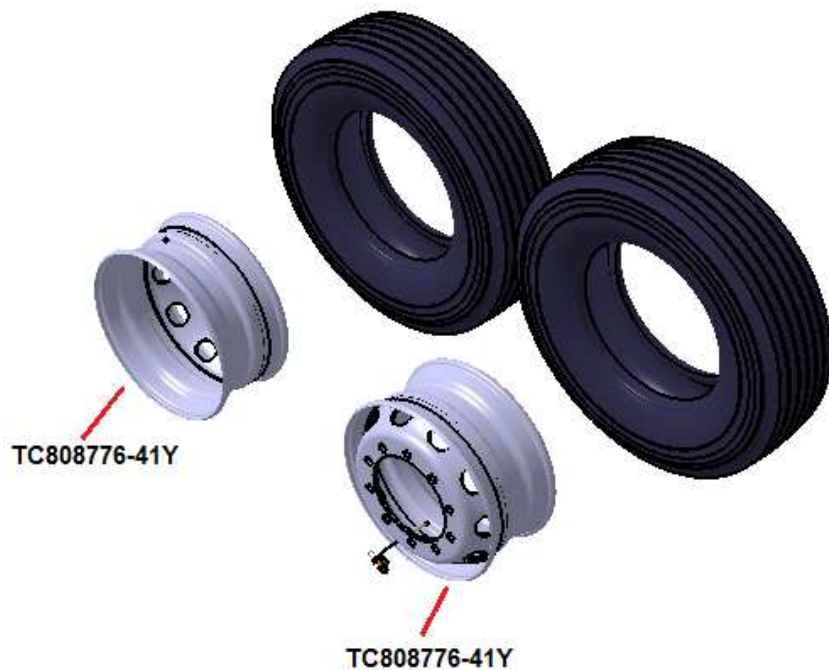
Figure-4

* Remove the existing rims (TC808776-41Y) from the wheels shown in Figure-4.

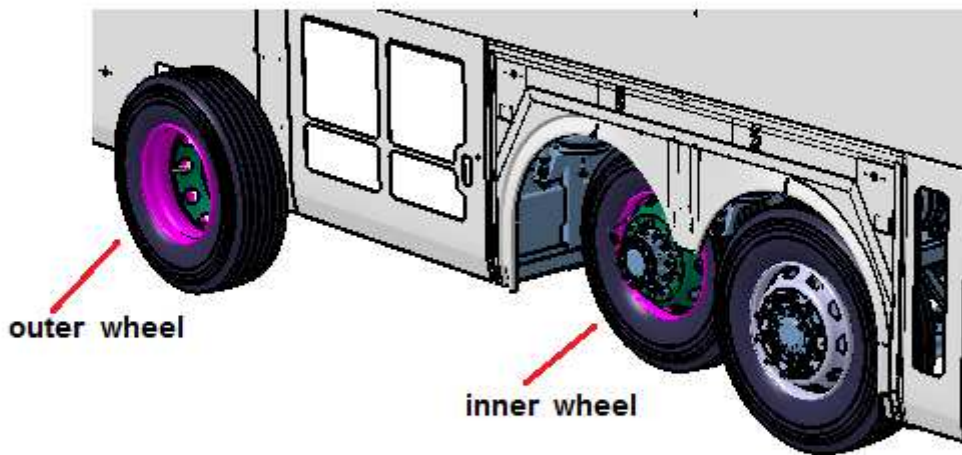
Figure-8

* Install both wheels to the rear axle respectively shown in Figure-8.
