# TECHNICAL SERVICE BULLETIN

Bulletin Number: T-16-06

**2015-17 SLINGSHOT – Swingarm Replacement**

Certain Slingshot vehicles may have been assembled with an improperly manufactured swing arm, resulting in decreased swing arm strength. If the swing arm is compromised it can result in a loss of forward momentum or control, increasing the risk of a crash.

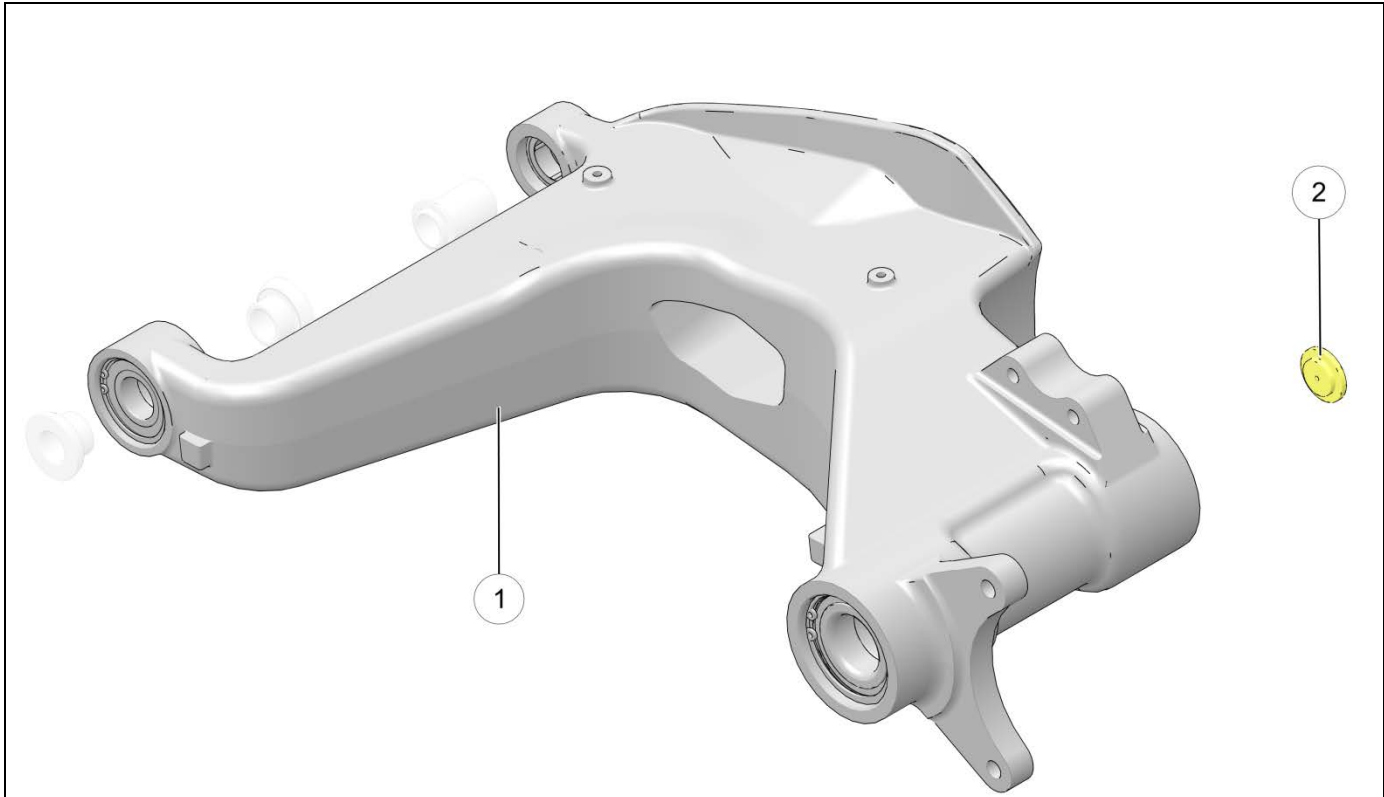
## KIT CONTENTS (P/N 2207085)

REF	PART DESCRIPTION	PART NUMBER	QTY
①	Swingarm Assembly w/bearings	5141107-XXX	1
②	Wheel Sprocket Puller Seat	5264214	1
	Loctite 680 (not shown)	8560253	1
	Kit Instructions (not shown)	9927930	1

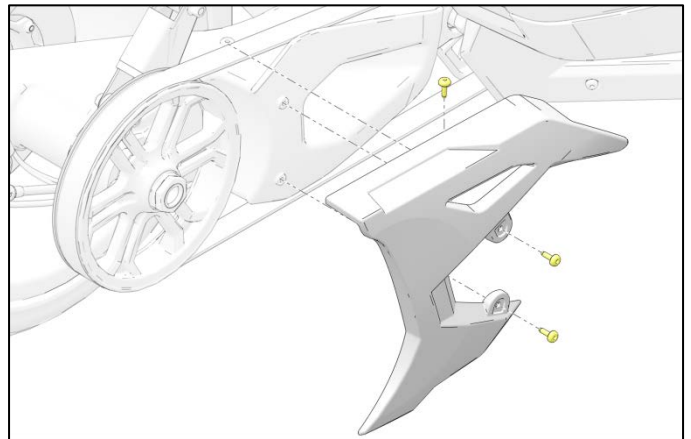
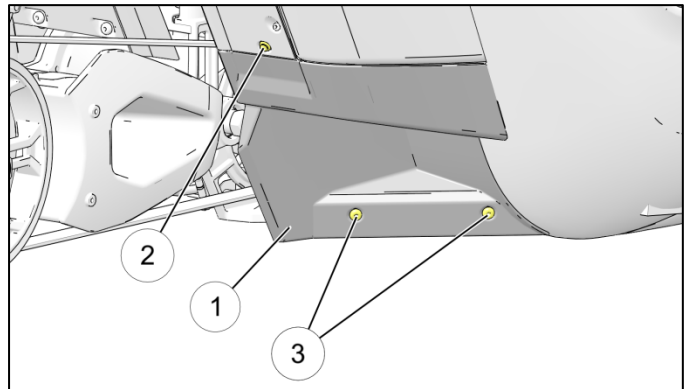
1. Shift transmission into neutral. Engage parking brake. Turn key to "OFF" position and remove from vehicle.
2. Remove three T-40 fasteners and Drive Belt Cover.
3. Remove both the driver and passenger side lower close out panels (1) by removing the push rivets (2) and T40 fasteners (3).

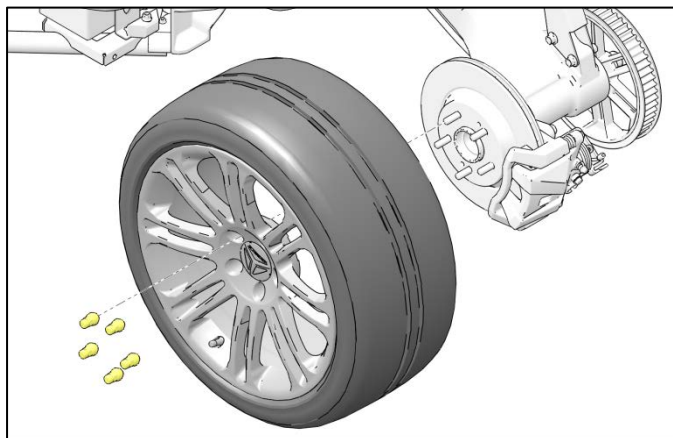
4. Remove lug nuts and remove rear wheel.

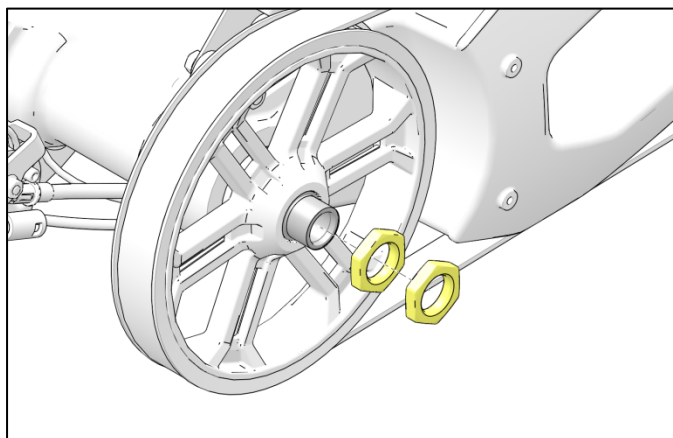
5. Remove the Axle Nut(s).

DO NOT reuse single axle nut.  
**SINGLE AXLE NUT = DISCARD**  
**DOUBLE AXLE NUTS = KEEP & CLEAN**

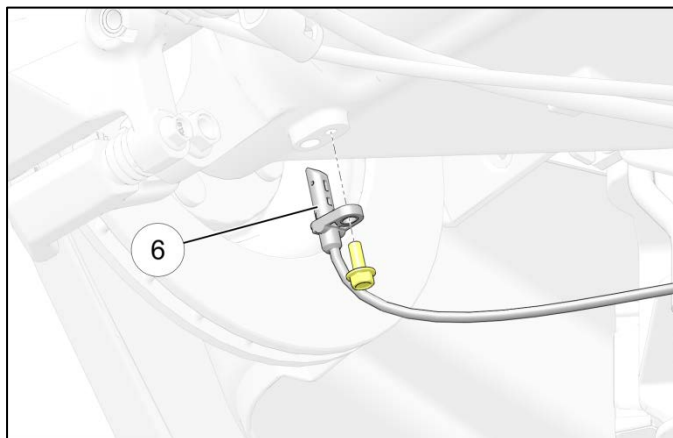
8. Locate the rear wheel speed sensor ⑥ underneath the swingarm and remove. Retain fastener for installation.

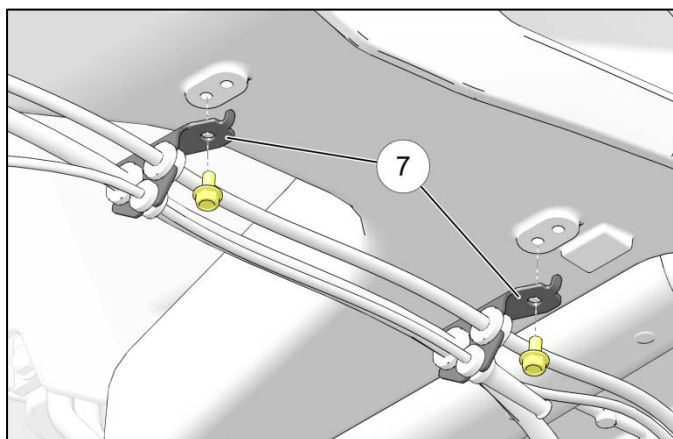
9. Remove routing line fasteners and brackets ⑦ from the bottom of the swingarm. Retain fasteners for installation.

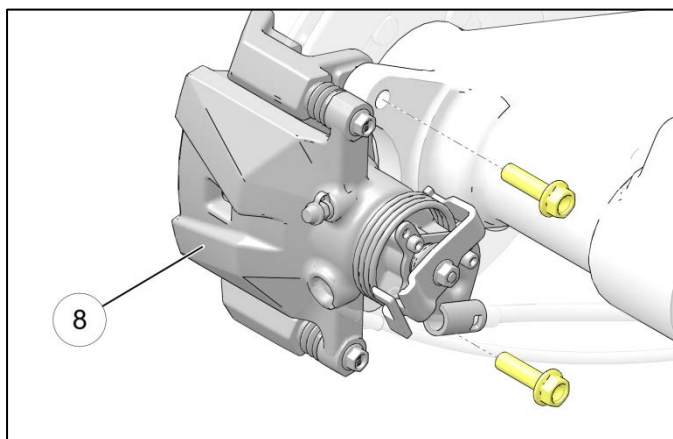
10. Remove two fasteners and brake caliper ⑧. Retain fasteners for installation.

When removing caliper, use care not to damage brake line. Support caliper to avoid kinking or bending brake line.

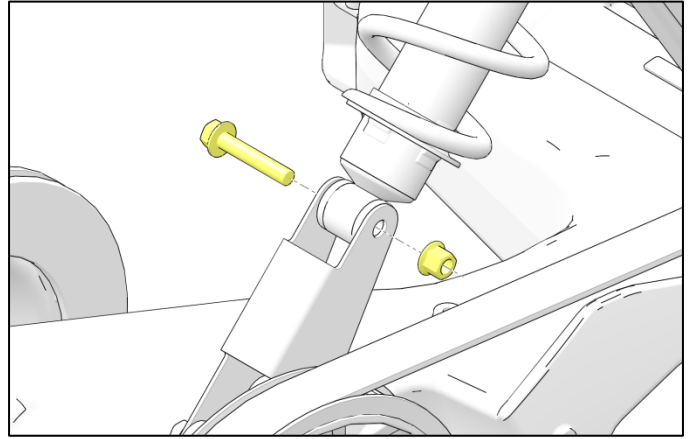
11. Support swingarm and remove lower shock mount bolt.

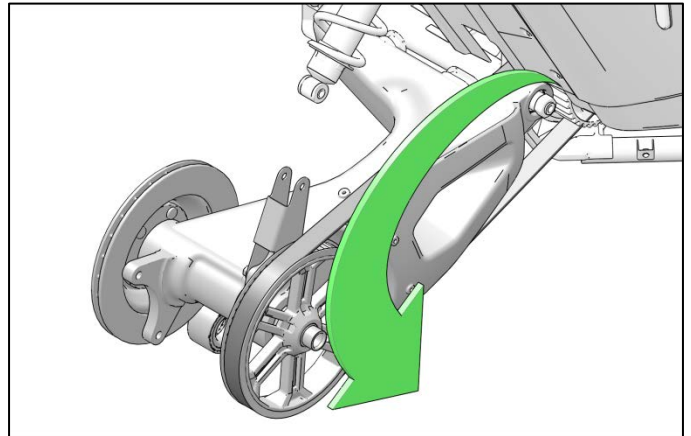
12. Allow swingarm to pivot downward and remove drive belt.

Use caution when lowering swingarm not to damage brake line and hoses.

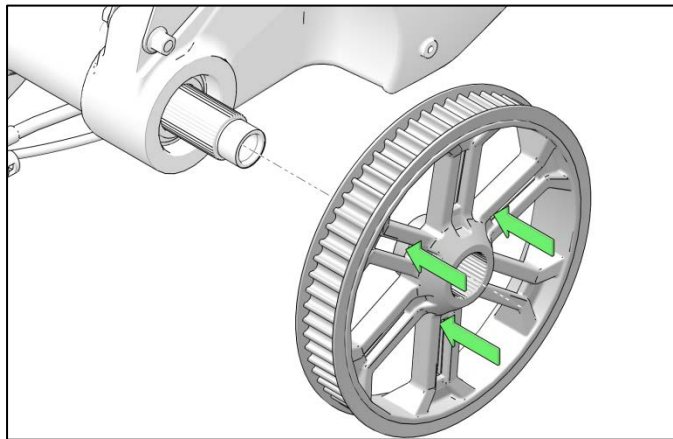
15. Use a commercially available 3 jaw puller to remove the rear sprocket, pressing against the provided puller seat. Install the puller between the sprocket spokes as shown.

Do not use puller on outer flange of the sprocket. Pulling on the outer flange will damage the sprocket.

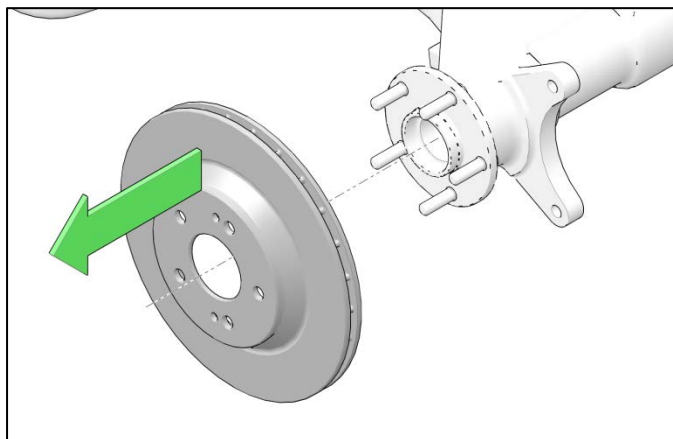
16. Remove brake disc from the axle.

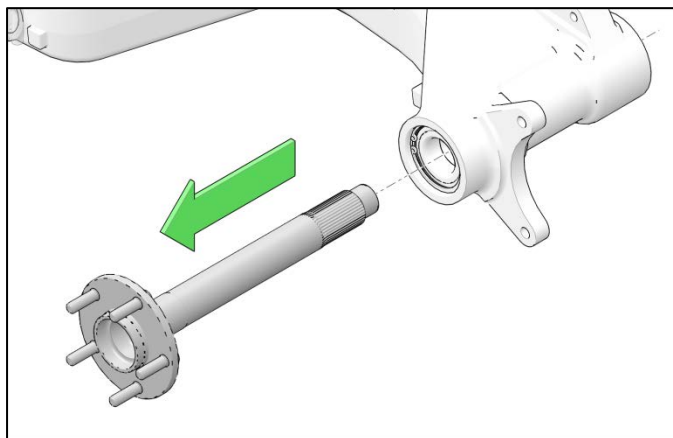
17. Remove axle from the swingarm.

If required, use a soft faced hammer to drive the axle out of the swingarm. Partially install the axle nut onto the axle before hitting with a hammer to avoid damage to the threads.

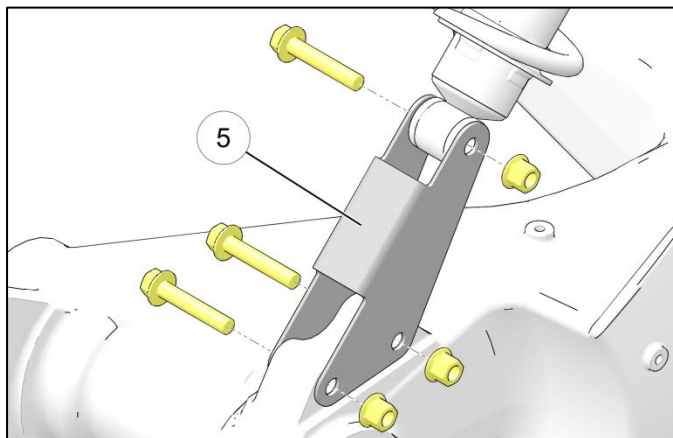
18. Remove three fasteners securing rear shock bracket to the swingarm and remove shock bracket ⑤. Retain fasteners for installation.

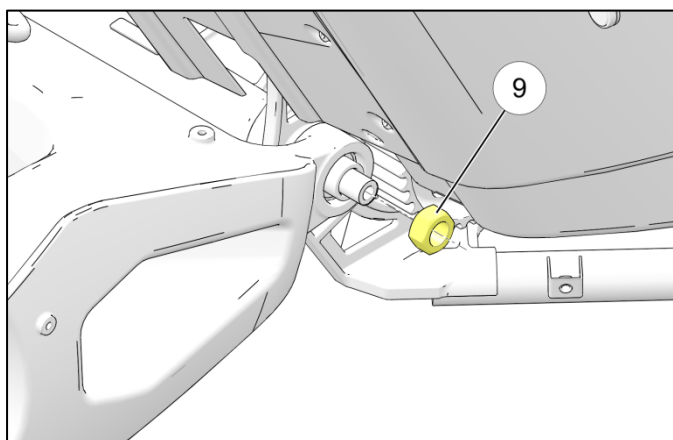
19. Remove pivot nut ⑨.

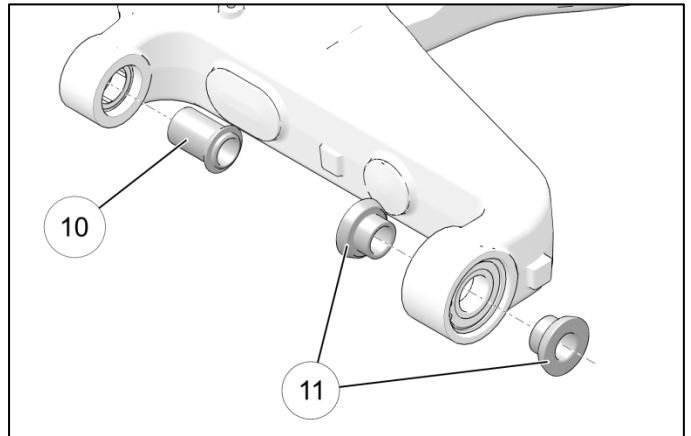
22. Remove bushings ⑩ and ⑪. Retain bushings for installation.

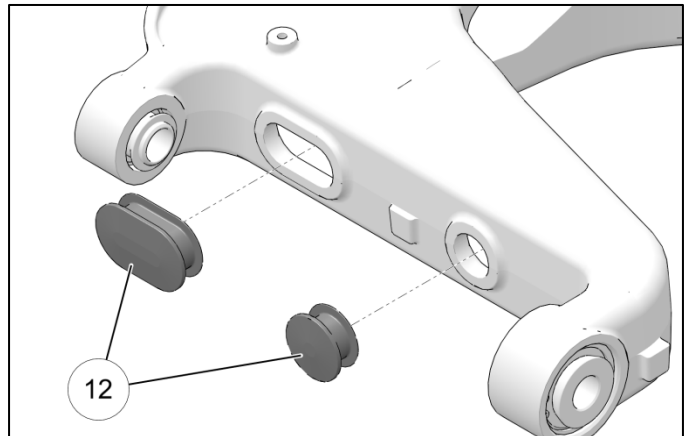
23. Remove two rubber grommets ⑫ from the swingarm.

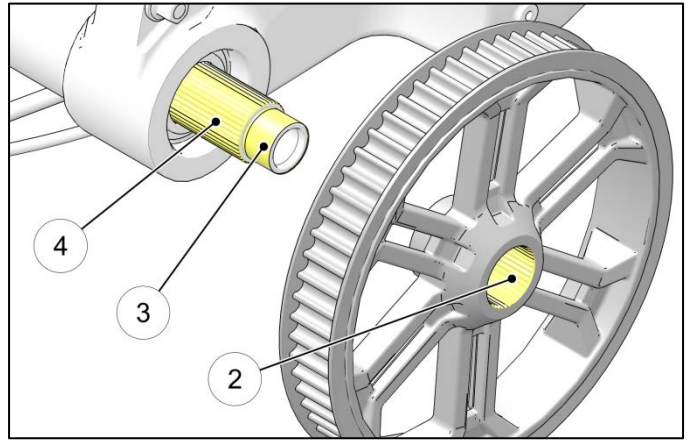
1. Thoroughly clean pivot shaft, pivot nut and all bushings removed from the original swingarm with contact cleaner.
2. Remove all Loctite residue. Using degreaser and a wire brush, thoroughly clean axle splines (4), threads (3) and the sprocket splines (2) before installation.

Removal of all Loctite material is a labor intensive process and may take up to 10 minutes or more to complete. It is critical that these surfaces are clean and no residual Loctite material or corrosion is present.

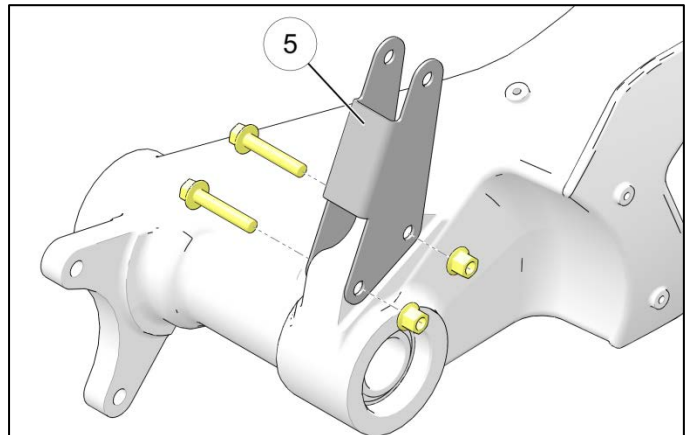
3. Install two fasteners securing rear shock bracket ⑤ to the swingarm. Torque fasteners to specification.

A secondary dealer representative must verify that the shock bracket fasteners have been torqued using a torque wrench set to the correct specification. Mark the fasteners with a paint pen to indicate the audit has been completed.

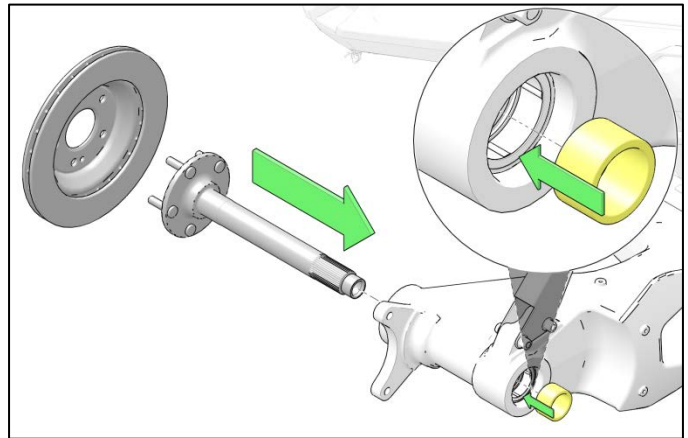
8. If installed, remove rear axle needle bushing before installing rear axle. Install brake disc and axle into swingarm. Inspect rear axle needle bushing to ensure it is not gouged or damaged. Install rear axle needle bushing.

A secondary dealer representative must verify that the needle bushing is not damaged before installation.

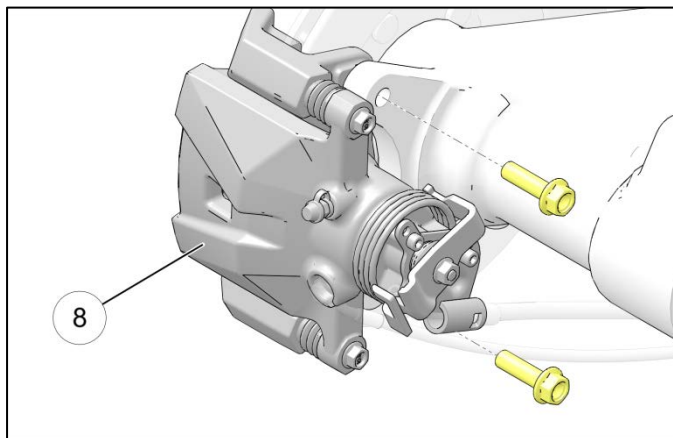
9. Position Brake Caliper (8) onto rotor and re-install two original fasteners. Torque fasteners to specification.

A secondary dealer representative must verify that the brake caliper fasteners were torqued using a torque wrench set to the correct specification. Mark the fasteners with a paint pen to indicate the audit has been completed.

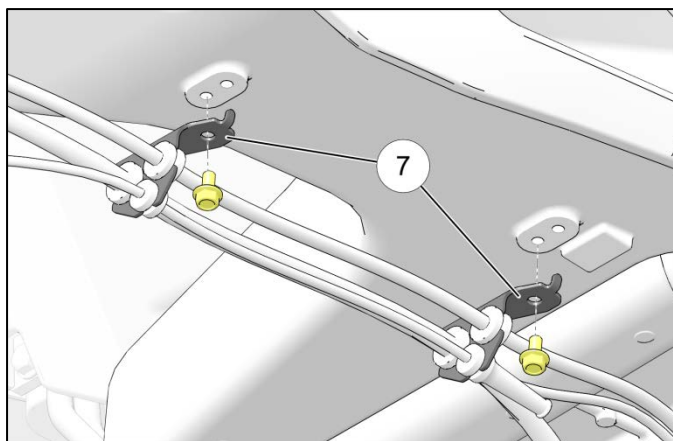
10. Install routing line fasteners and brackets (7) to the bottom of the swingarm. Torque fasteners to specification.

Routing Line Fasteners:  
**8 lb-ft (11 Nm)**

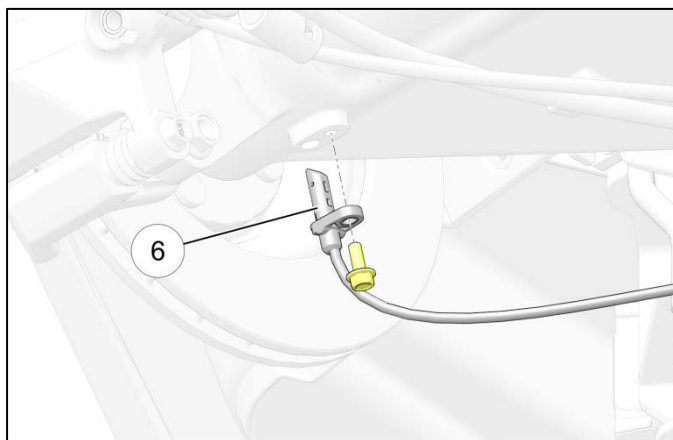
11. Install the rear wheel speed sensor (6) underneath the swingarm. Torque fastener to specification.

A secondary dealer representative must verify that the routing line fasteners and wheel speed sensor fastener have been torqued using a torque wrench set to the correct specification. Mark the fastener with a paint pen to indicate the audit has been completed.

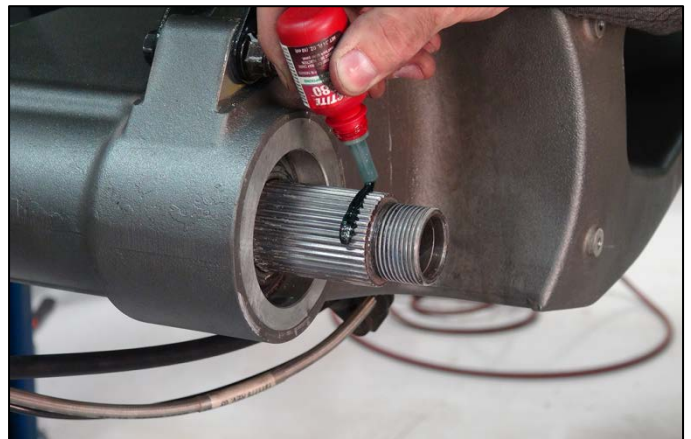
13. Inspect axle splines and threads, sprocket splines, and axle nut threads to ensure they are clean and free of old Loctite.
14. Apply a bead of Loctite (provided in kit) around the leading edge of the rear axle and driven sprocket splines.

A secondary dealer representative must verify that Loctite has been applied to leading edge of the rear axle and driven sprocket splines. Record time and date of Loctite application on the T-16-06 bulletin completion form.

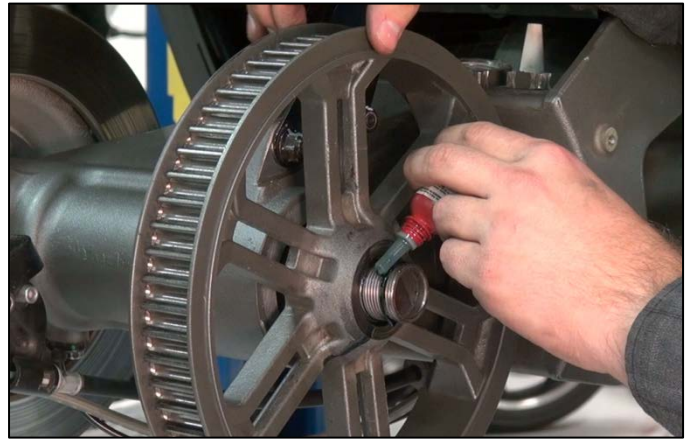
A secondary dealer representative must verify that Loctite has been applied to leading edge of the rear axle and inside rear axle nut threads. Record time and date of Loctite application on the T-16-06 bulletin completion form.

18. Install inside rear axle nut. Torque nut to specification.

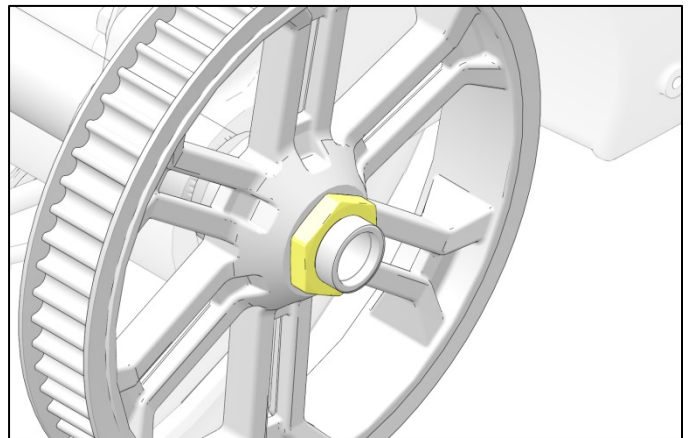
DO NOT reuse single axle nut.  
**SINGLE AXLE NUT = DISCARD**  
**DOUBLE AXLE NUTS = REUSE**

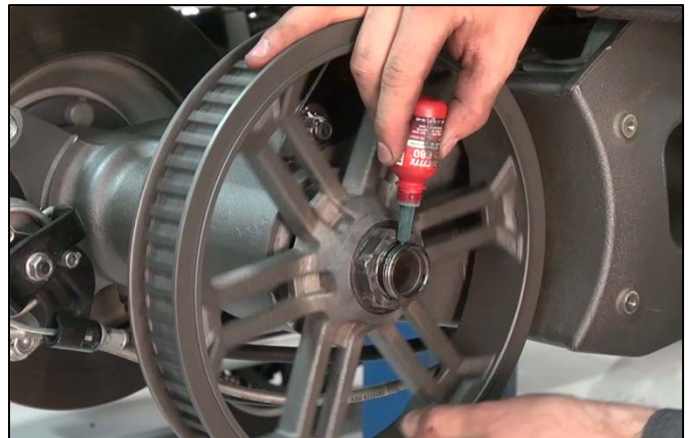
A secondary dealer representative must verify that Loctite has been applied to leading edge of the rear axle and outside rear axle nut threads. Record time and date of Loctite application on the T-16-06 bulletin completion form.

20. Install outside rear axle nut. Torque nut to specification.

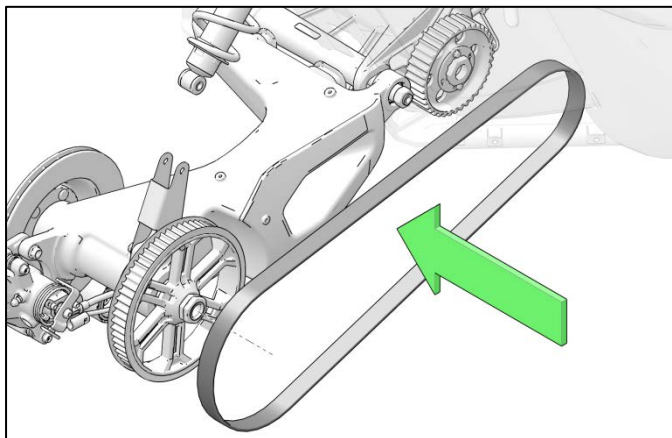
The belt is directional and marked with a part number that can be read when facing the vehicle. Make sure the belt is installed properly.

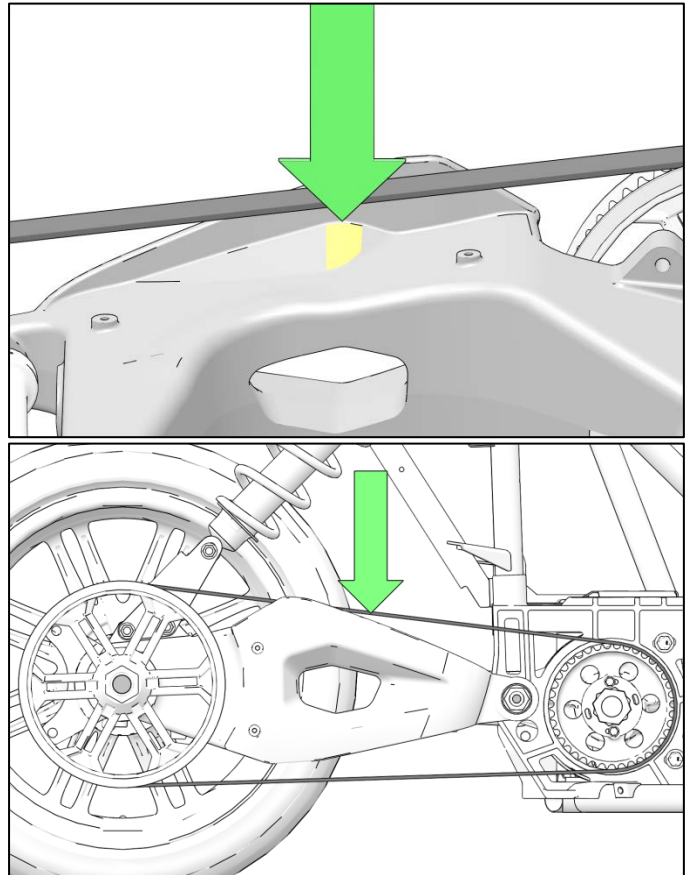
Drive Belt Span: **26.4 in (671.6 mm)**  
Drive Belt Width: **1.3 in (34.0 mm)**  
Drive Belt Mass: **8.4**

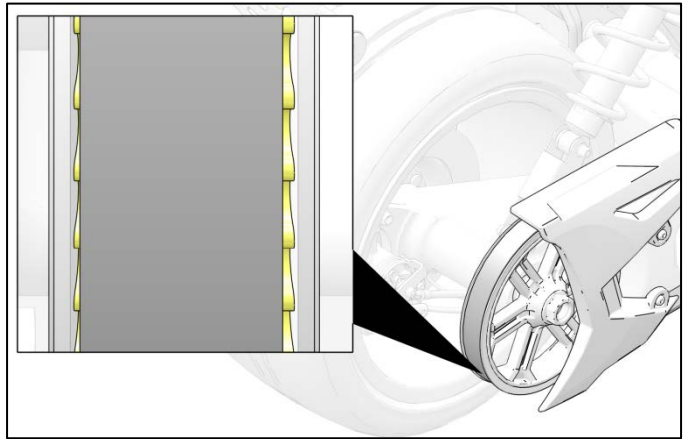
22. Rear wheel alignment is satisfactory when the drive belt tracks closer to the inboard driven sprocket flange. Sprocket teeth should still be visible on both sides of the drive belt.
23. If drive belt does not track properly, loosen Pivot Shaft Nut and tighten or loosen Pivot Shaft ¼ turn at a time to adjust where the drive belt tracks. Rotate the rear wheel forward and observe where the belt tracks on the rear sprocket.

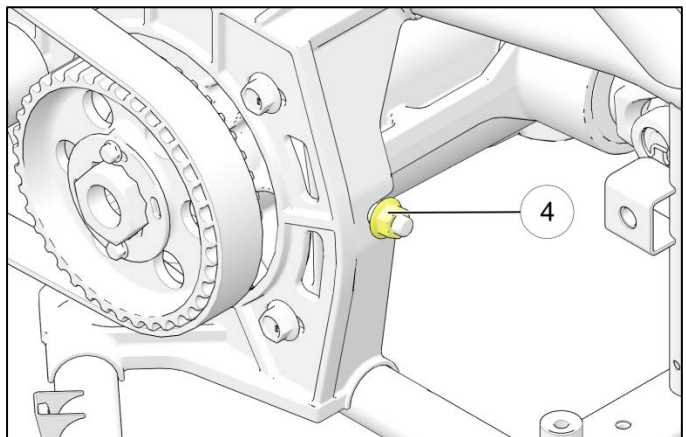
25. Lower vehicle to the ground.
26. Check belt tension with Sonic Tension Meter or measure deflection.

Drive Belt Deflection with 10 lbs of pressure:  
**NEW BELT: 0.3 in (8 mm)**  
**USED BELT: 0.4 in (10 mm)**
