# TECHNICAL SERVICE BULLETIN

Bulletin Number: T-16-06  
Model Years: 2015-2017

**2015-17 SLINGSHOT – Swingarm Replacement**

Certain Slingshot vehicles may have been assembled with an improperly manufactured swing arm, resulting in decreased swing arm strength. If the swing arm is compromised it can result in a loss of forward momentum or control, increasing the risk of a crash.

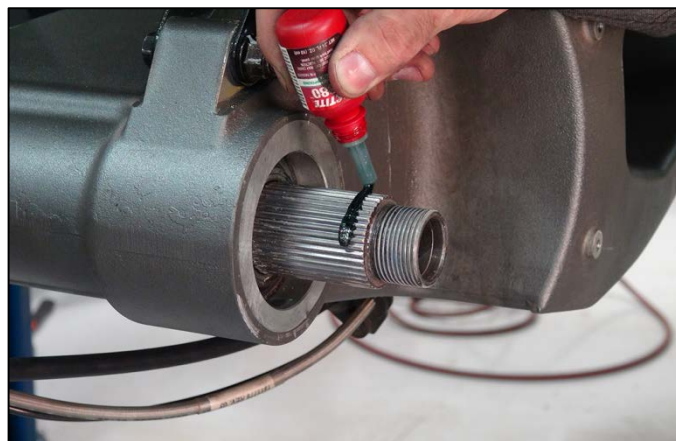
13. Inspect axle splines and threads, sprocket splines, and axle nut threads to ensure they are clean and free of old Loctite.
14. Apply a bead of Loctite (provided in kit) around the leading edge of the rear axle and driven sprocket splines.

A secondary dealer representative must verify that Loctite has been applied to leading edge of the rear axle and driven sprocket splines. Record time and date of Loctite application on the T-16-06 bulletin completion form.
