SAFETY RECALL

SR16-86B

12-VOLT POWER SOURCE RELAY REPLACEMENT 9700 (B13R)

On the vehicles affected by this recall, it is necessary to replace one (1) and in some cases two (2) 12-volts power source relays.

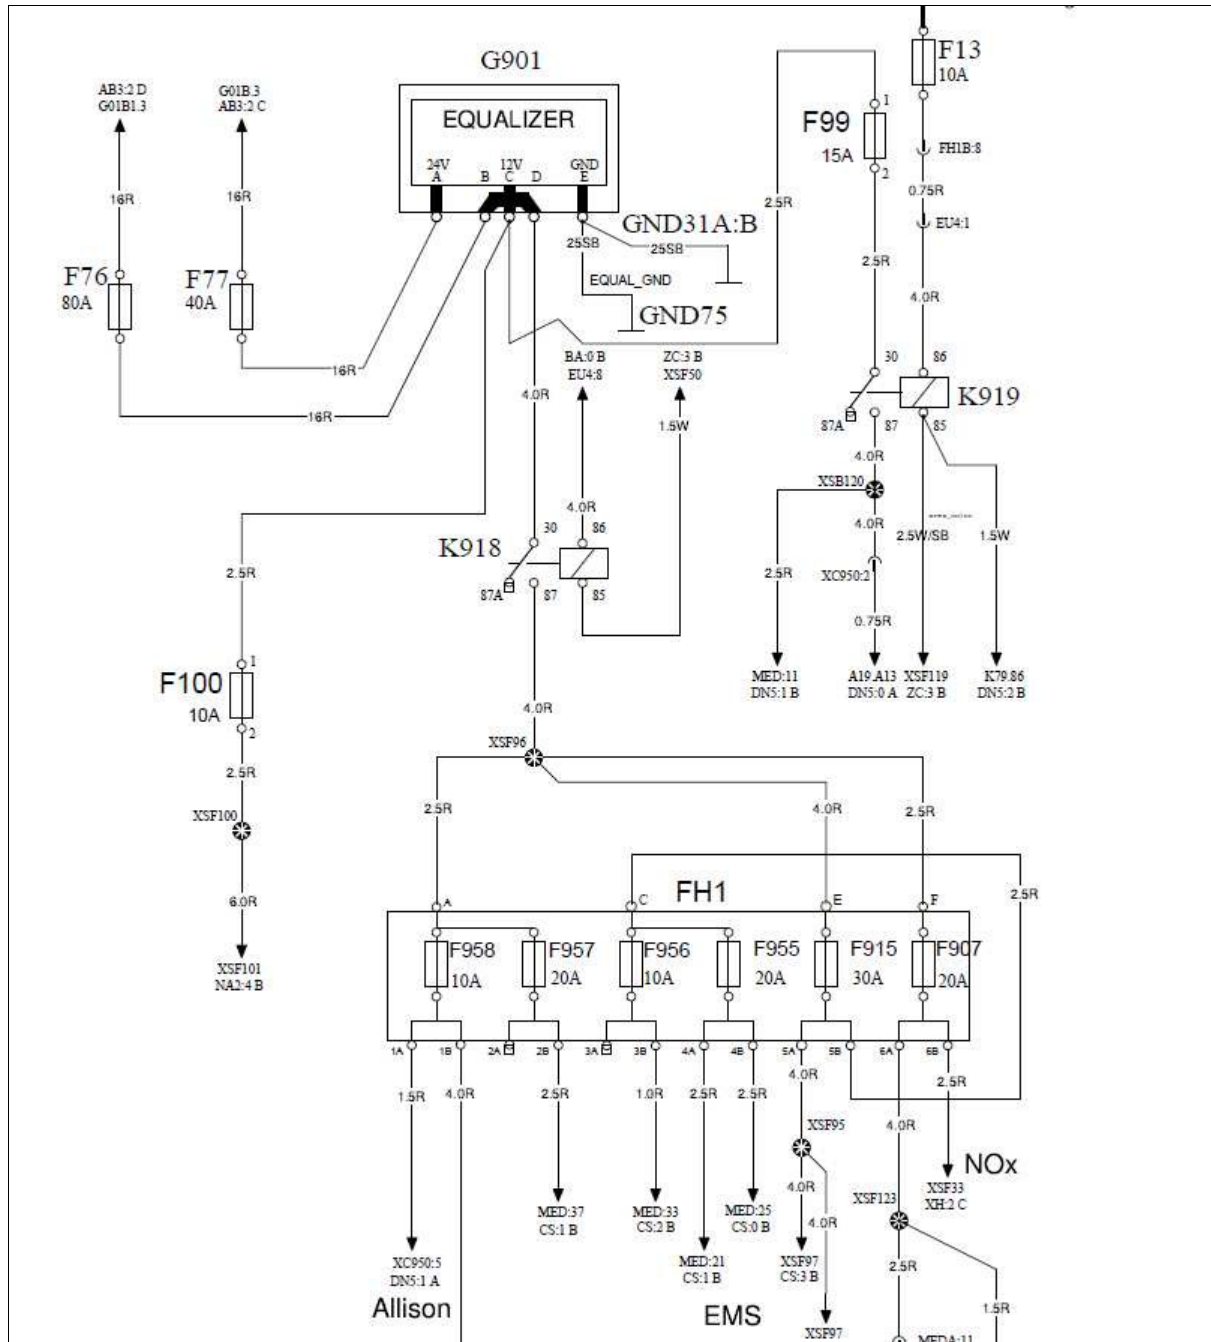
FIGURE 1: WIRING DIAGRAM SHOWING K918 & K919 – EQUIPPED WITH ALLISON TRANSMISSION

RANGE	WHAT TO DO
Model Year: up to 2013 Vehicles up to 3CET2S22XD5 <u>160297</u>	Relay K917: Replace existing relay K917 with relay p/n 21244697 (Cartier Mini) Relay K918: Replace existing relay K918 with relay p/n 564218 (Cartier Maxi). Refer to the following instruction.
Model Year: 2013 – 2015 From 3CET2S225D5 <u>160756</u> up to 3CET2V227F5 <u>168569</u>	Relay K918: Replace existing relay K918 with relay p/n 564218 (Cartier Maxi). Refer to the following instruction.
Model Year: from 2015 Equipped with Allison transmission From 3CET2V224F5 <u>169811</u>	Relay K919: Replace existing relay K919 with relay p/n 21244697 (Cartier Mini) Relay K918: Replace existing relay K918 with relay p/n 564218 (Cartier Maxi). Refer to the following instruction.
Model Year: from 2015 Equipped with I-Shift transmission From 3CET2V224F5 <u>169811</u>	Relay K918: Replace existing relay K918 with relay p/n 564218 (Cartier Maxi). Refer to the following instruction.

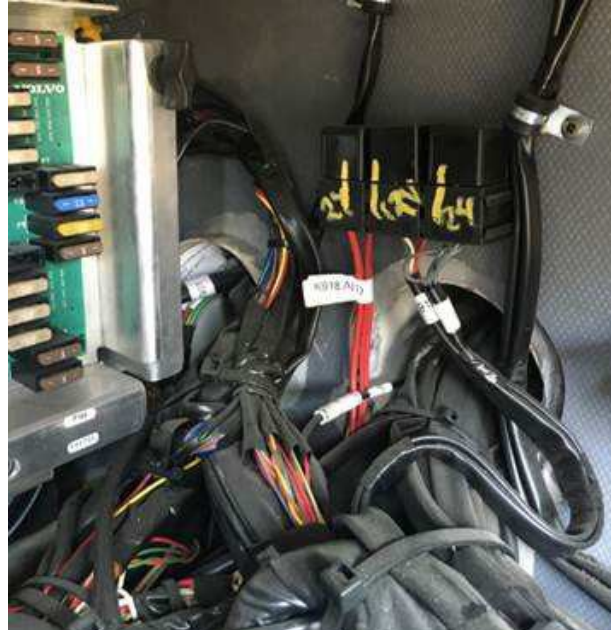
FIGURE 3: For vehicles not equipped with I-START dual battery system (until **3CET2V42XG5176275**), find K918 at the right side of electrical distribution unit.

- 5) Locate relay K918. See FIGURE 3 & FIGURE 4

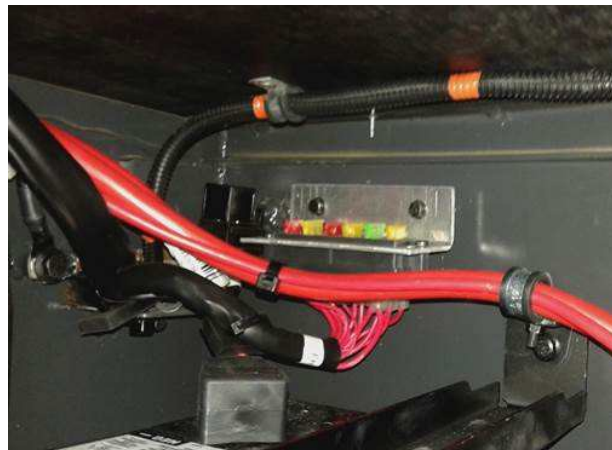
FIGURE 4 : For vehicles equipped with I-START dual battery system (from **3CET2V220G5177311**), find K918 at the starter batteries compartment.

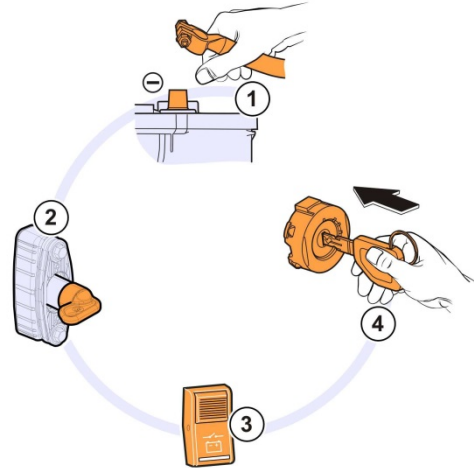
FIGURE 8

- 15) Turn on the vehicle. Follow these steps:
- Connect NEGATIVE cable in vehicle battery;
 - Turn on battery switch;
 - Turn on vehicle switch in the dashboard;
 - Insert vehicle key.
