**RECALL: This modification has top priority and must be performed immediately to ensure customer safety**

**Subject: Inspection, Repositioning and Securing of the wiring harness routing and ground cable installation**

**Affected Models: 2012, 2013, 2014, 2015 and 2016 690 Duke**

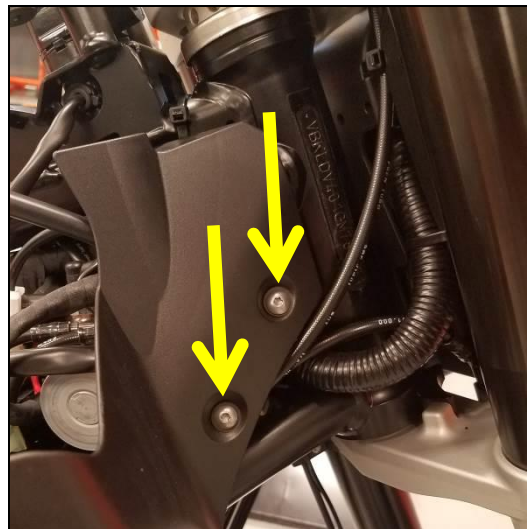
1. Remove the fuel tank and then remove the right side frame cover. **(Fig. 1)**

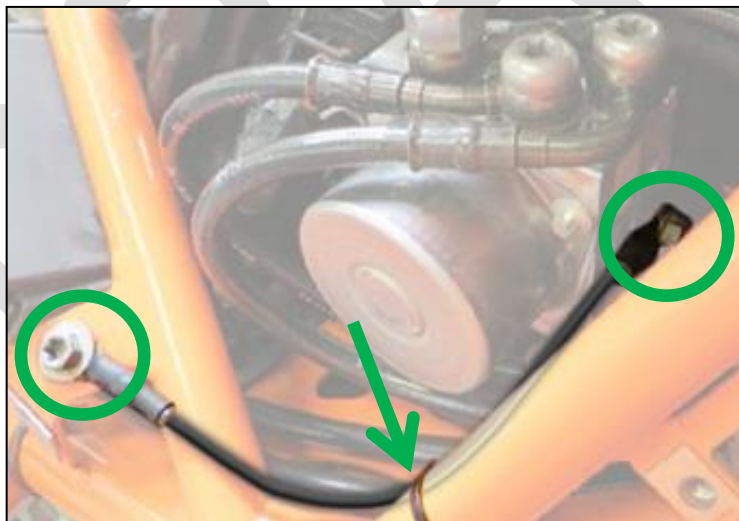
2. Attach the ground cable onto the ABS modulator using an 8mm gear wrench. **(Fig. 2)**
3. Mount the ground cable to the frame using the new collar screw and contact washer between cable and frame, secure the wire to the frame using a cable tie. **(Fig. 2)**

4. Check the entire wiring harness for visible damage around the ABS modulator (chafing, damaged coating, exposed wires, etc.). If any damage to the wiring harness is found take a photo and contact Dealer Services before continuing the repair.

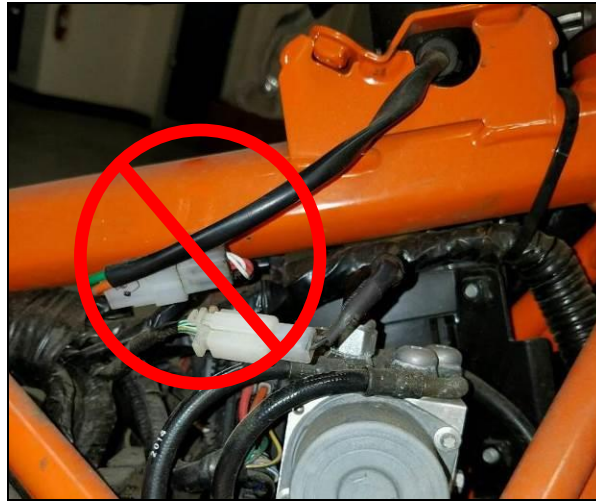
(Fig. 3) DISPLAYS INCORRECT ROUTING

**Please observe:** The minimum clearance between the ABS modulator and an electrical line must be at least 20 mm.

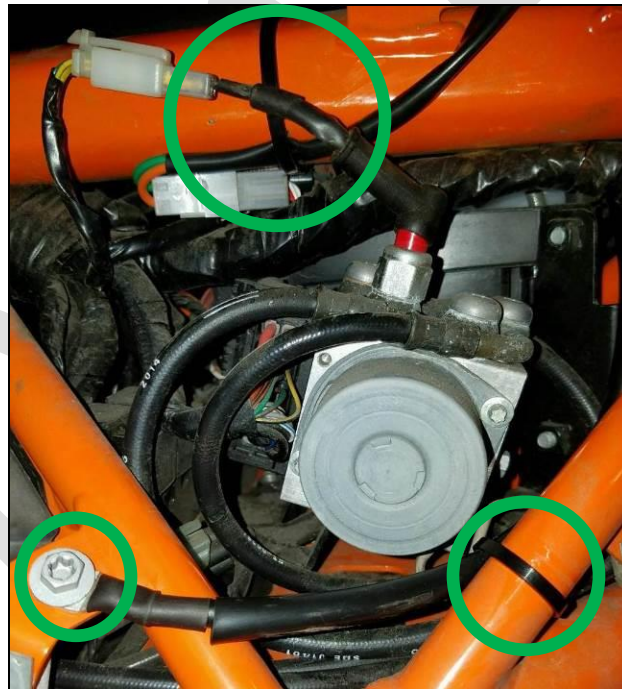
5. Secure the Green & Orange wiring harness as shown using a cable tie. (Fig. 4)

6. Take a photo of the repositioning of the wiring harness, cable tie placement and mounted ground cable so you can attach it to the warranty claim for proof of correction.

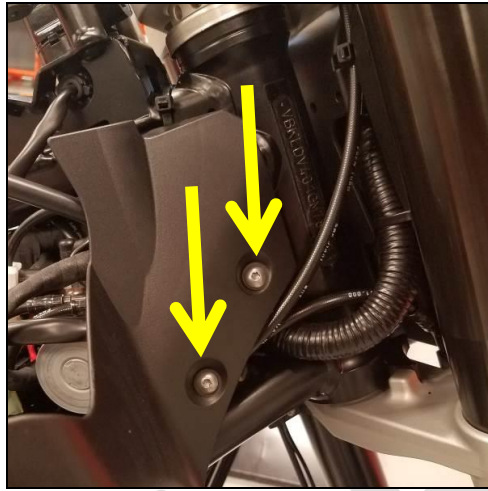
1. Remove the fuel tank and then remove the right side frame cover. **(Fig. 5)**

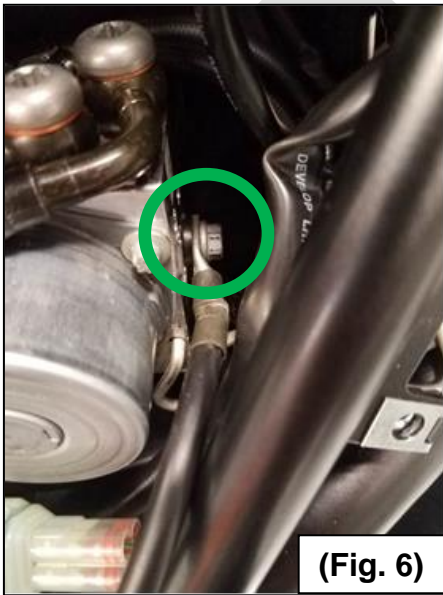
2. Attach the ground cable onto the ABS modulator using an 8mm gear wrench. **(Fig. 6)**
3. Attach the ground cable to the frame and secure the wire to the frame using a cable tie. **(Fig. 7)**

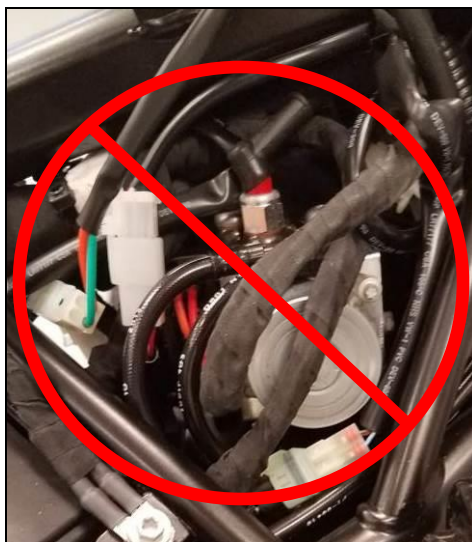
(Fig. 8) DISPLAYS INCORRECT ROUTING

**Please observe: The minimum clearance between the ABS modulator and an electrical line must be at least 20 mm.**

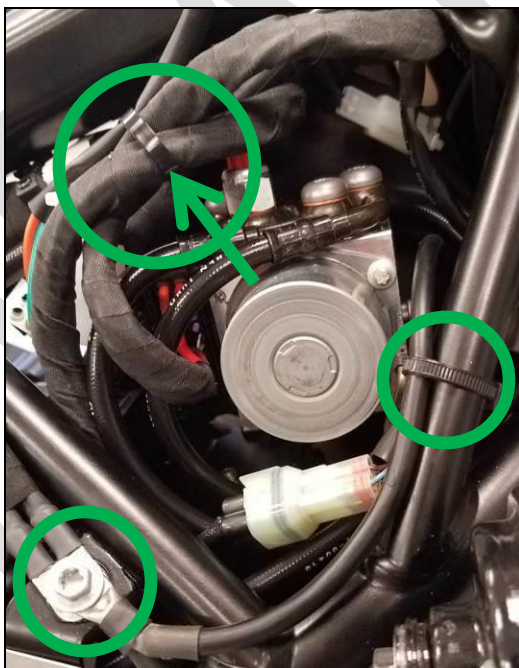
5. Secure the wiring harness as shown using a cable tie. (Fig. 9)

6. Take a photo of the repositioning of the wiring harness, cable tie placement and mounted ground cable so you can attach it to the warranty claim for proof of correction.
