# Product Safety Recall

## 16146 Right Rear Side Air Bag

Reference Number: N162076520

| <b>Condition</b> | General Motors has decided that a defect which relates to motor vehicle safety exists in certain 2017 model year Chevrolet Malibu vehicles. The right-hand rear side airbag (RSIAB) in these vehicles may have a weak weld on the inflator manifold. In the event of an RSIAB deployment in a right-side impact, this defect can cause inflator components to separate, propelling debris or hot gas into the interior compartment. It is also possible that the airbag may inflate only partially, or not at all, in the event of a right side impact crash. If the airbag components separate and are propelled into the interior compartment during deployment in a crash, or the airbag does not inflate, there may be an increased risk of injury to the occupants. |

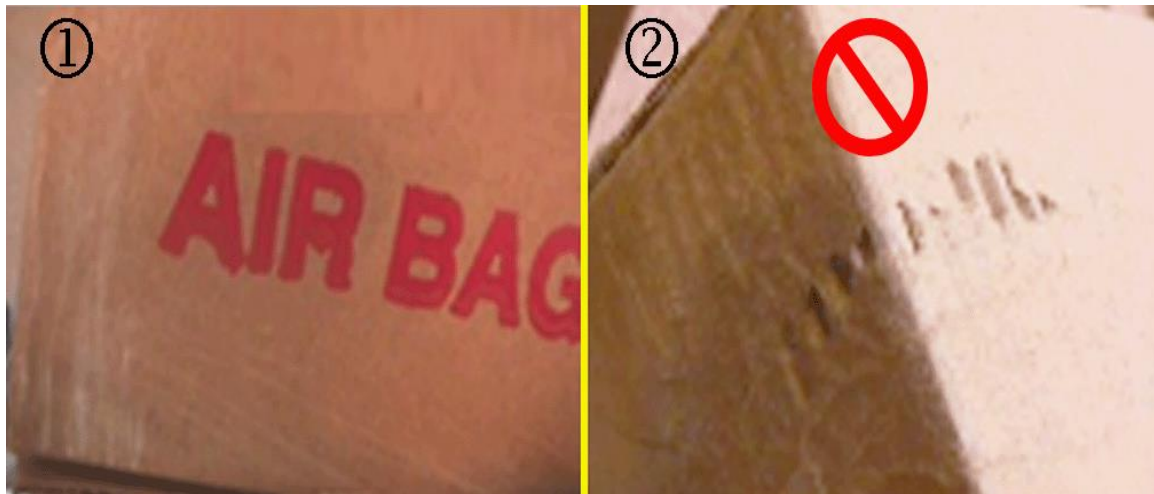
**Note:** Examples of **Acceptable packaging (1)** are shown on the left side of the graphics below; **Unacceptable packaging (2)** are shown on the right.

- **Abrasions:** Abrasions result from sliding the package against a rough surface (e.g. concrete floors). Major abrasions (2) are NOT acceptable. Note the flutes are visible.

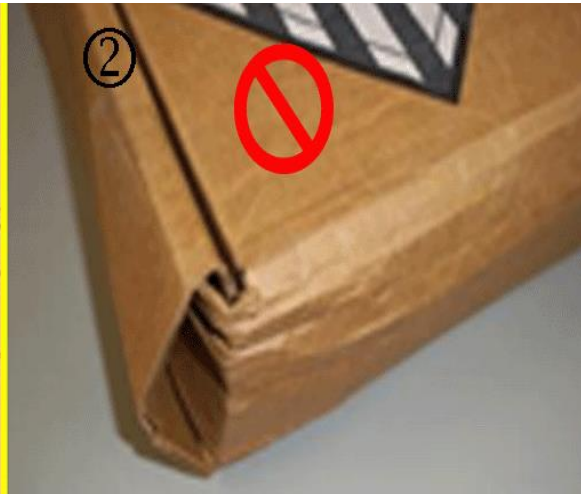
3691563

- **Compressions:** Compressions result from superimposed weights (e.g. stacked too high) or from dropping the packages. Small dimples (1) are acceptable.

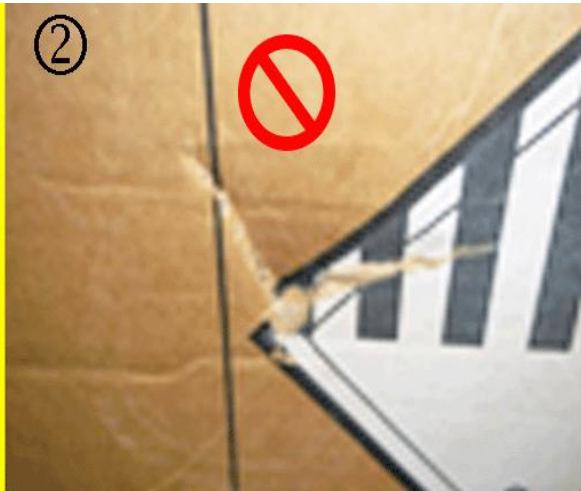
3961564

- **Dents:** Minor dents (1) occur through normal handling and picking (e.g. pulling from bin locations) and are acceptable. Major dents (2) result from impacts with others objects (e.g. pallet impacts).

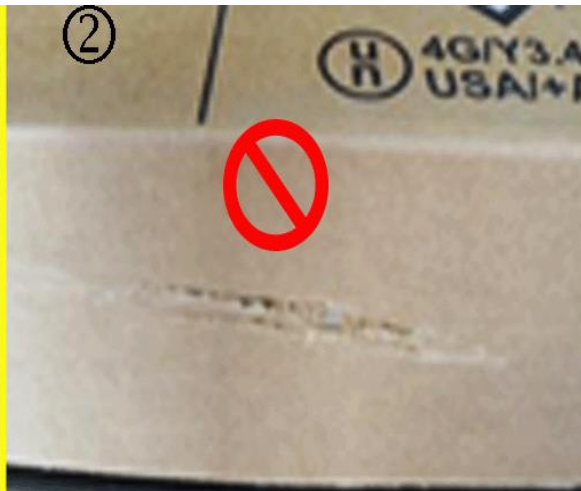
3961565

- **Incisions:** Minor incisions (1) are acceptable. Major incisions (2) (e.g. pallet box cut open with utility knife) are NOT acceptable.

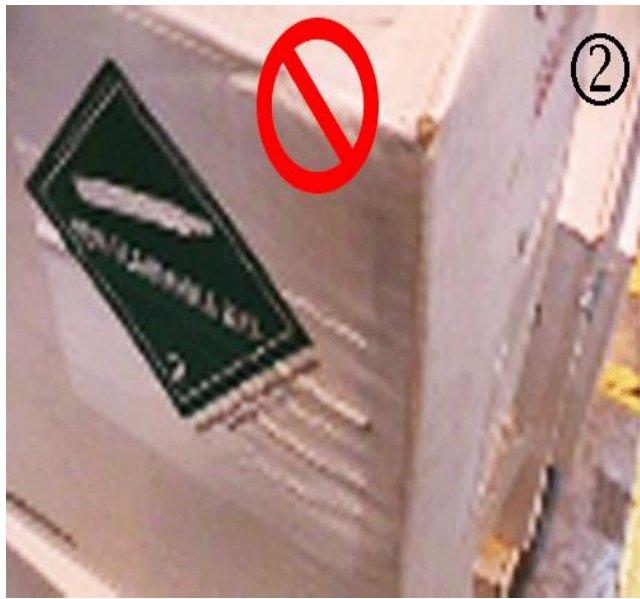
3961569

- **Water Damages:** Water Damages, such as the example shown above, are NOT acceptable. Water damages will affect the structural integrity of the packaging. These packages should be repacked in appropriate specification packages.

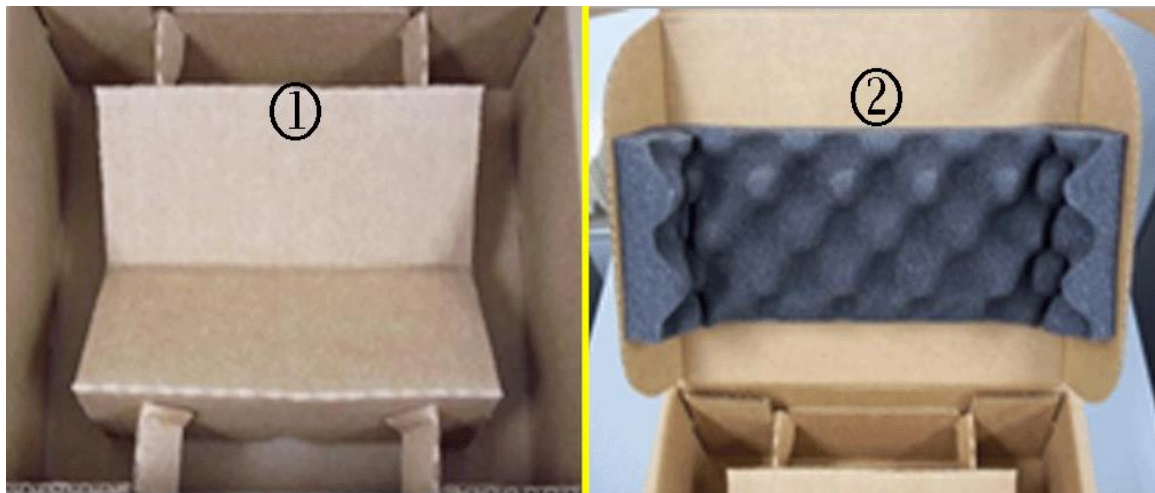
3961570

**Important:** The components required for the completed return package are dunnage (1) and foam (2), as shown in the graphic above.

1. **DO NOT DEPLOY THE AIRBAG.** Ensure that the box the replacement airbag arrived in is not damaged and place the side impact airbag in the box. Also, make sure to include a copy of the repair order in the box.

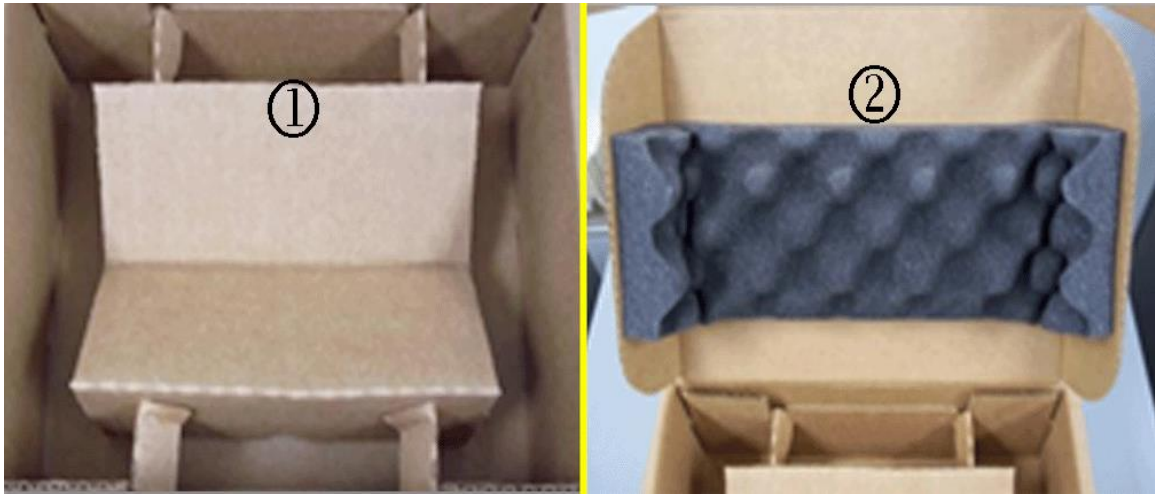
3961570

**Important:** The components required for the completed return package are dunnage (1) and foam (2), as shown in the graphic above.

1. **DO NOT DEPLOY the AIRBAG.** Ensure that the box the replacement airbag arrived in is not damaged and place the side impact airbag in the box. Also, make sure to include a copy of the repair order in the box.

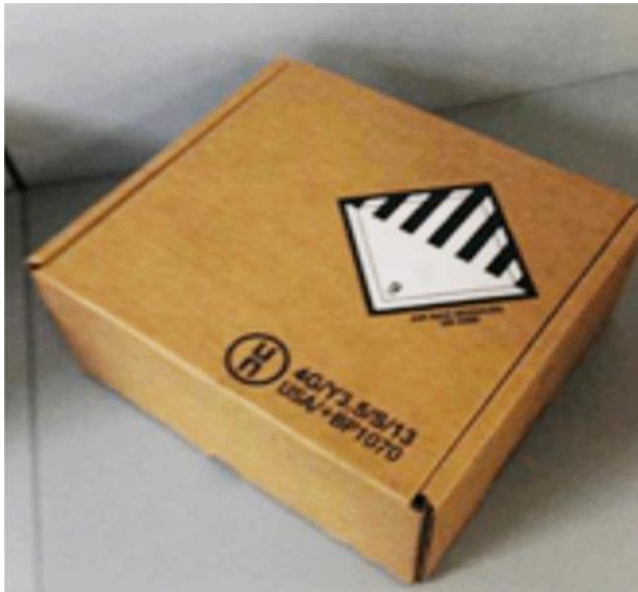
3955264

2. Close and secure the side rollover tuck top box following the closing instructions below:

- The tape strip should extend at least 2 inches (1) onto either side of the front fold and the bottom surface of the box. The minimal tape length should be 4 inches.
- 2.1. Seal the front flap with a strip of 2 inch wide clear plastic adhesive pressure sensitive tape (generic packaging plastic tape) measuring at least 4 inches long.
  - 2.2. Black out any old shipping labels and barcodes (other than those noted above) with a permanent black marker.
  - 2.3. DO NOT complete FedEx documents that may be enclosed in the box with the new module. These are intended for dealers using **Option A** only.
