Action Required For Identifying the Recalled Bendix® SR-5™ Valve

Identifying SR-5 valves covered in this field action

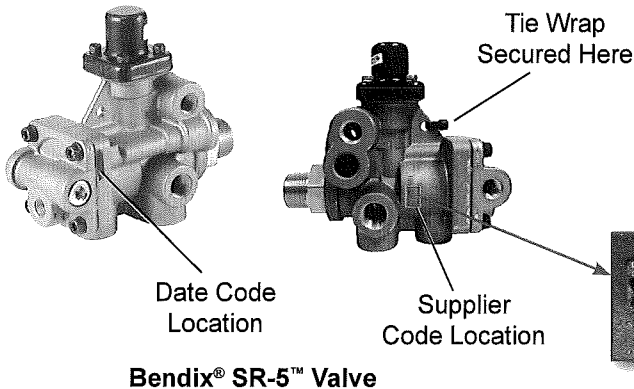
To verify that the Bendix® SR-5™ valve has been repaired per the recall campaign, look for the presence of a black or green tie wrap secured to the valve body. *No further action is required.*

The Bendix SR-5 valves covered by this campaign can be identified by the supplier code and the date of manufacture located on the valve body. Verification of both is required to determine if the valve is a part of the campaign. Valves covered by this campaign must meet the following criteria:

1. The supplier code—"IKD"—cast in the body and located as shown in the illustration above; and
2. The date of manufacture between January 1, 2014 and March 4, 2016, inclusive. To verify the date code see *Interpreting the Date Code* below.

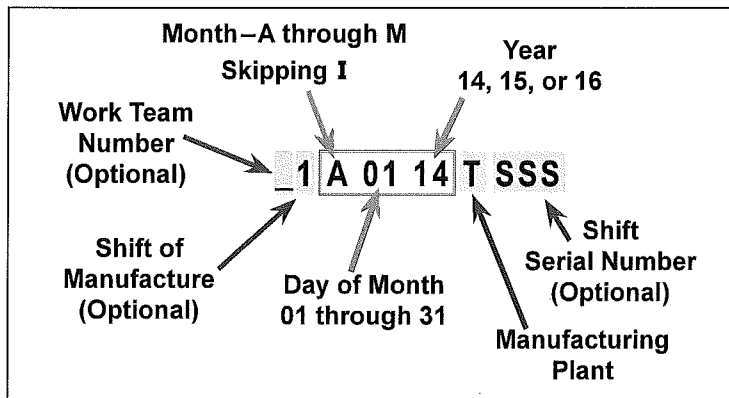
A date code is stamped (not cast) on the SR-5 valve body housing. *Locate the date code – removing the paint coating, if necessary – to read the code.* Disregard the Work Team Number, Shift of Manufacture, Manufacturing Plant and Shift Serial Number codes shown in gray below. The portion of the date code that determines the date of manufacture is highlighted and can be interpreted as follows:

- The first field is the month (A=January, B=February, etc. – excluding the letter I – so that J=September, and so on),
- The next two fields are the day of the month (e.g. 01=1st); and
- The next two fields are the year (e.g. 14=2014)
