## TECHNICAL INSTRUCTIONS FOR SAFETY RECALL G0R FRONT PASSENGER AIRBAG INFLATOR MODULE CERTAIN 2010 MY 4RUNNER

### UPDATE 9-5-18

The subject vehicles are equipped with front passenger airbag inflators produced by Takata. According to Takata, the propellant in these inflators may degrade after prolonged exposure to high absolute humidity and fluctuating high temperatures. Degraded propellant can cause inflator rupture during airbag deployment. In the event of an inflator rupture, metal fragments could pass through the airbag cushion material, striking the vehicle occupants, and result in serious injury or death.

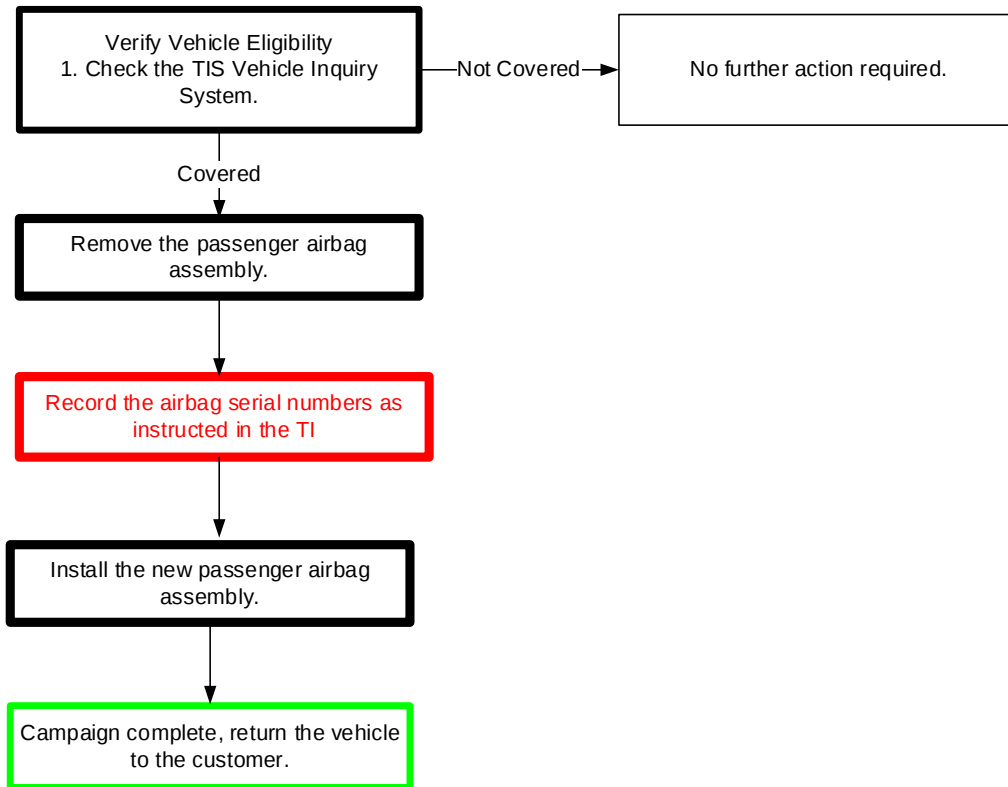
## I. OPERATION FLOW CHART

The flow chart is for reference only. **DO NOT** use it in place of the full technical instructions. Follow **ALL** steps as outlined in the full technical instructions to confirm the campaign is completed correctly.

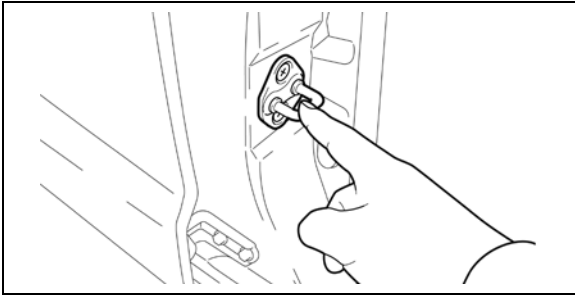
#### 1. ELIMINATE STATIC ELECTRICITY

- Before starting work and periodically while working on the vehicle, touch a metallic part of the vehicle to discharge static electricity in the body.

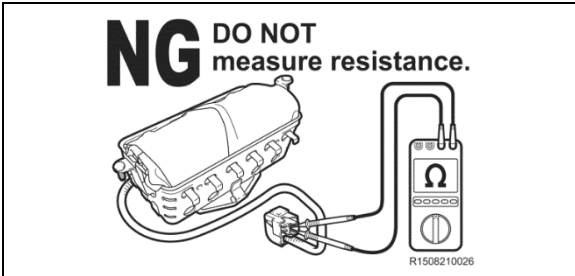
#### 2. DO NOT MEASURE RESISTANCE

- DO NOT** measure resistance of airbag components, this may cause accidental activation.

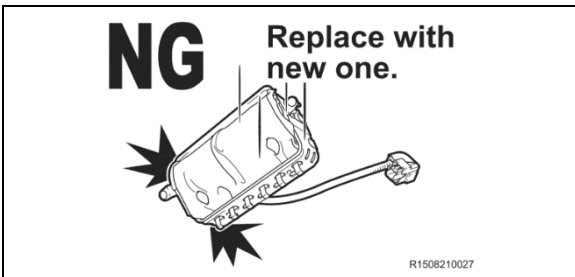
#### 3. HANDLE THE AIRBAG CAREFULLY

- If an airbag is dropped, replace it with a **NEW** one.

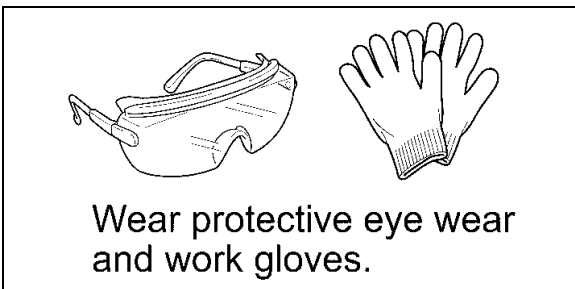
#### 4. WEAR PROTECTIVE EQUIPMENT

- Always wear appropriate protective equipment when working on the SRS.

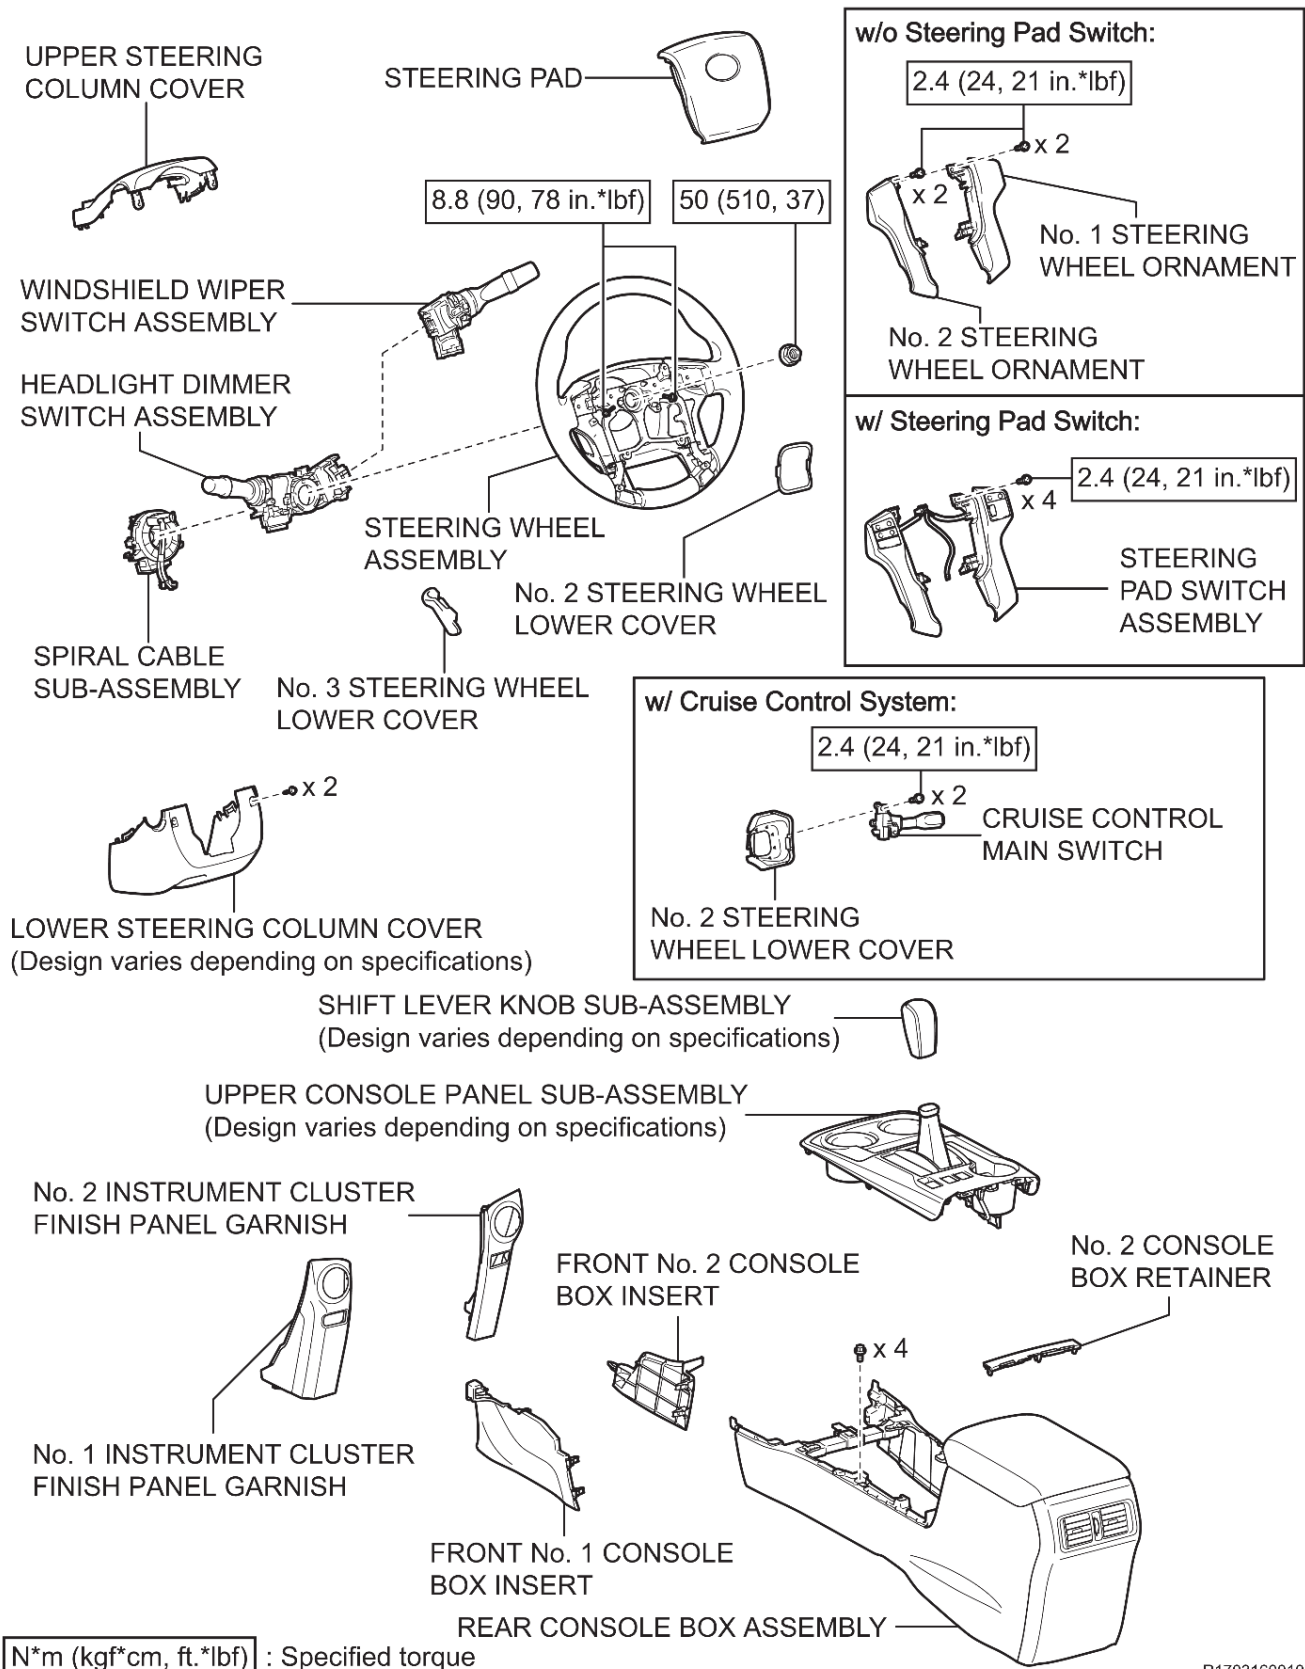
R1703160010

FRONT PILLAR  
GARNISH RH

FRONT DOOR OPENING TRIM  
WEATHERSTRIP RH

COWL SIDE TRIM BOARD RH

DOOR SCUFF PLATE ASSEMBLY RH

Part manufactured  
before August 2013:

Part manufactured  
after August 2013:

**NOTE:** The left front A-Pillar garnish needs to be replaced on vehicles manufactured prior to August 2013. Only one garnish is required per vehicle depending upon color code. The kit contains the garnish and the non-reusable clip. (see parts information)

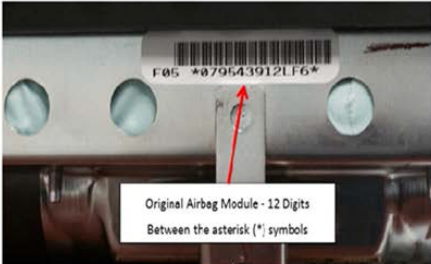
#### Airbag Serial Number Label Example

- The airbag serial number is **ALWAYS** the **12 DIGITS** located between the asterisks.
- The 3 digits before the asterisk **ARE NOT** part of the serial number, and **SHOULD NOT** be entered or an inaccurate response may be returned.

Original Airbag Module - 12 Digits Between the asterisk (\*) symbols

The Airbag module Assembly serial number is a 12 digit code. It can be found along with a bar code on opening the Airbag assembly unit. To manually enter these details into the application, the technician has to identify the 12 digit code between two Asterisks (\*) inside the Airbag assembly unit. The first seven characters of this 12 digit code are numbers and the 10<sup>th</sup> digit is either 'K' or 'L' always.

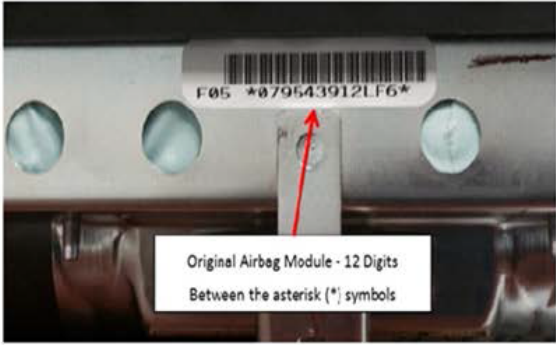
a) If the airbag serial number cannot be scanned or is not present check the box as shown below.

Check this box if the label is damaged or missing

If the airbag serial number and barcode are not legible or are not present, check the box in the application indicating the serial number is not legible.

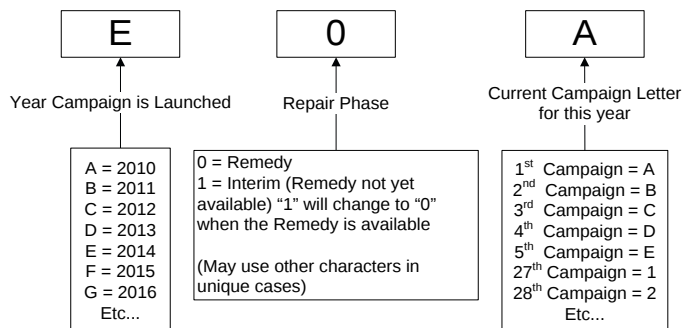
### A. CAMPAIGN DESIGNATION DECODER

Examples:

A0D = Launched in 2010, Remedy Phase, 4<sup>th</sup> Campaign Launched in 2010

B1E = Launched in 2011, Interim Phase, 5<sup>th</sup> Campaign Launched in 2011

C1C = Launched in 2012, Interim Phase, 3<sup>rd</sup> Campaign Launched in 2012
