## TECHNICAL INSTRUCTIONS FOR SAFETY RECALL G0P FRONT PASSENGER AIRBAG INFLATOR MODULE CERTAIN 2010-2013 MY 4Runner

### UPDATE 9-5-18

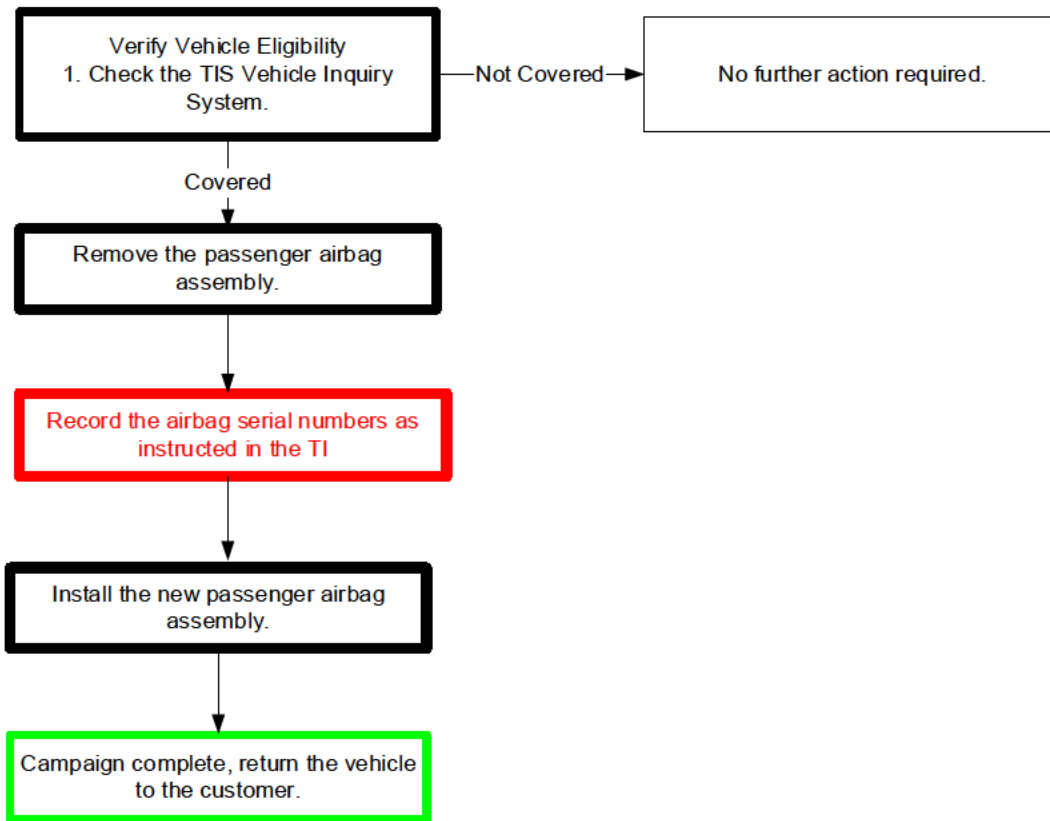
## I. OPERATION FLOW CHART

The flow chart is for reference only. **DO NOT** use it in place of the full technical instructions. Follow **ALL** steps as outlined in the full technical instructions to confirm the campaign is completed correctly.

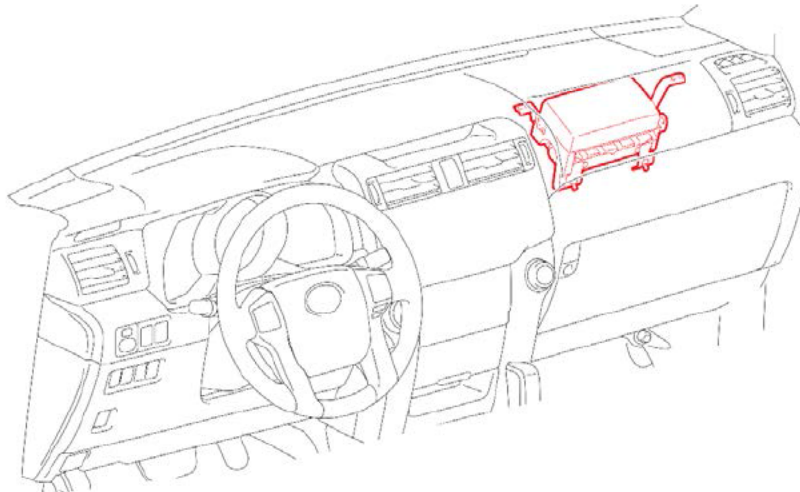
R170316000SA01

The subject vehicles are equipped with front passenger airbag inflators produced by Takata. According to Takata, the propellant in these inflators may degrade after prolonged exposure to high absolute humidity and fluctuating high temperatures. Degraded propellant can cause inflator rupture during airbag deployment. In the event of an inflator rupture, metal fragments could pass through the airbag cushion material, striking the vehicle occupants, and result in serious injury or death.

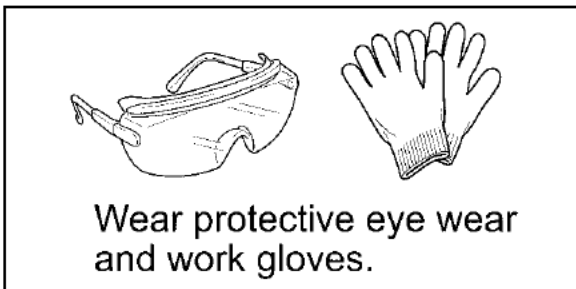
#### 4. WEAR PROTECTIVE EQUIPMENT

- Always wear appropriate protective equipment when working on the SRS.

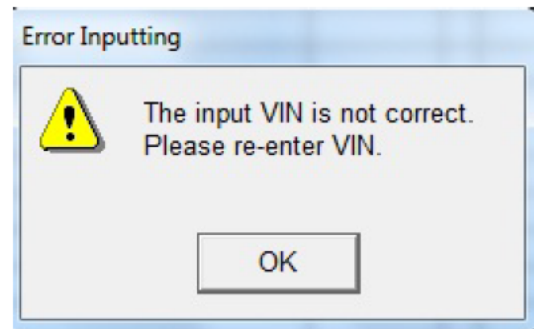
- After the health check has completed, run a diagnostic report by clicking on the link on the health check screen.

**NOTE: If the VIN was not entered in ALL CAPS when Techstream was launched, an error will be displayed and there will be a prompt to reenter the VIN**

- Enter the vehicle mileage and repair order information, then click the 'report' button.

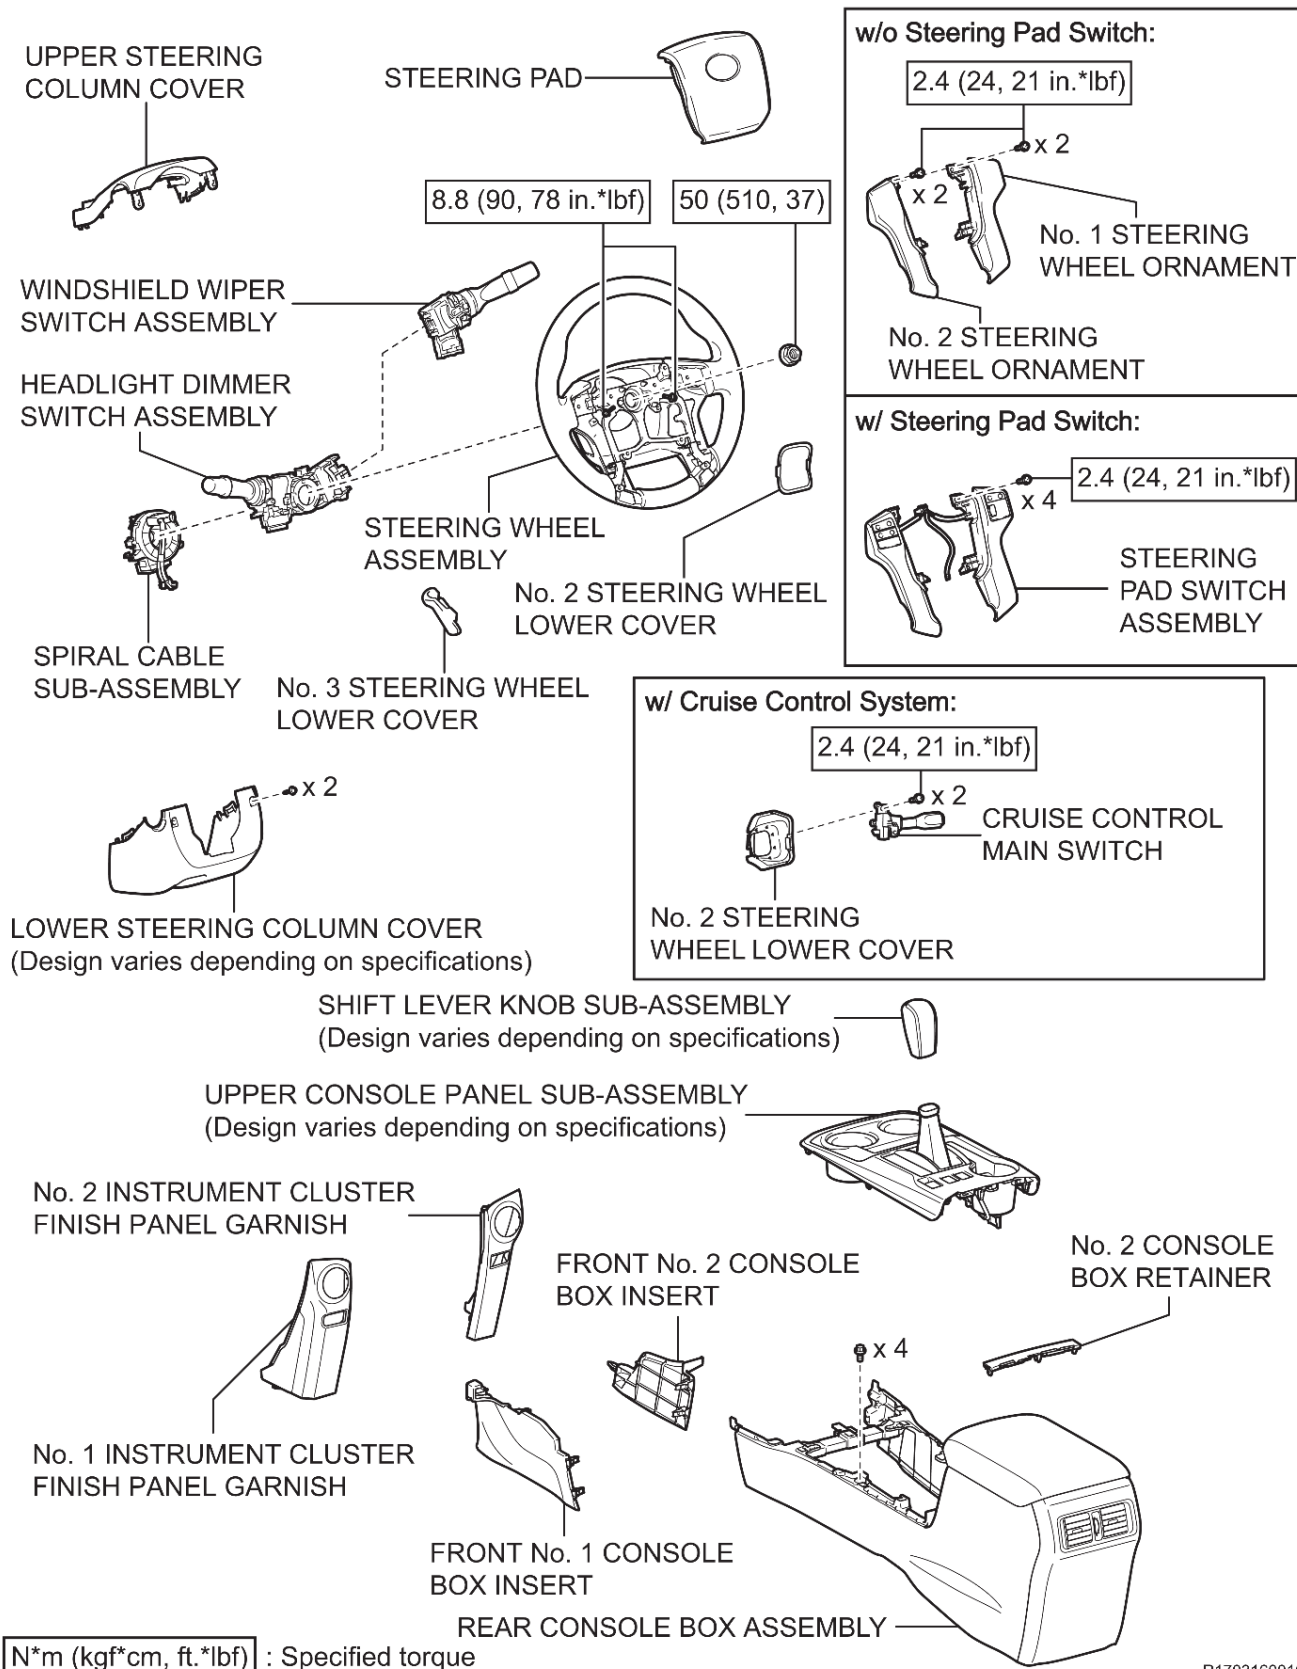
R1703160010

**CAUTION-PLASTIC RETAINING CLIPS ARE FRAGILE. REMOVE WITH CARE**

FRONT PILLAR  
GARNISH RH

FRONT DOOR OPENING TRIM  
WEATHERSTRIP RH

**NOTE:** The left front A-Pillar garnish needs to be replaced on vehicles manufactured prior to August 2013. Only one garnish is required per vehicle depending upon color code. The kit contains the garnish and the non-reusable clip. (see parts information)

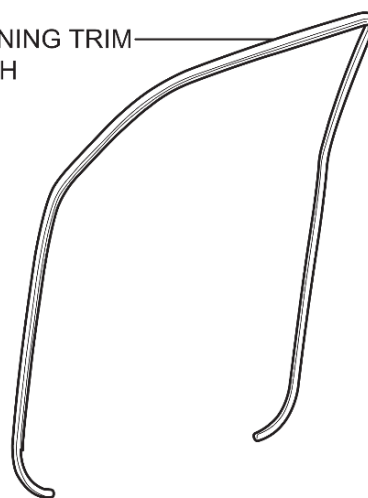
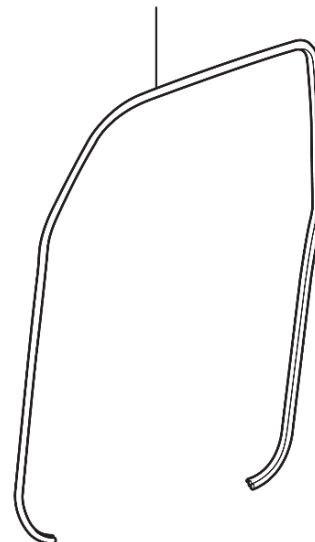
R1703160011

COWL SIDE TRIM BOARD RH

DOOR SCUFF PLATE ASSEMBLY RH

Part manufactured  
before August 2013:

Part manufactured  
after August 2013:

● FRONT PILLAR  
GARNISH LH

No. 1 FRONT PILLAR  
GARNISH COVER LH

FRONT PILLAR  
GARNISH LH

FRONT DOOR OPENING TRIM  
WEATHERSTRIP LH

COWL SIDE TRIM BOARD LH

DOOR SCUFF PLATE ASSEMBLY LH

● Replacement part

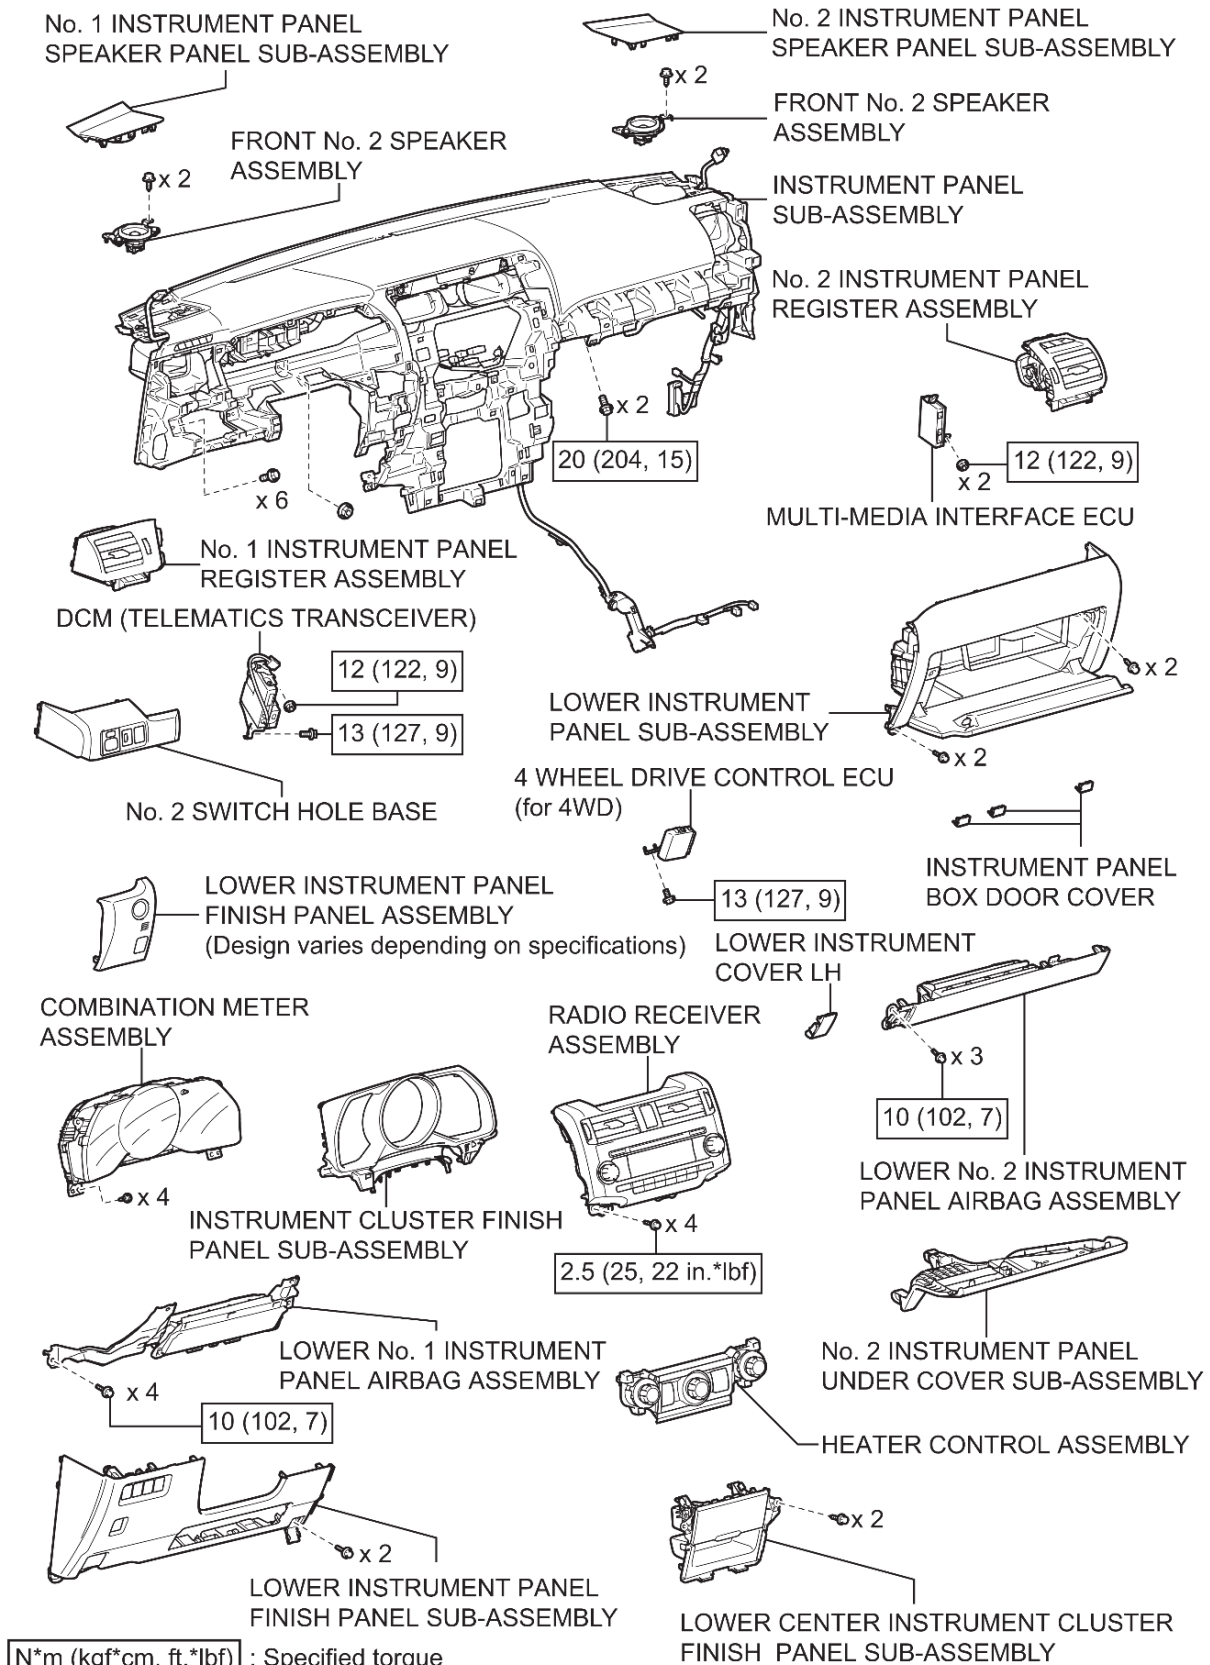
R1703160012

**CAUTION-PLASTIC RETAINING CLIPS ARE FRAGILE. REMOVE WITH CARE**

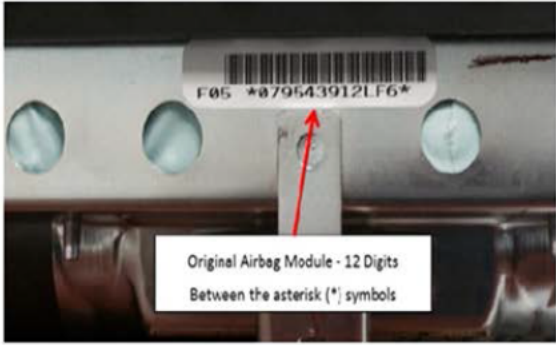
a) If the airbag serial number cannot be scanned or is not present check the box as shown below.

Original Airbag Module - 12 Digits  
Between the asterisk (\*) symbols

Check this box if the label is damaged or missing

b) Go to Page 12 to continue airbag scanning.

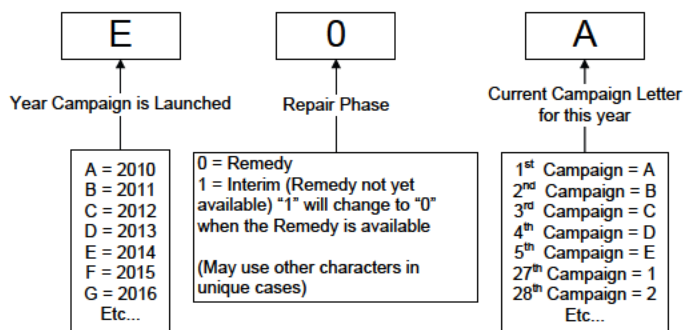
### A. CAMPAIGN DESIGNATION DECODER

Examples:

A0D = Launched in 2010, Remedy Phase, 4<sup>th</sup> Campaign Launched in 2010

B1E = Launched in 2011, Interim Phase, 5<sup>th</sup> Campaign Launched in 2011

C1C = Launched in 2012, Interim Phase, 3<sup>rd</sup> Campaign Launched in 2012
