| RE: <b>Recall Campaign Update Notification – 2020080007</b><br><b>Takata Priority Groups 9 &amp; 10</b><br><b>Replace Front Passenger-Side Airbags</b><br>Certain MY12-15 C-Class Coupe (C204) vehicles | DATE: September 25, 2020 |

### IMPORTANT TAKATA RECALL CAMPAIGN UPDATE

SUBJECT: Model W204 and C204  
Model Years 2012-2015  
Replace Front Passenger-side Airbag

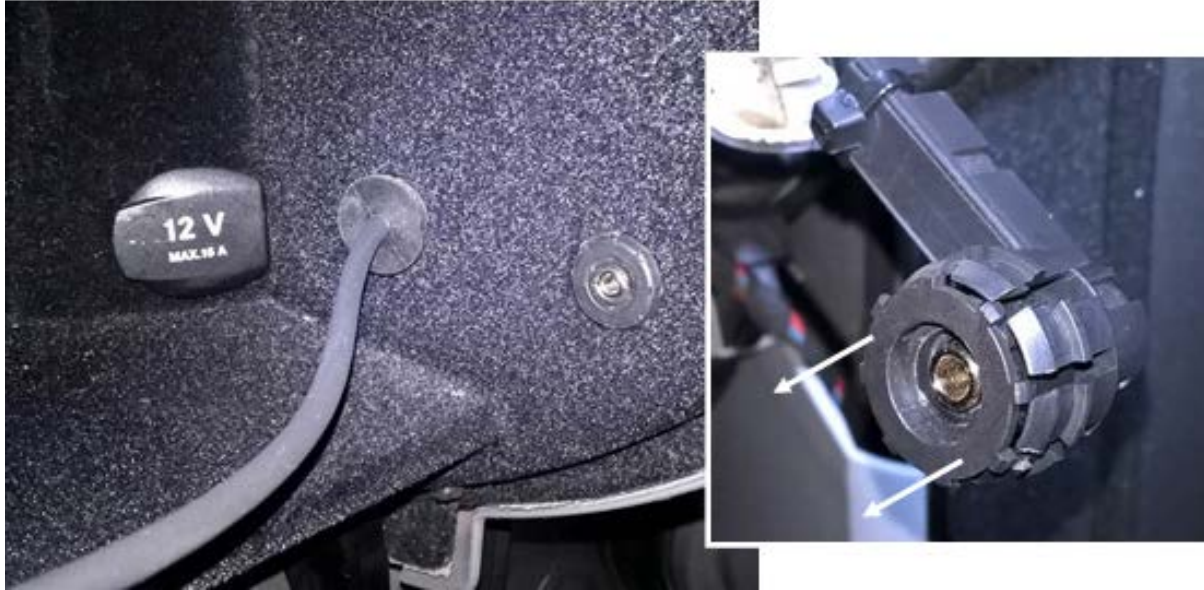
Figure 3

**i** Pull iPod cable **with** rubber grommet out of glove box housing until the connector plug makes contact with the housing. **Do not pull cable out of rubber grommet** because it is bonded to the rubber grommet and will otherwise be damaged!

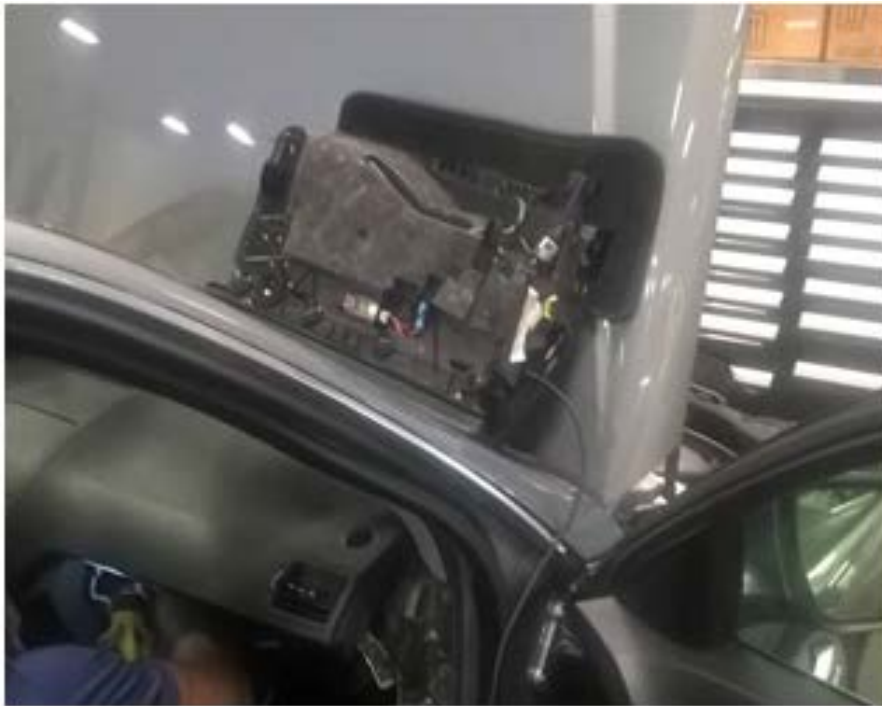
Figure 4

**i** Pull out the iPod cable as far as possible and set down glove box housing on the windshield **with** exterior iPod cable connected (**figure 4**).

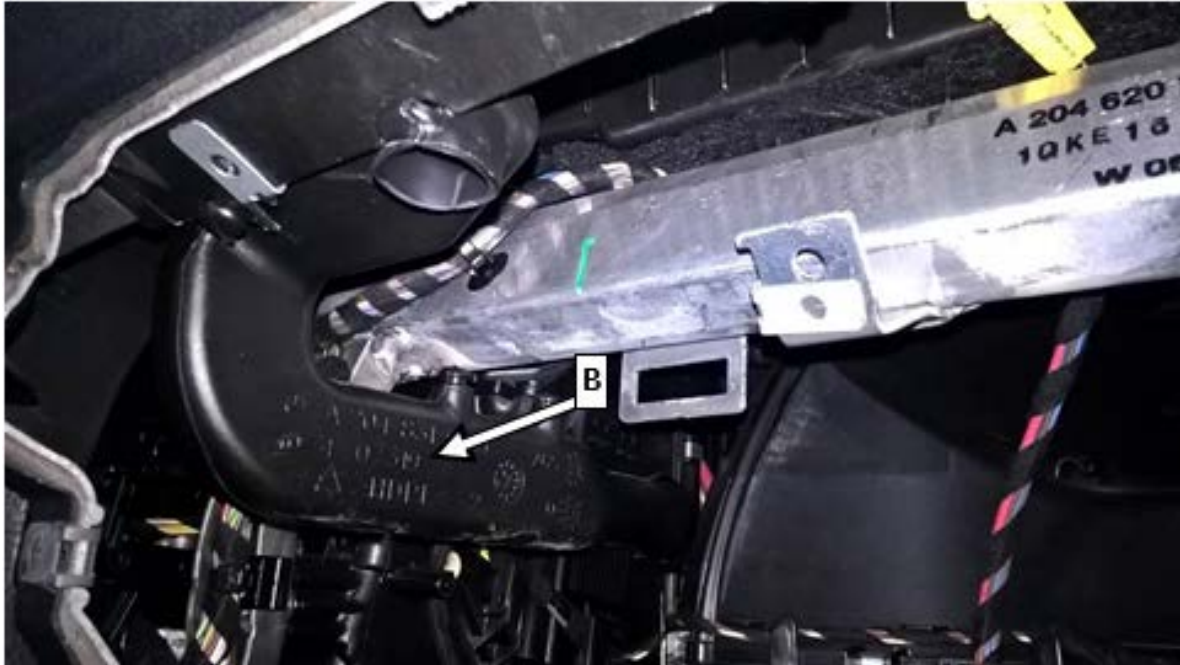
Figure 5

4. Remove air duct (**B**, figure 5) above the glove compartment.

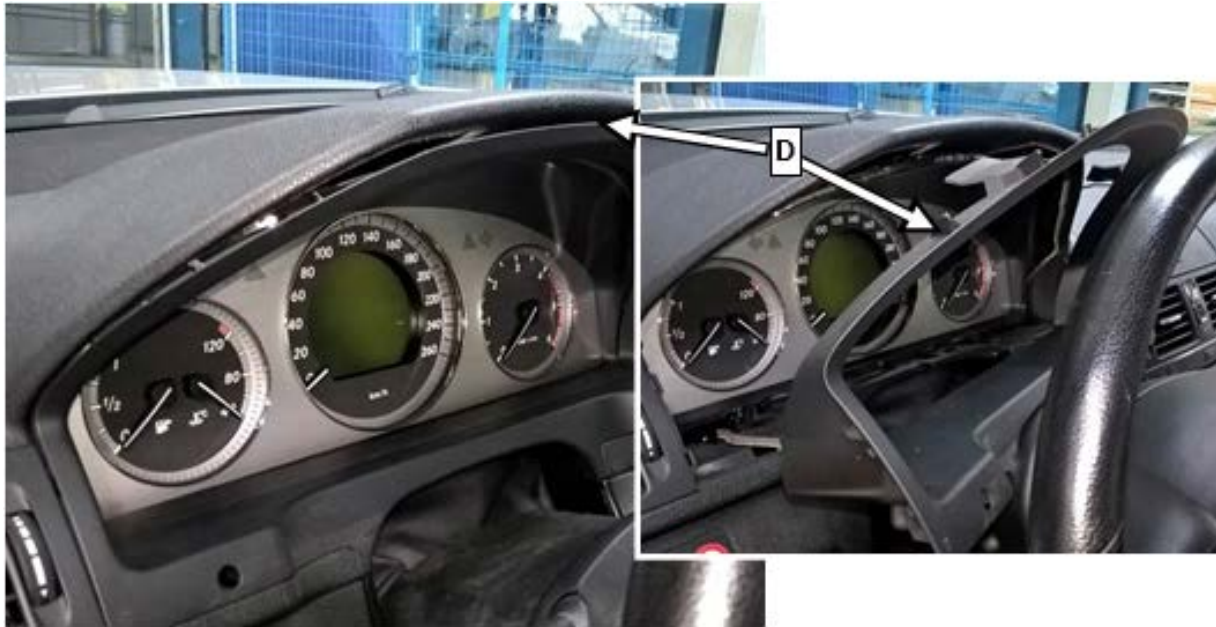
Figure 7

6. Remove center console (**AR68.20-P-2000CW**).
7. Remove automatic climate control and operating unit.  
**i** For basic data of model W204, see **AR83.40-P-6350CW**
8. Remove trim (**D, figure 7**) around the instrument cluster.

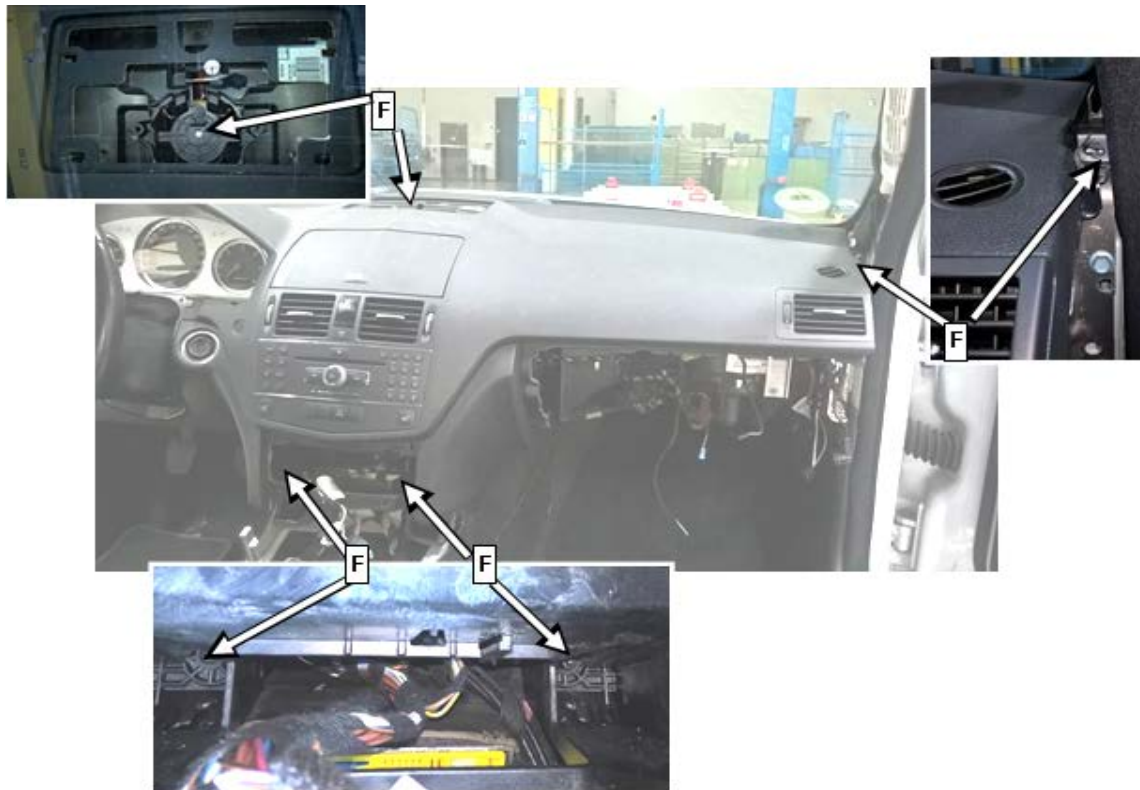
Figure 9

10. Remove four screws (**F**, **figure 9**) for fastening the instrument panel

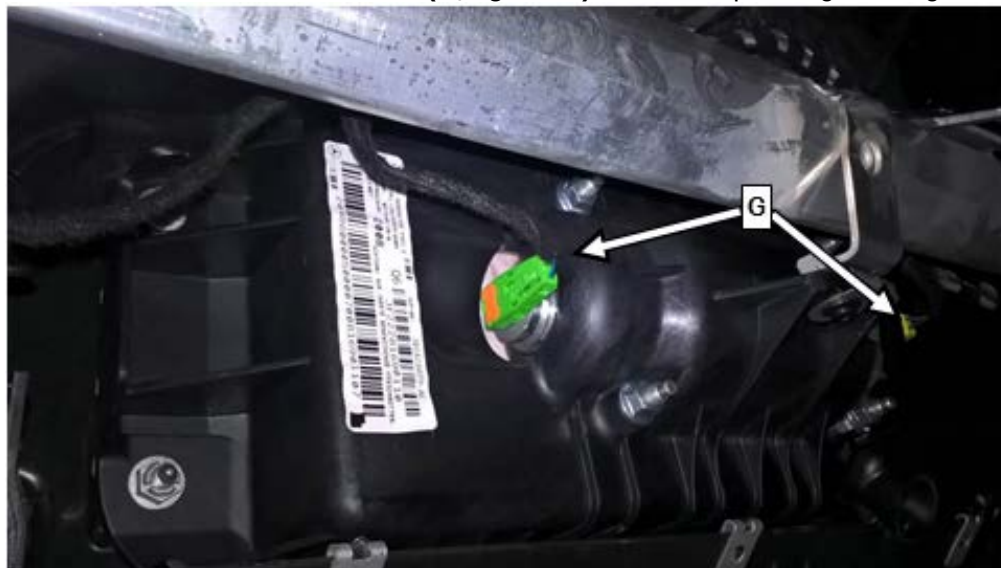
Figure 10

11. Disconnect electrical contacts (**G**, **figure 10**) at the front passenger airbag.

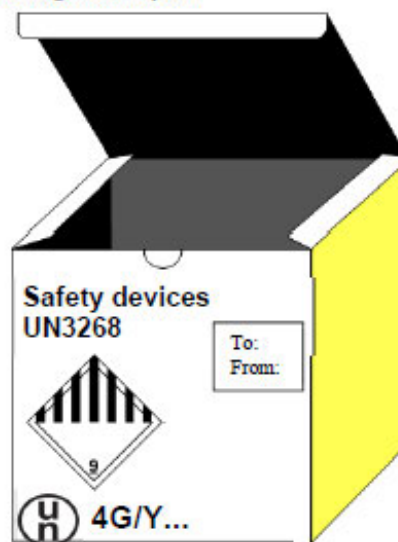
- Carefully open received box and remove new airbag. Keep box intact & save all contents!
- Place used airbag into replacement airbag box, re-using any packaging material (e.g., cardboard inserts) used for the new airbag. Package as the new airbag was packaged.
- Use plastic adhesive tape 50 mm wide to secure the box closed. Do not obscure labels or text on the box with the tape.
- Ensure that the 4G fiberboard box is not ripped or damaged.

- The following words ("marking") must also be clearly visible on the same side of the box as the Class 9 label:  
**Safety devices**  
**UN3268** (font size must be  $\geq \frac{1}{2}$  inch)
- Affix "To/From" address label to same or adjacent packaging face as the hazardous markings/labels.
- The UN 4G code preprinted near the bottom edge of the box must also be clearly visible.
