| RE: <b>Recall Campaign Launch Notification – 2020080007 Takata PG10 Replace Front Passenger-Side Airbags</b><br>Certain MY12-14 C-Class Sedan (W204) vehicles | DATE: April 21, 2020 |

| Recall Campaign Launch Notification | | | August 21, 2020 |
|---|---|---|---|
| Campaign No. : | NHTSA ID: | Campaign Desc. : | Takata Recall – PG 10<br>Replace Front Passenger-Side Airbag |

SUBJECT: **Model W204****Model Years 2012-2014****Replace Front Passenger-side Airbag**

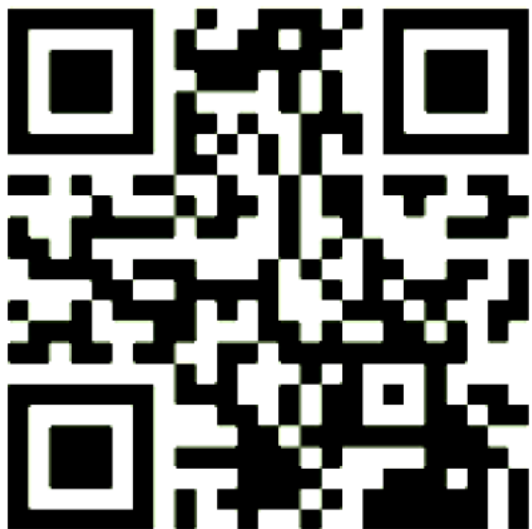
Figure 1

- To install and transmit the data a WiFi connection is required.
- After downloading the App, a one-time security authentication is required by means of encrypted QR code. Verification can be performed by scanning the QR code below, before using the application.

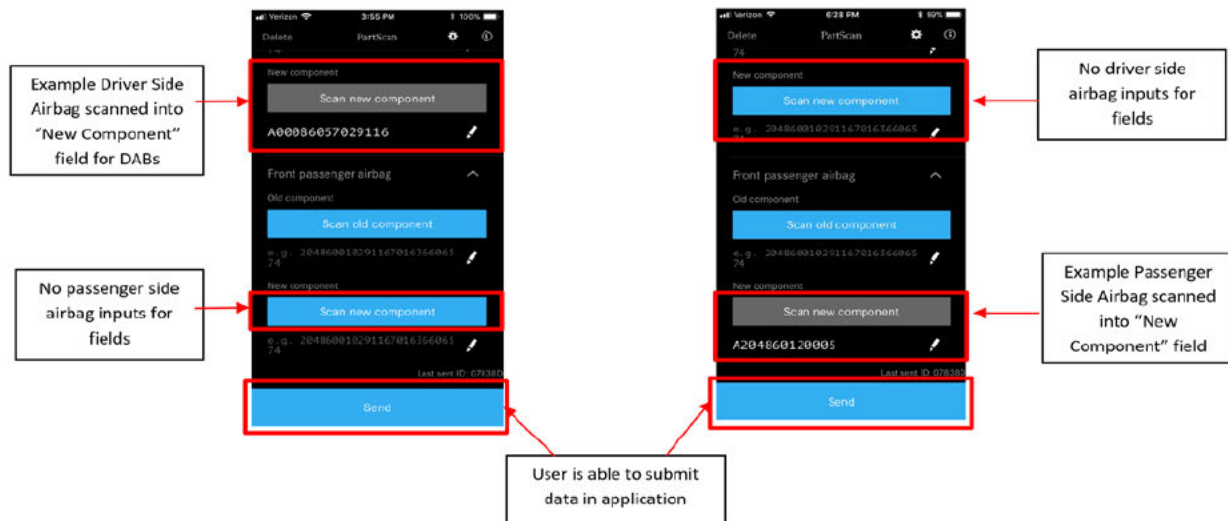
- The PartScan App must be utilized properly for every Takata airbag recall repair.
- If the VIN is missing, illegible or incomplete, it must be entered manually
- The airbag barcode scan may only be skipped if the barcode is missing, illegible or incomplete.
- **Never** scan a “dummy” barcode to skip the entry fields – See Example below
  - **When only the passenger airbag replacement is required scan and only press the passenger airbag “scan old component”.**
- Always make sure the proper airbag is scanned in the respective entry field in the App (driver airbag for driver-side, passenger airbag for passenger-side)
- Part Scan Examples: Driver-side airbag only and Passenger-side airbag only scans

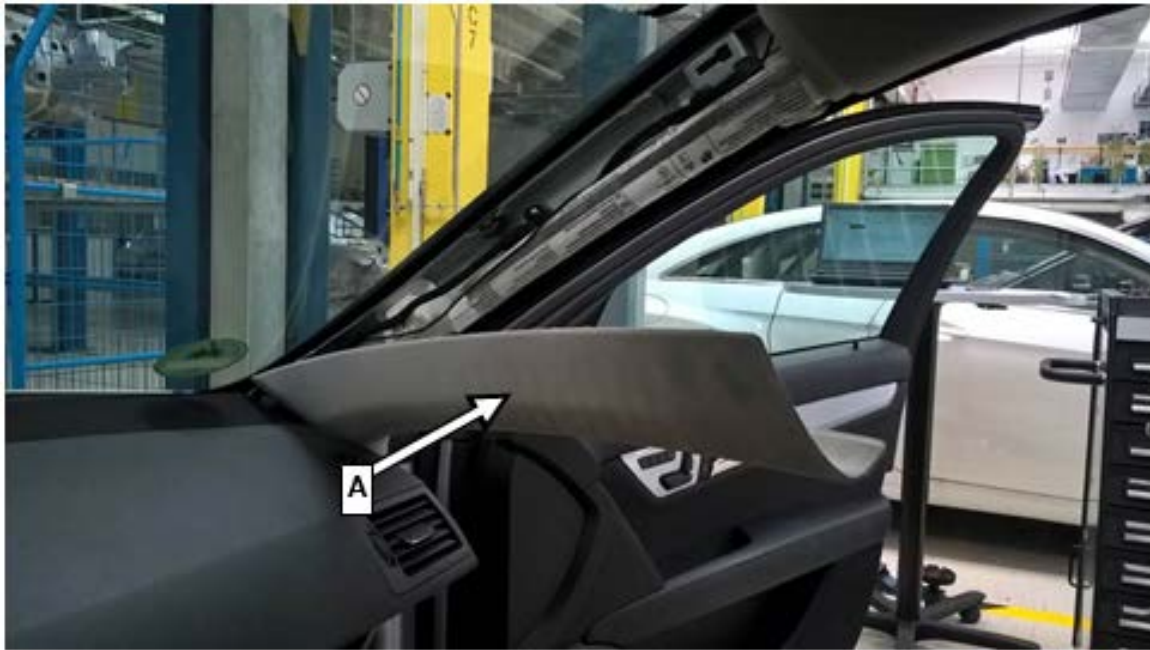
Figure 2

1. Disconnect ground line from the on-board electrical system battery.
2. Remove right A-pillar trim (**A**, figure 2).

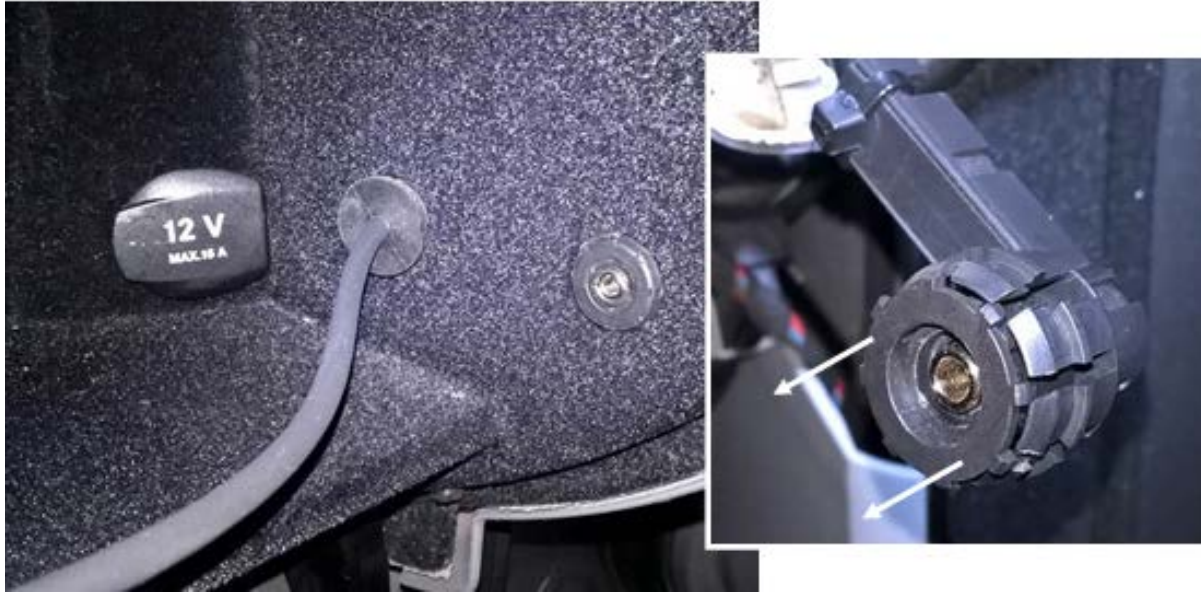
Figure 3

**i** Pull iPod cable **with** rubber grommet out of glove box housing until the connector plug makes contact with the housing. **Do not pull cable out of rubber grommet** because it is bonded to the rubber grommet and will otherwise be damaged!

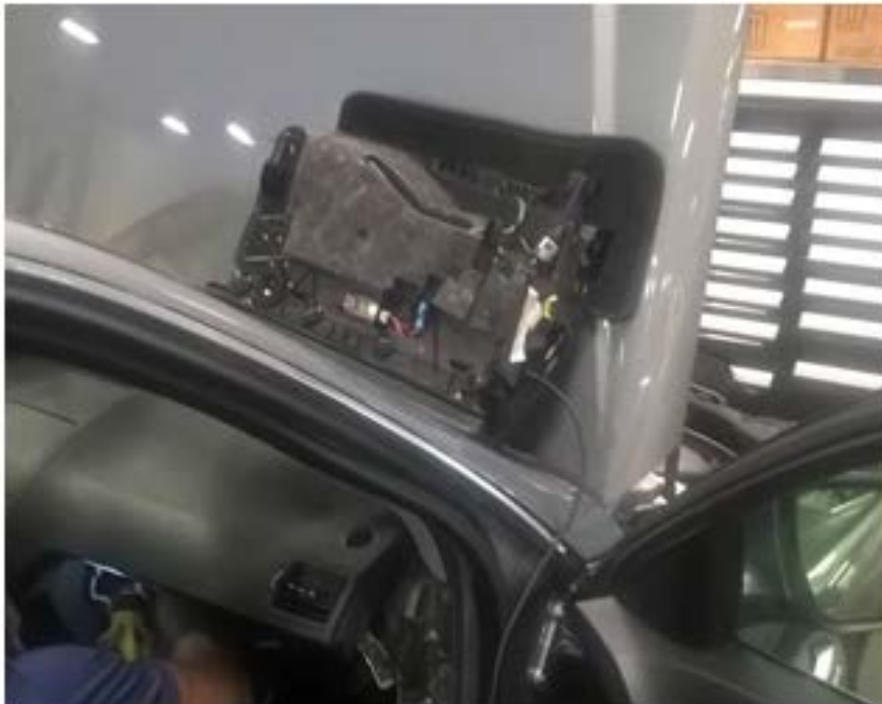
Figure 4

**i** Pull out the iPod cable as far as possible and set down glove box housing on the windshield **with** exterior iPod cable connected (**figure 4**).

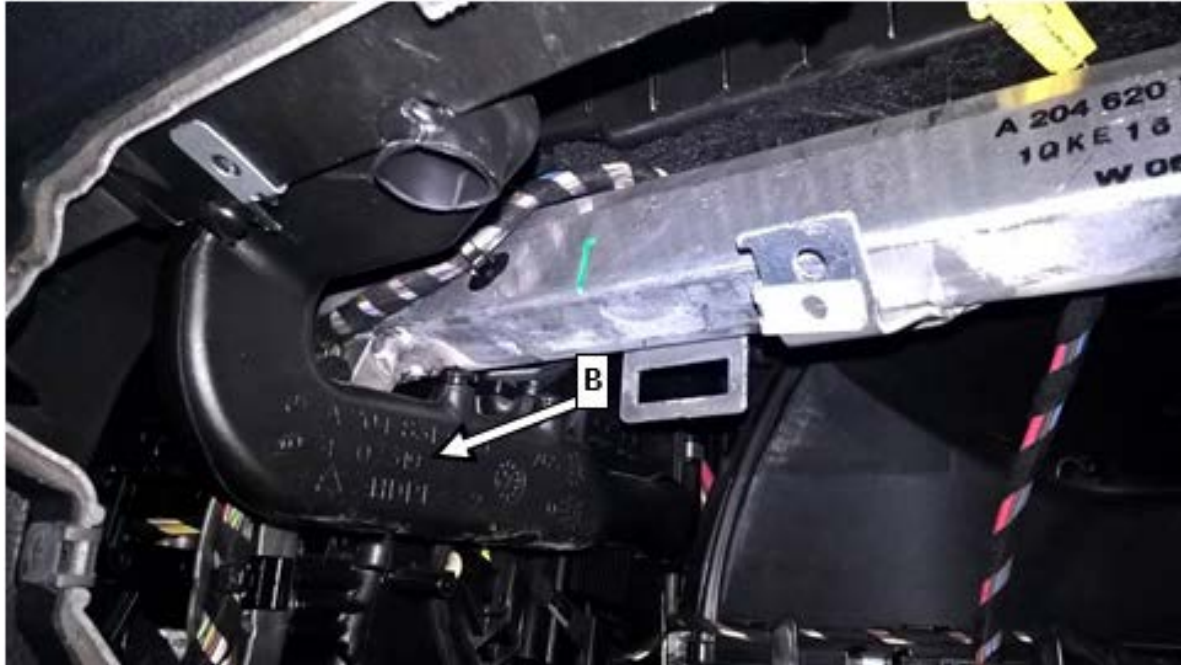
Figure 5

4. Remove air duct (**B**, figure 5) above the glove compartment.

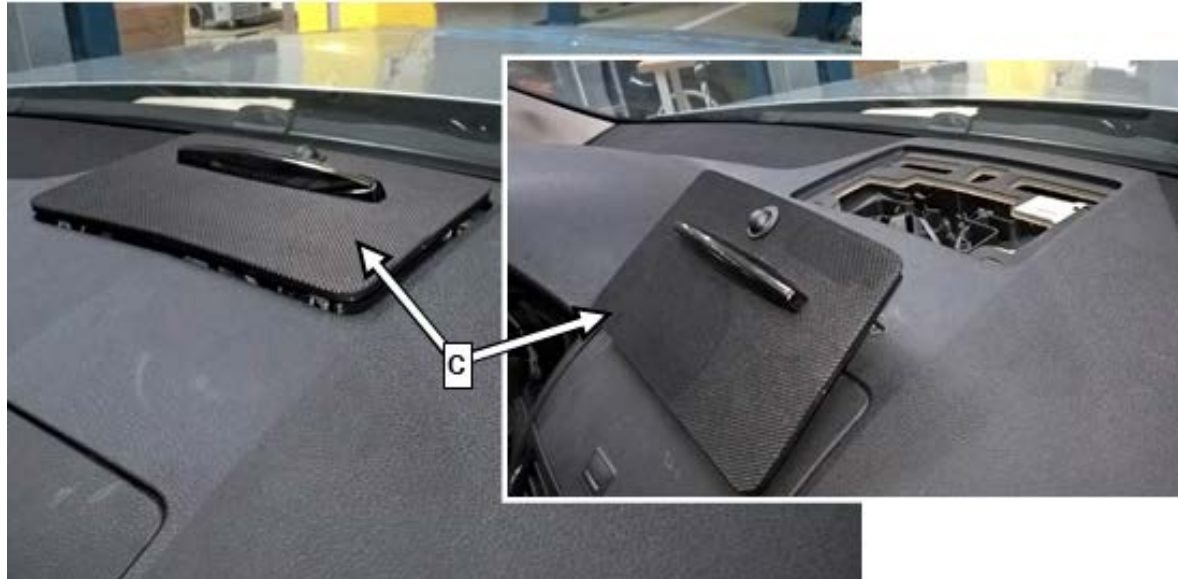
Figure 6

5. Unclip and remove cover (**C, figure 6**) at the instrument panel on top.

**i** With a sound system, also remove speaker under the cover.

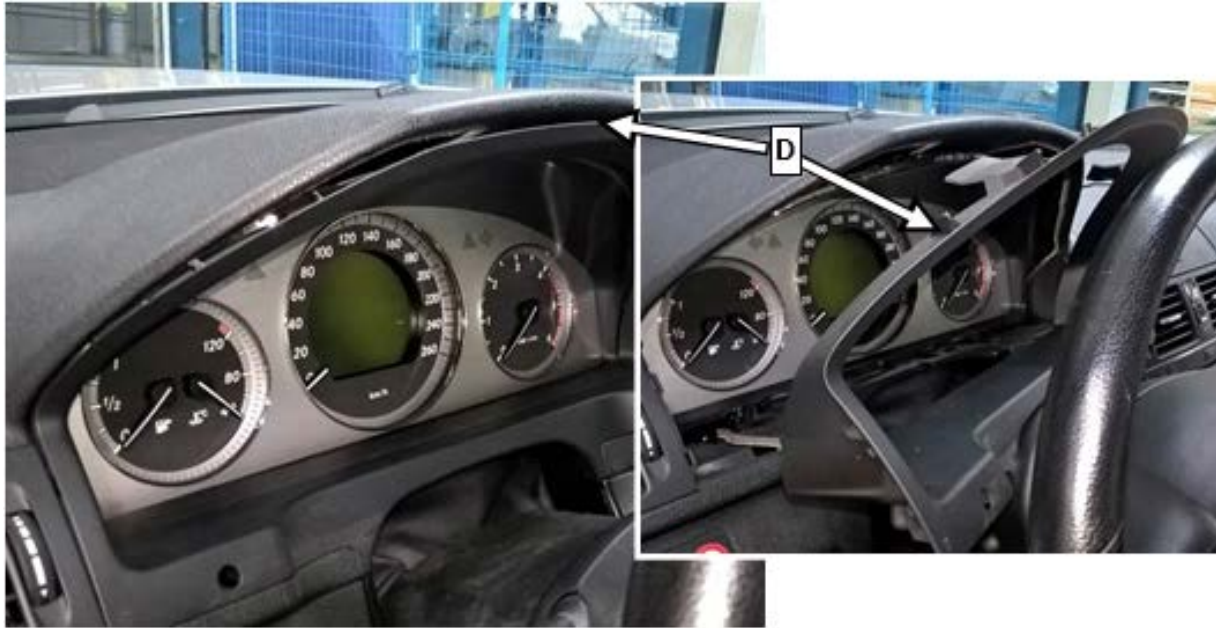
Figure 7

6. Remove center console (**AR68.20-P-2000CW**).
7. Remove automatic climate control and operating unit.  
**i** For basic data of model W204, see **AR83.40-P-6350CW**
8. Remove trim (**D, figure 7**) around the instrument cluster.  
**i** For basic data of model W204, see **AR54.30-P-6015CW**.

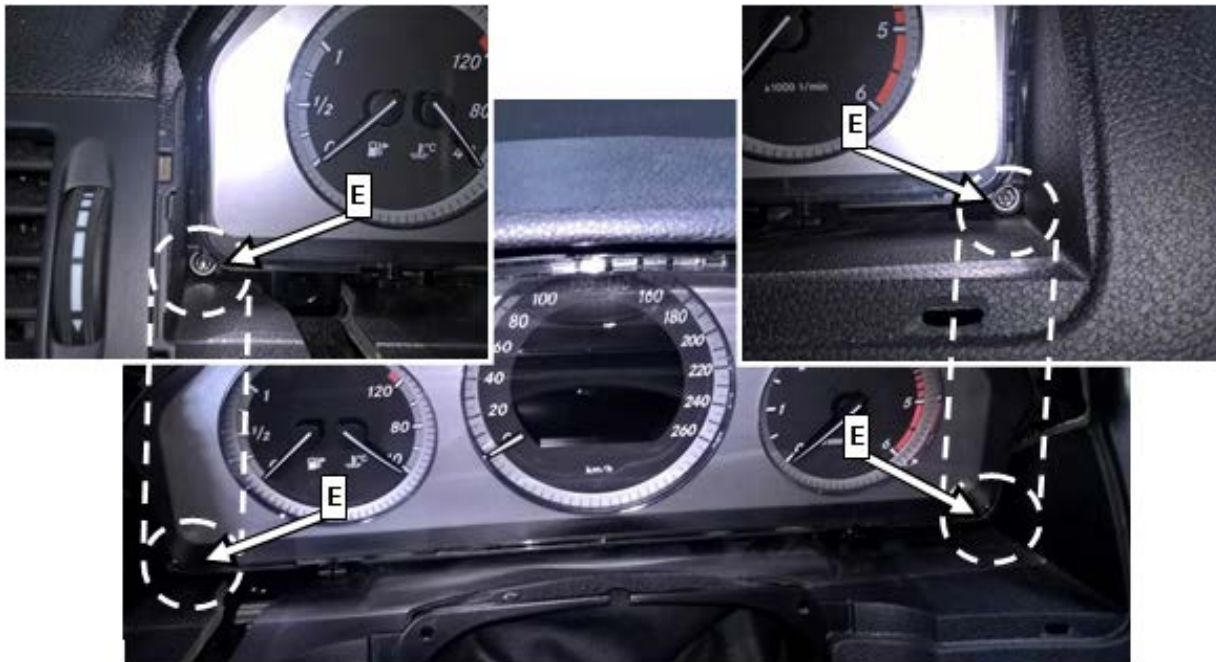
Figure 8

9. Remove the two bottom threaded connections (**E, figure 8**) of the instrument cluster.

**i** These screws are simultaneously fasteners for the instrument panel.

**i** The upper two screws do not need to be removed.

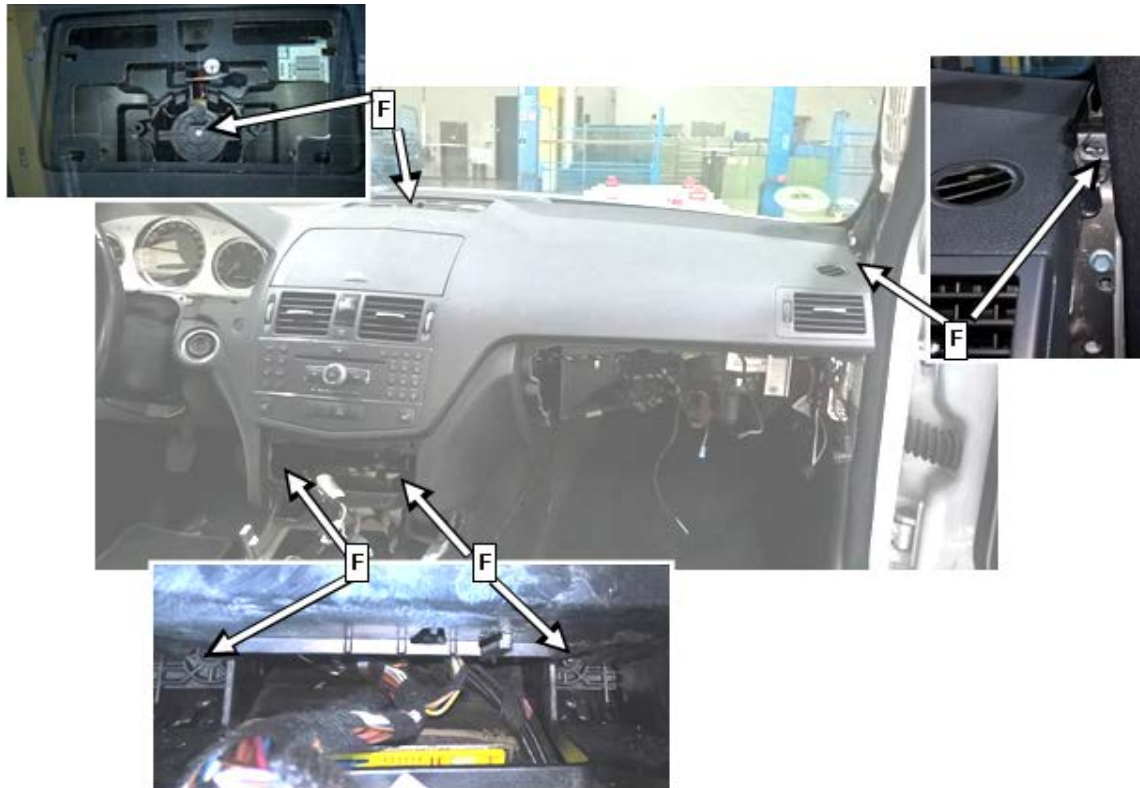
Figure 9

10. Remove four screws (**F**, **figure 9**) for fastening the instrument panel

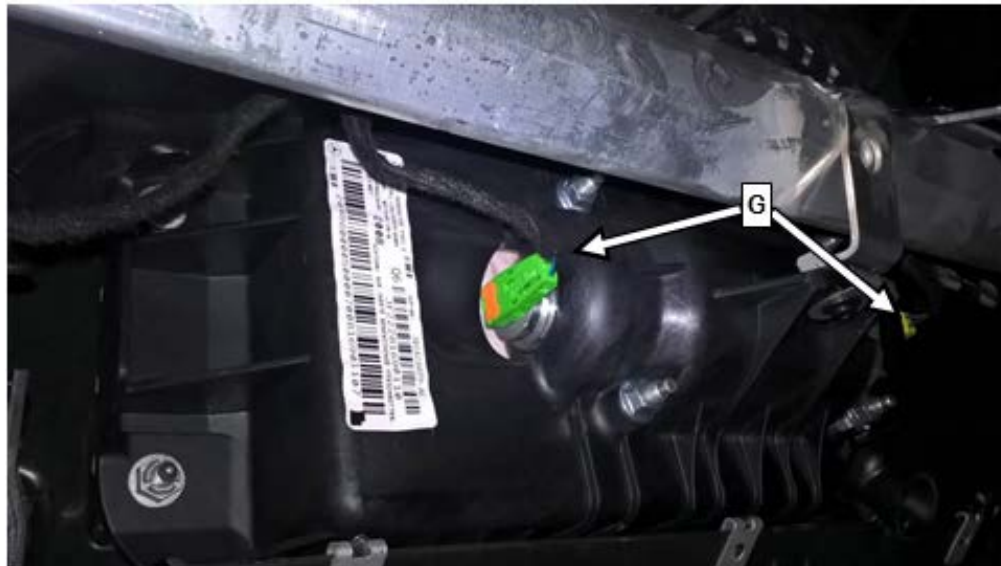
Figure 10

11. Disconnect electrical contacts (**G**, **figure 10**) at the front passenger airbag.

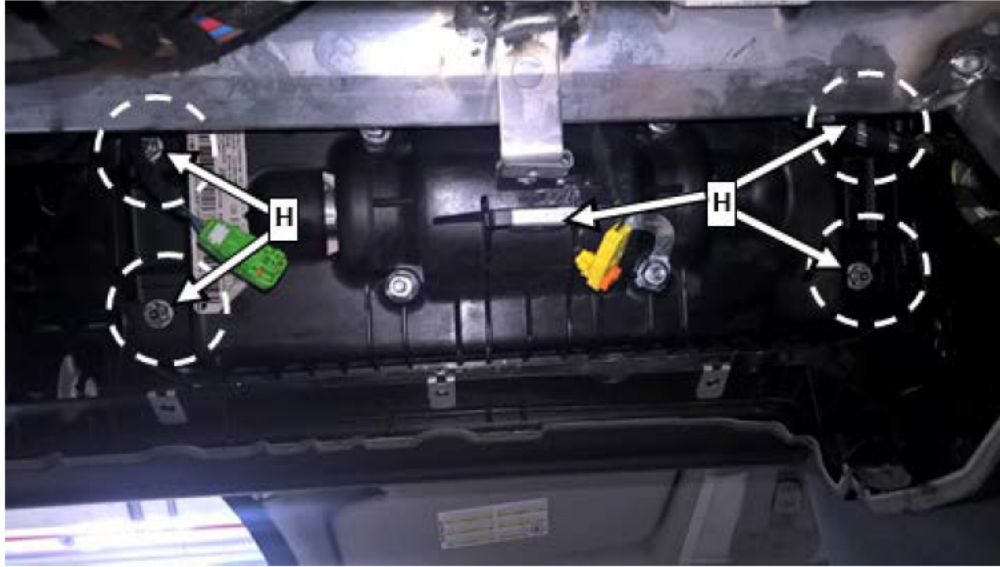
Figure 11

12. Remove lock nuts (**H**, **figure 11**) for the front the passenger airbag.

**i** Lock nuts should only be replaced if they are damaged. For more info see:  
**AH00.00-N-0001-01A / Modification notes 27.10.2016**

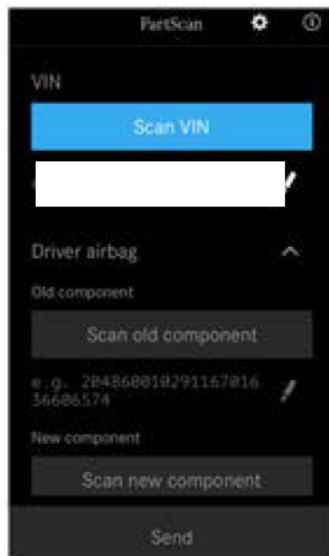
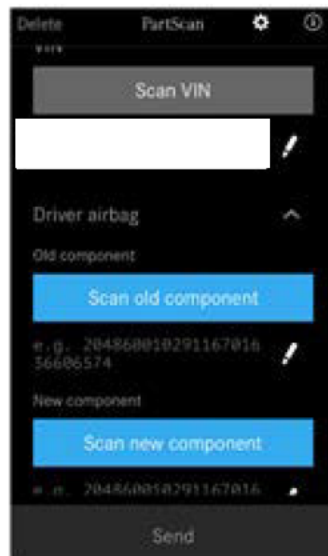
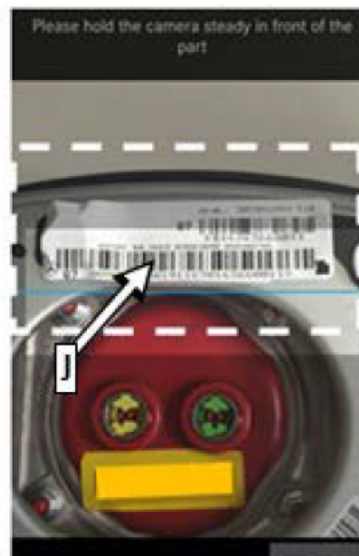
13. Slightly raise instrument panel at the front passenger side and remove the front passenger airbag in a downwards direction. Take special care not to crack the dashboard material. **DO NOT REMOVE THE DASHBOARD**
14. The PartScan App **must** be utilized properly for every Takata airbag recall repair. Use the "Scan VIN" button (figure 12) to scan the vehicle identification number either by the barcode or the text field.
  - i** After scanning, compare the vehicle identification number that has been read in the app and correct any scanning errors manually.
  - i** All required data can also be read off and entered manually.

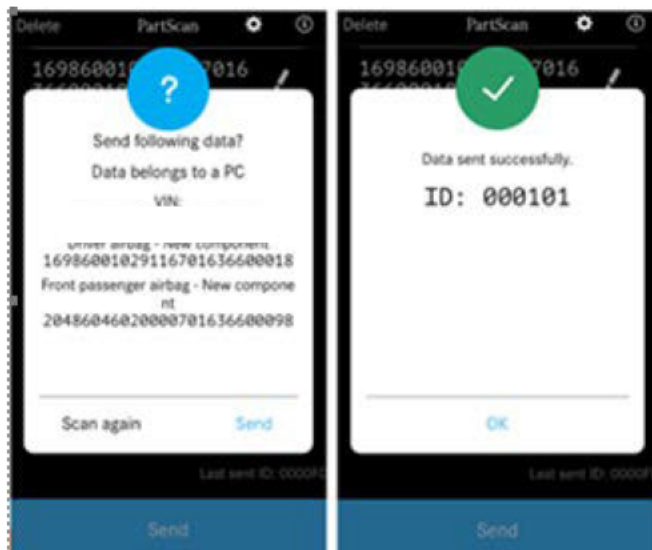
Figure 16

The generated scan ID (figure 16) must be recorded in writing in the workshop order and then stored in a tamper-proof manner.

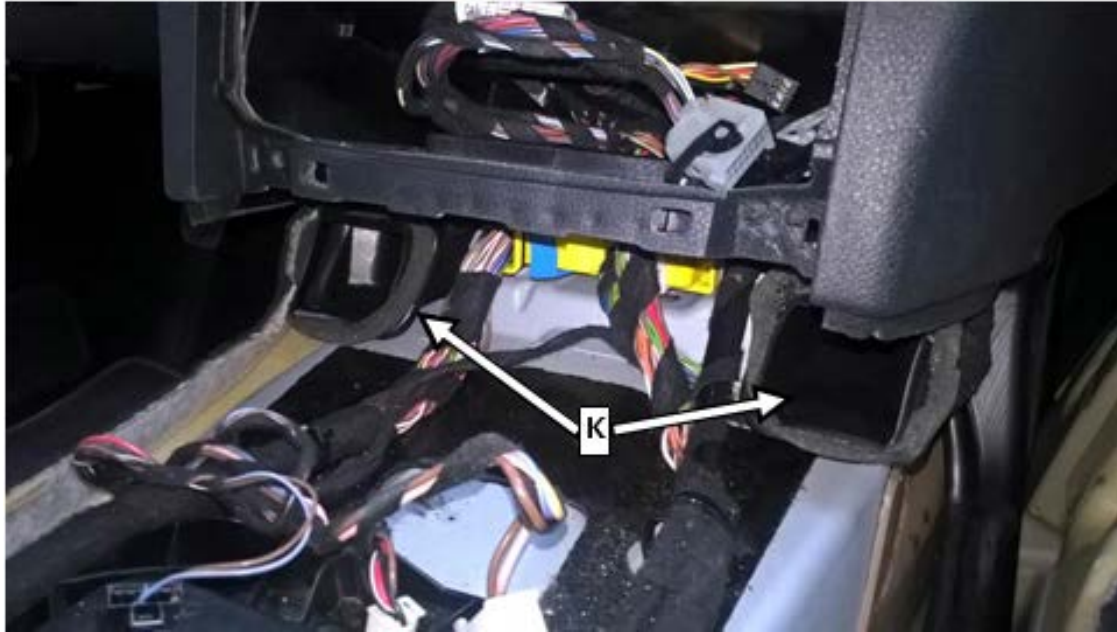
Figure 17

The air ducts are pulled out when the instrument panel is raised.

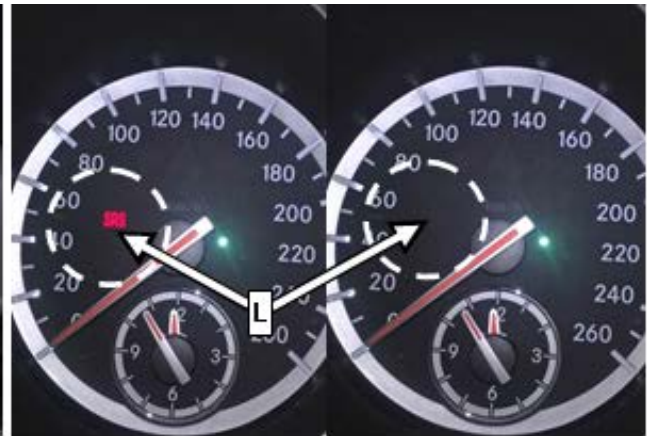
23. Turn the transmitter key in the electronic ignition lock to **position 1** and check whether the airbag indicator lamp (**L**, **figure 18 or 19**) correctly switches off after a few seconds.

**i** The SRS check is thus completely ensured after airbag replacement.

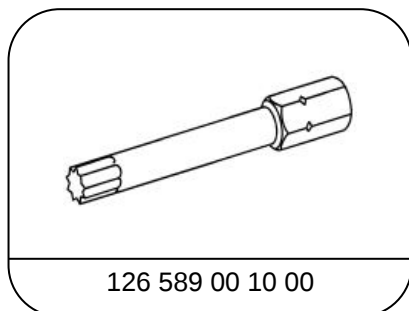
126 589 00 10 00

Screwdriver bit

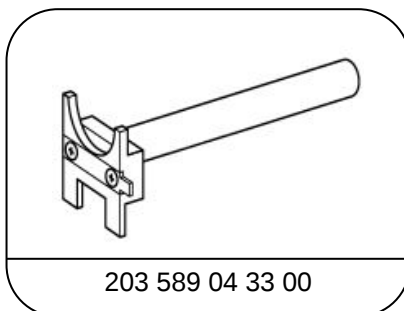
203 589 04 33 00

Removal lever

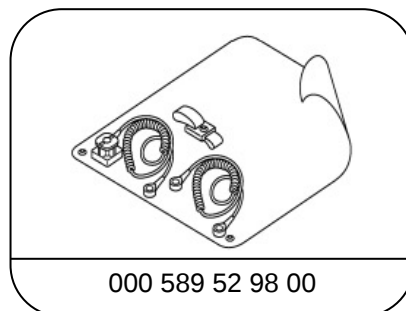
000 589 52 98 00

Electro Static Discharge (ESD) kit (or locally sourced equivalent)

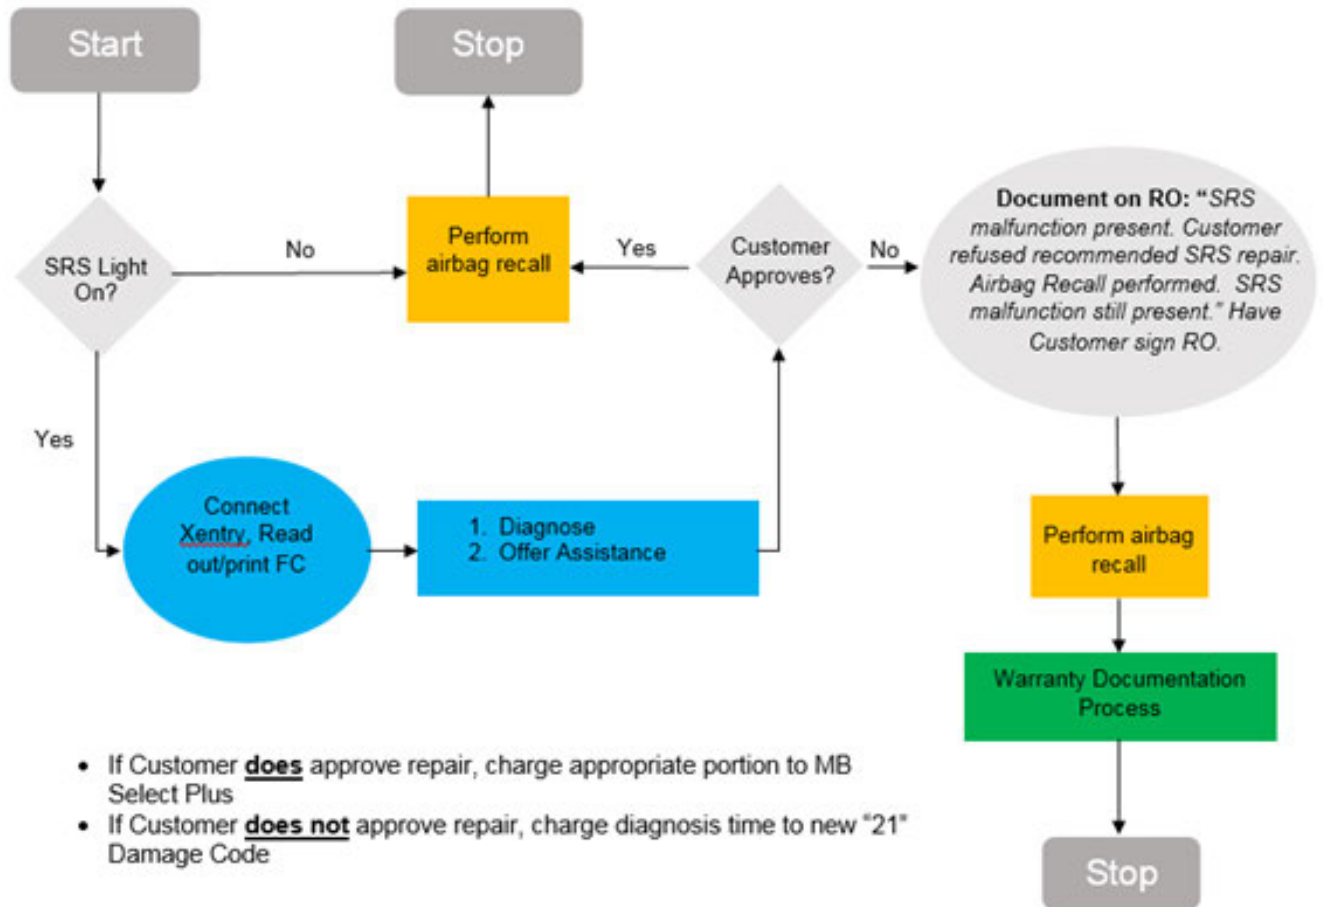
# Attachment A - SRS Light Diagnosis/Repair Process - Takata Airbag Recall Only

1. Claim against new "21" damage code
  - a) **21664 00 Takata Diagnosis – No Repair**
2. Up to 2 hours diagnostic time permitted
3. Ensure diagnostic time is properly punched on RO
4. Ensure RO is documented properly
5. Attach RO to warranty claim

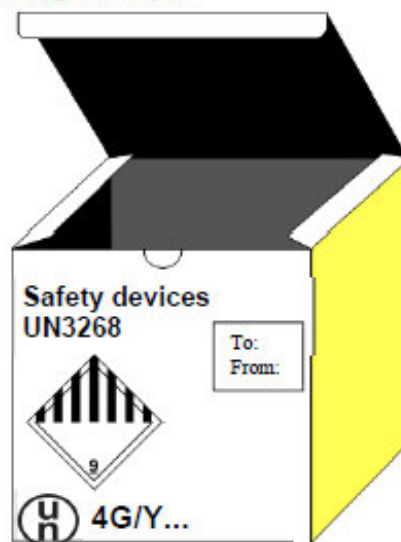
- Carefully open received box and remove new airbag. Keep box intact & save all contents!
- Place used airbag into replacement airbag box, re-using any packaging material (e.g., cardboard inserts) used for the new airbag. Package as the new airbag was packaged.
- Use plastic adhesive tape 50 mm wide to secure the box closed. Do not obscure labels or text on the box with the tape.
- Ensure that the 4G fiberboard box is not ripped or damaged.

- The following words ("marking") must also be clearly visible on the same side of the box as the Class 9 label:  
**Safety devices**  
**UN3268** (font size must be  $\geq \frac{1}{2}$  inch)
- Affix "To/From" address label to same or adjacent packaging face as the hazardous markings/labels.
- The UN 4G code preprinted near the bottom edge of the box must also be clearly visible.

- Note:** The Packing Group and the EX# are no longer required to be printed on the HAZMAT bill of lading.
- Package example:**

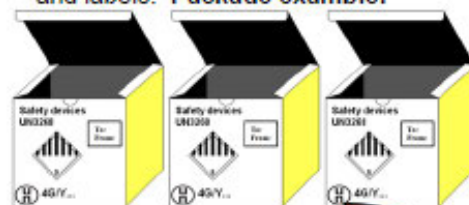
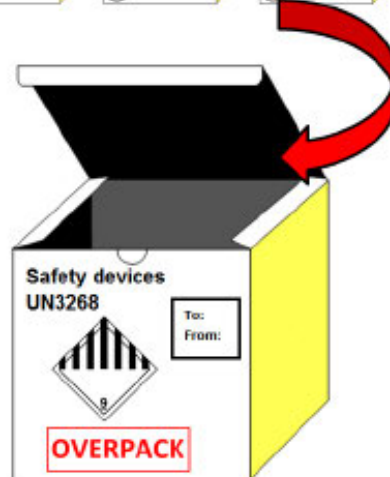
- Package each airbag in a separate UN spec box prepared with the labels/markings described above.
- Place each individual airbag box inside a larger non-UN spec box to keep the shipment together.
- This larger box is called an "OVERPACK."

- The OVERPACK must have the identical markings and label as the boxes contained inside.
- The OVERPACK must have the "OVERPACK" statement on the same face as the hazard markings and labels. **Package example:**
