| RE: <b>URGENT Takata Recall Campaign Information</b><br><b>2019110016 Takata PG7 Front Passenger-Side Airbags</b><br>MY2012 C-Class Vehicles (204) | DATE: May 14, 2020 |

Campaign No.2019110016, December 2019

SUBJECT: Model 204 and 207

Replace Front Passenger-side Airbag

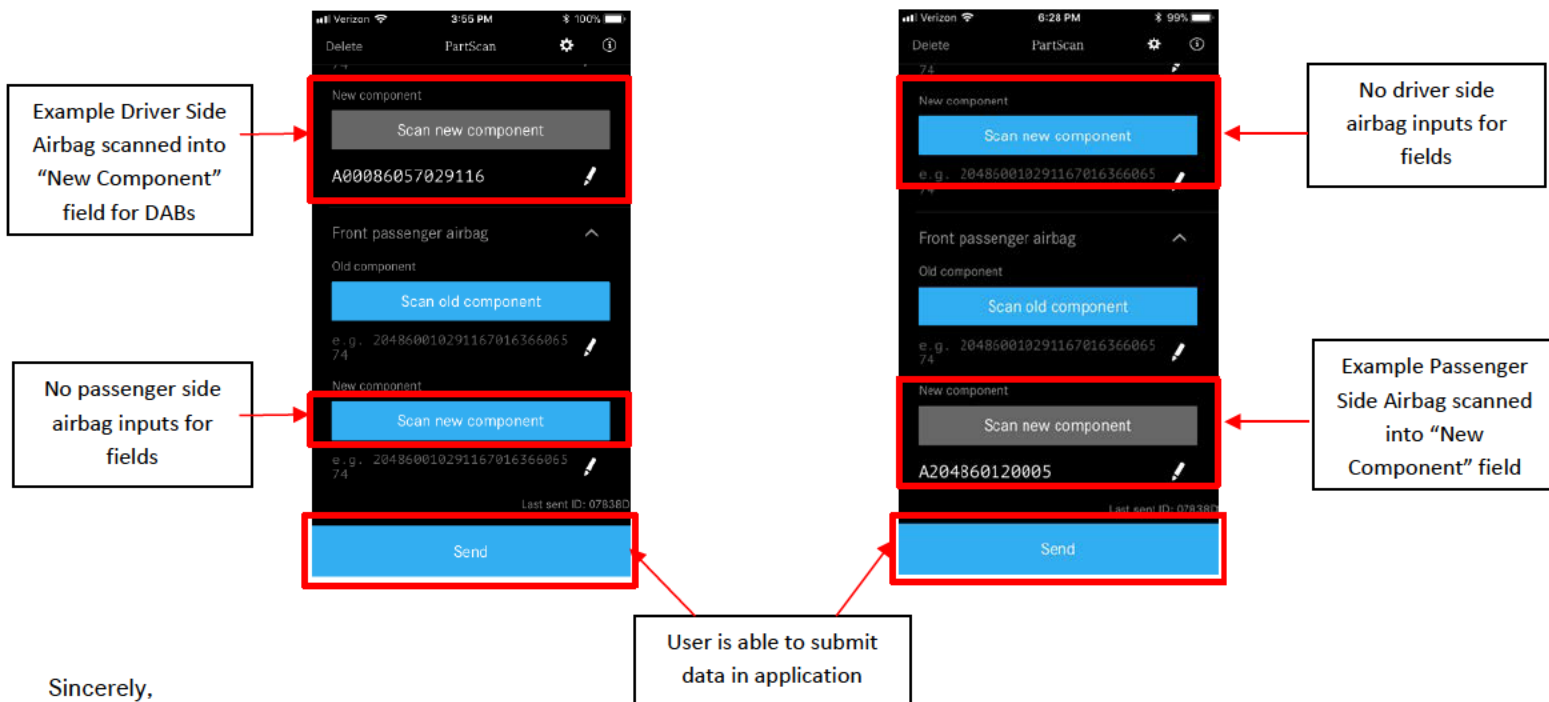
- Always make sure the proper airbag is scanned in the respective entry field in the App (driver airbag for driver-side, passenger airbag for passenger-side)Part Scan Examples: Driver-side airbag only and Passenger-side airbag only

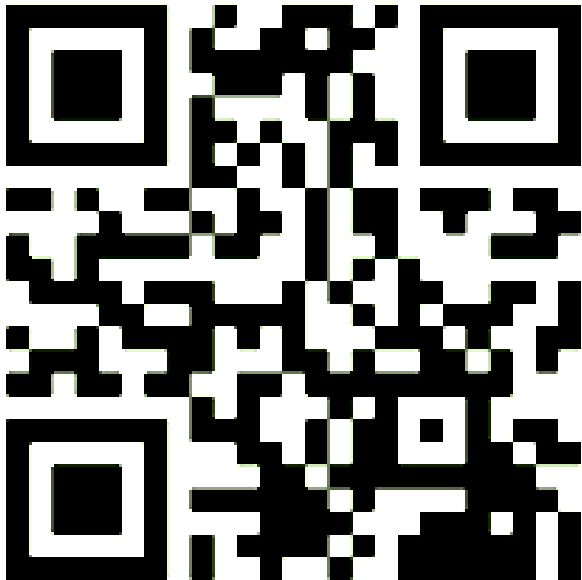
Figure 1

- To install and transmit the data a WiFi connection is required.
- After downloading the App, a one-time security authentication is required by means of encrypted QR code. Verification can be performed by scanning the QR code below, before using the application.

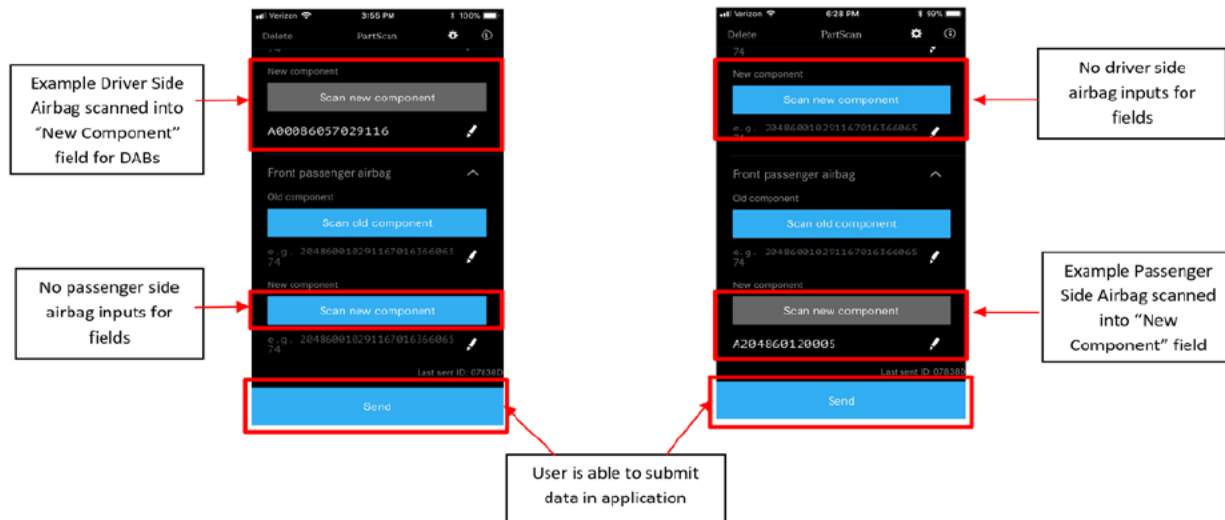
- The PartScan App must be utilized properly for every Takata airbag recall repair.
- If the VIN is missing, illegible or incomplete, it must be entered manually
- The airbag barcode scan may only be skipped if the barcode is missing, illegible or incomplete.
- **Never** scan a “dummy” barcode to skip the entry fields – See Example below
  - When only the driver airbag replacement is required, skip the passenger airbag scan by leaving fields blank.
  - When only the passenger airbag replacement is required scan and only press the passenger airbag “scan old component”.
- Always make sure the proper airbag is scanned in the respective entry field in the App (driver airbag for driver-side, passenger airbag for passenger-side)
- Part Scan Examples: Driver-side airbag only and Passenger-side airbag only scans

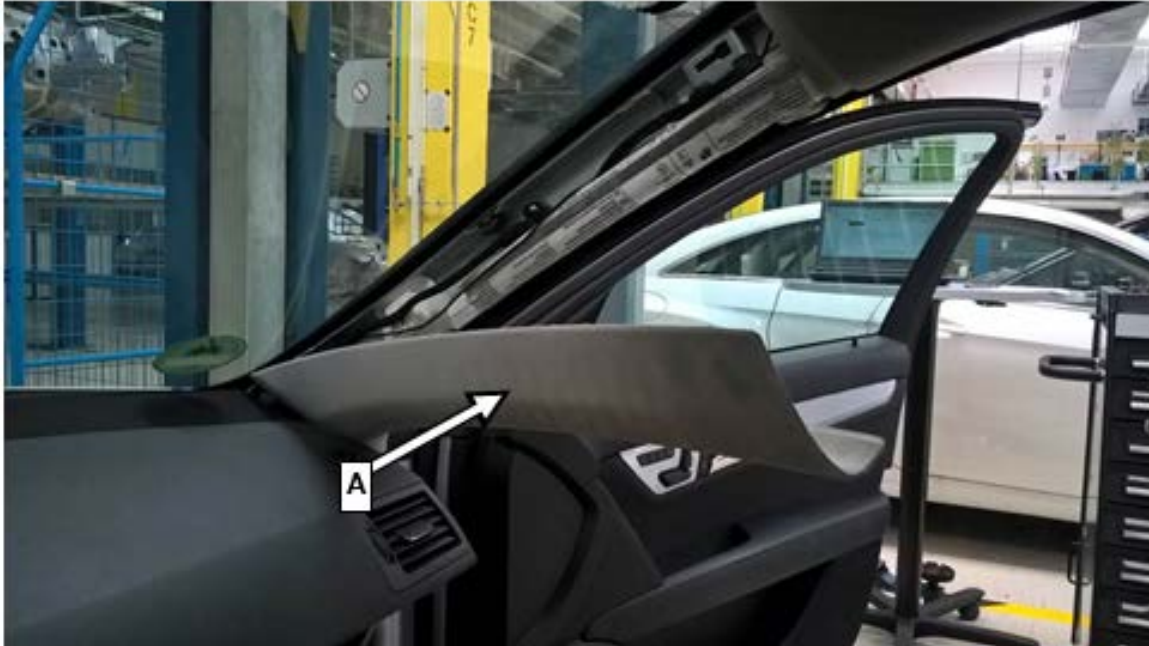
Figure 2

1. Disconnect ground line from the on-board electrical system battery.
2. Remove right A-pillar trim (A, figure 2).

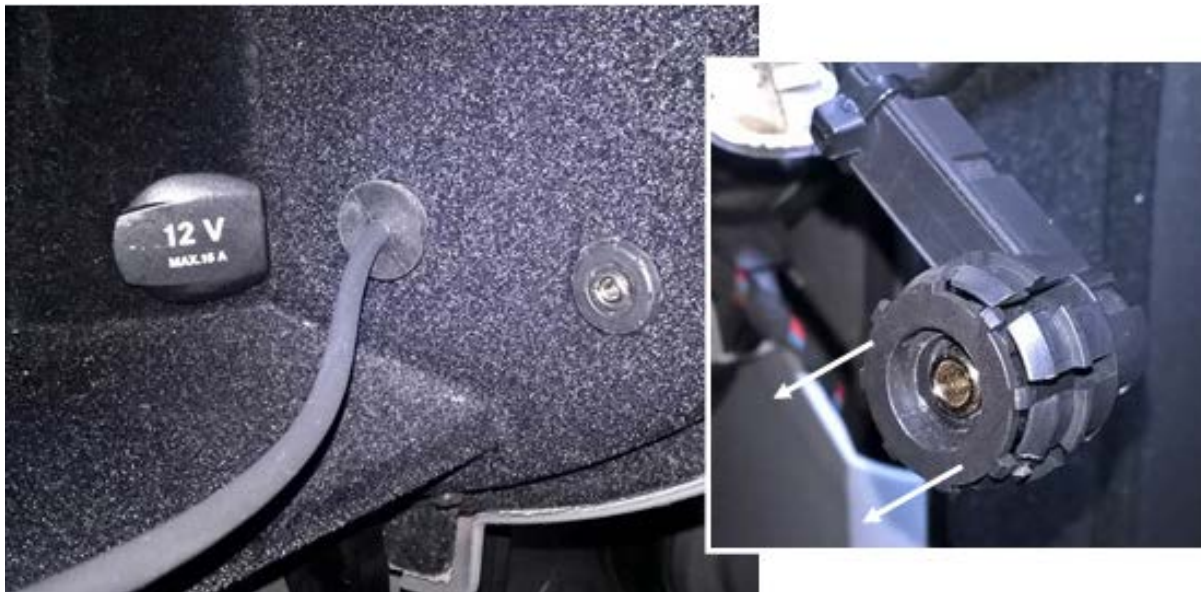
Figure 3

**i** Release inner retaining ring (**figure 3**) at the AUX connection towards the inside. The connection can then be removed from the glove box housing.

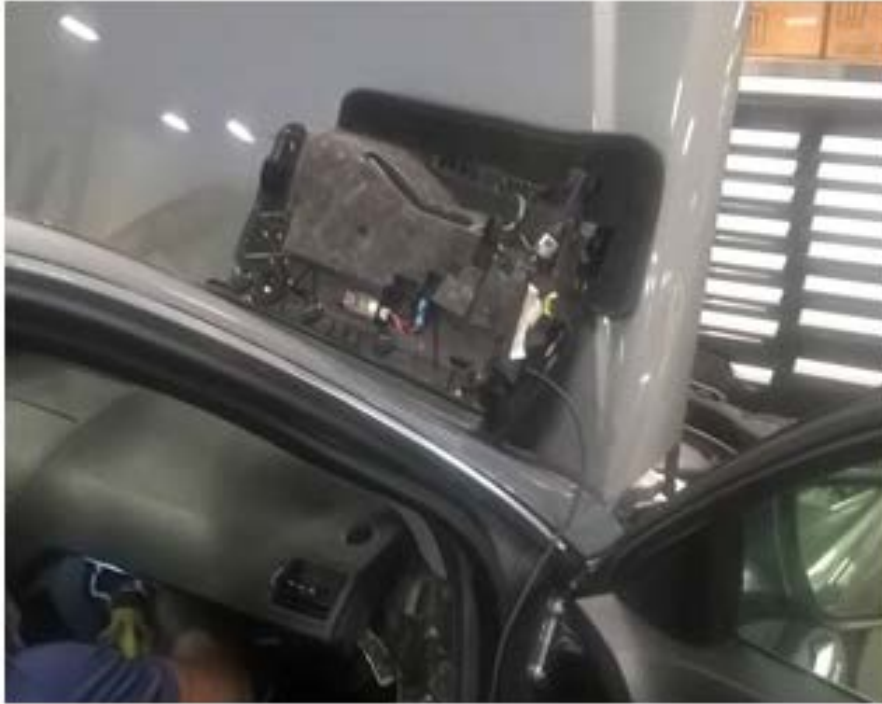
Figure 4

**i** Pull out the iPod cable as far as possible and set down glove box housing on the windshield **with** exterior iPod cable connected (**figure 4**).

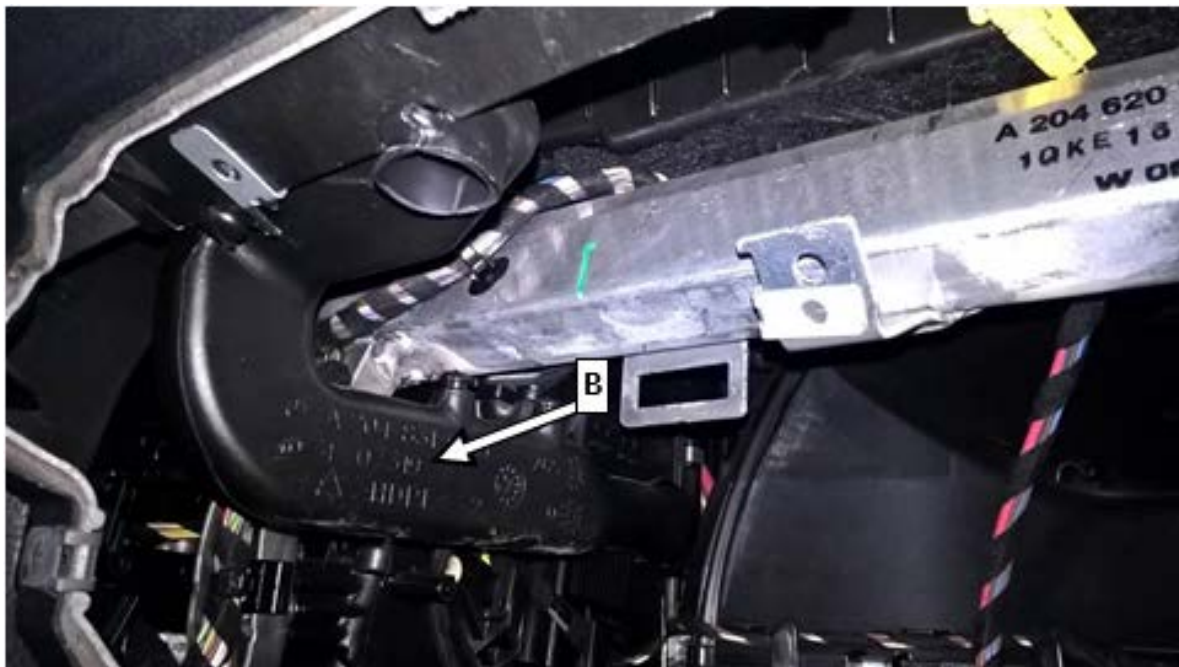
Figure 5

4. Remove air duct (**B**, figure 5) above the glove compartment.

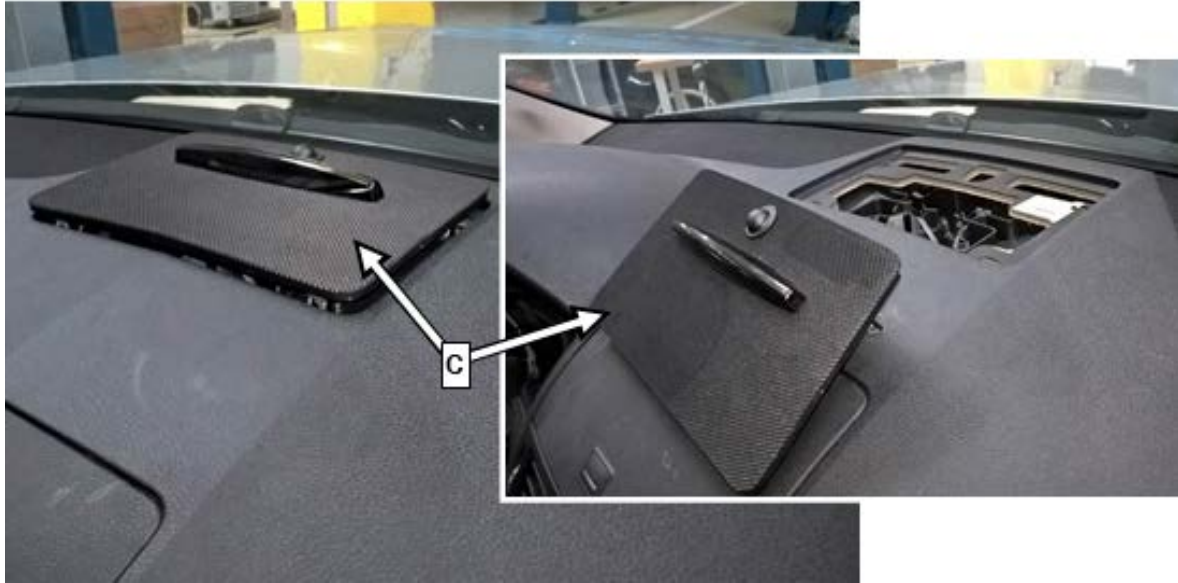
Figure 6

5. Unclip and remove cover (**C**, figure 6) at the instrument panel on top.  
*i* With a sound system, also remove speaker under the cover.

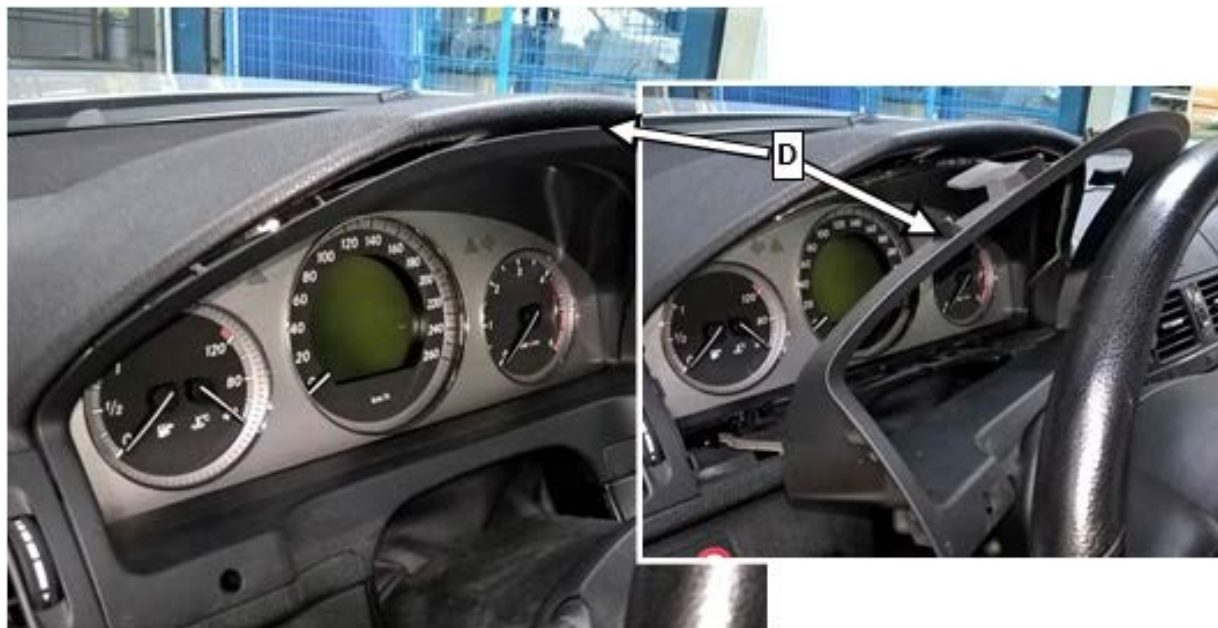
Figure 7

For basic data of model 207, see **AR83.25-P1124EC**.
8. Remove trim (**D, figure 7**) around the instrument cluster.
  -

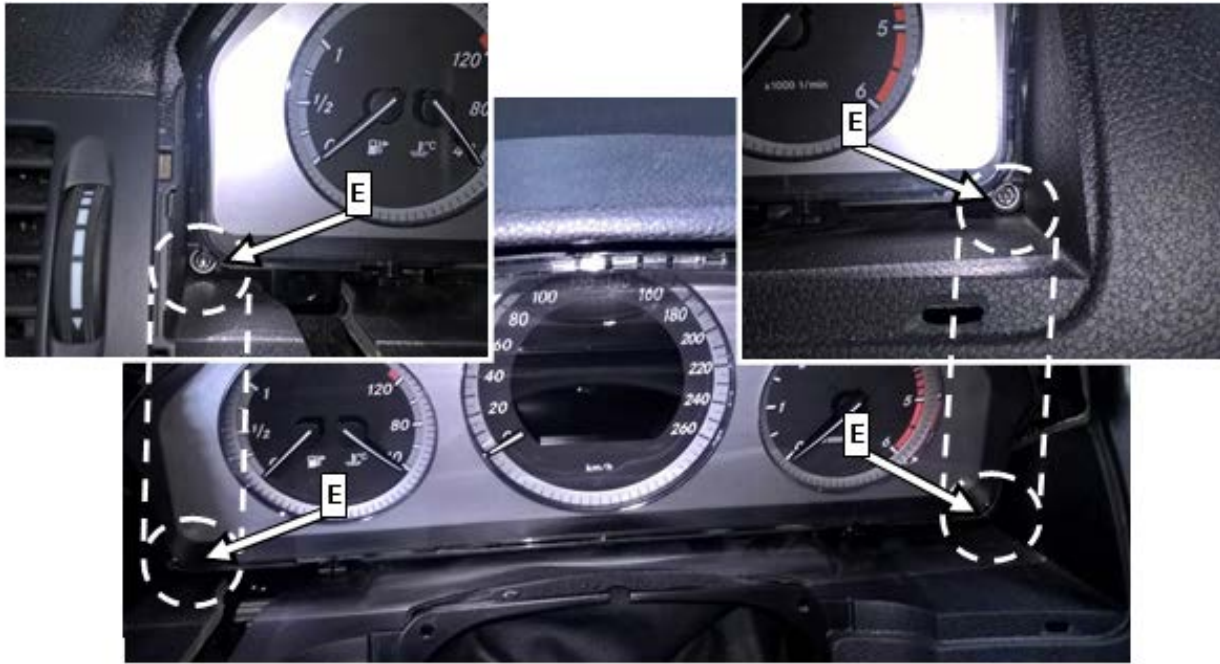
**Figure 8**

9. Remove the two bottom threaded connections (**E**, **figure 8**) of the instrument cluster.

**i** These screws are simultaneously fasteners for the instrument panel.

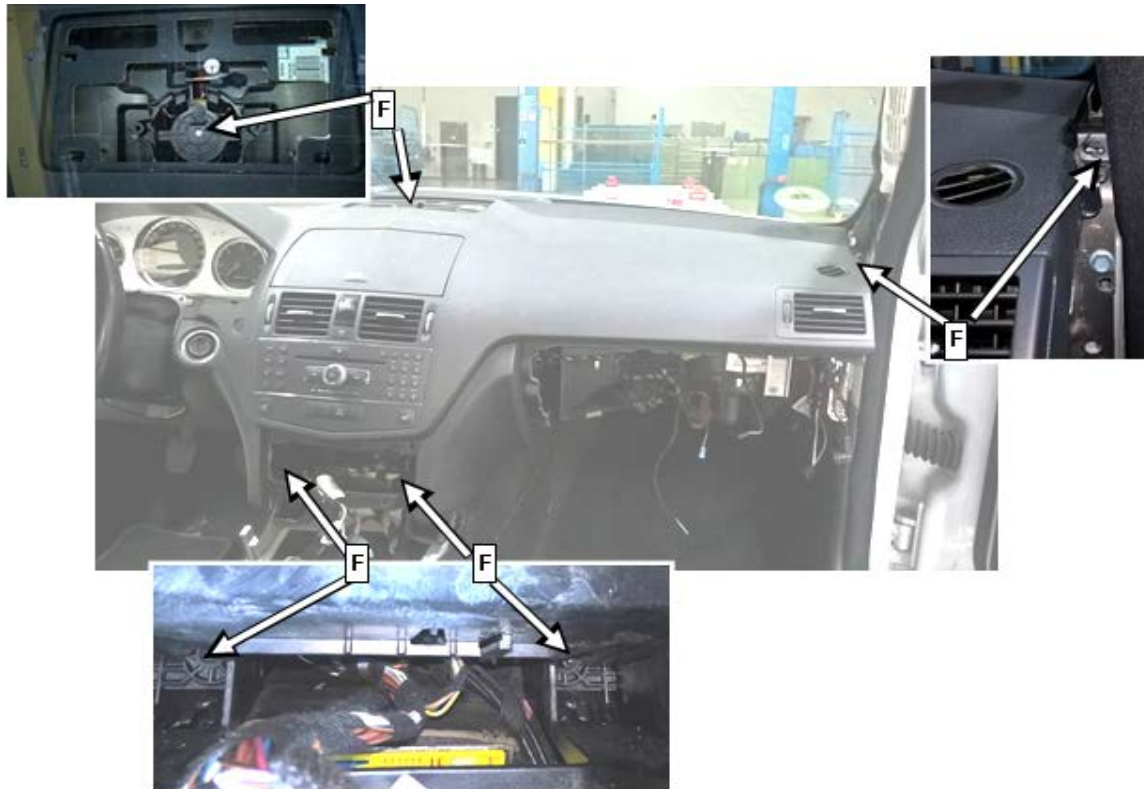
**Figure 9**

10. Remove four screws (**F**, **figure 9**) for fastening the instrument panel

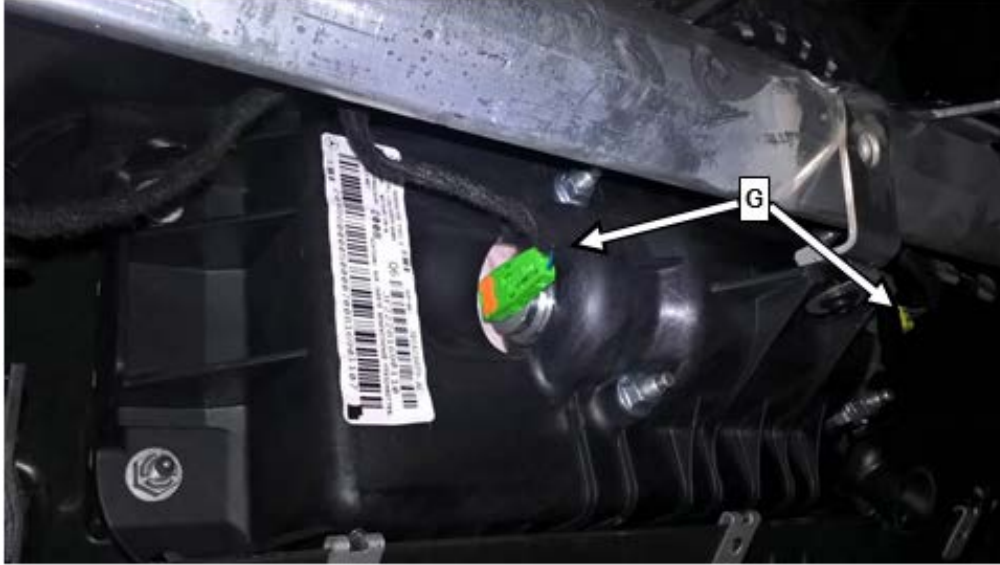
Figure 10

11. Disconnect electrical contacts (**G**, **figure 10**) at the front passenger airbag.

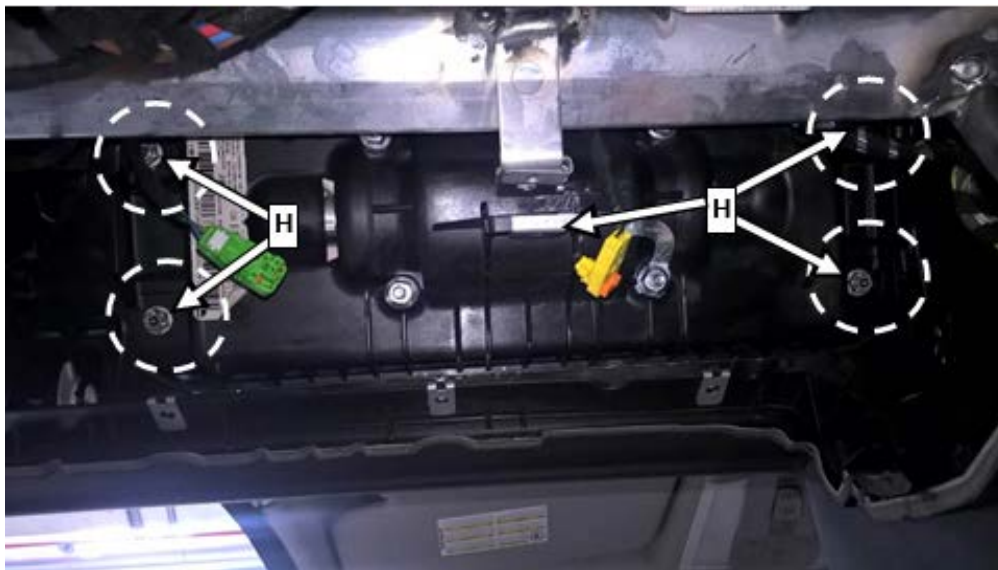
Figure 11

12. Remove lock nuts (**H**, **figure 11**) for the front the passenger airbag.

**i** Lock nuts should only be replaced if they are damaged. For more info see:  
**AH00.00-N-0001-01A / Modification notes 27.10.2016**

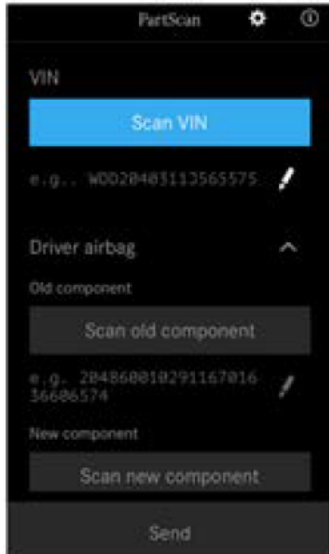
Figure 12

14. **The PartScan App must be utilized properly for every Takata airbag recall repair.**  
 Use the "Scan VIN" button (**figure 12**) to scan the vehicle identification number either by the barcode or the text field.

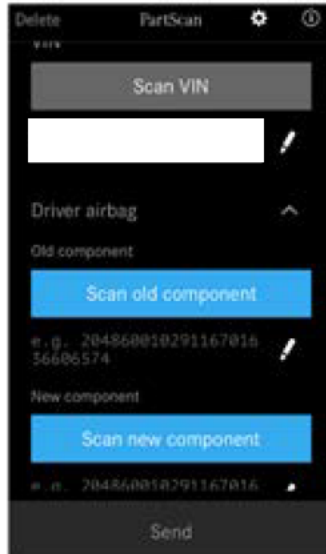
Figure 13

**16.** Scan barcodes of the removed passenger airbag using the button "Scan old component" (figure 13).

**17.** Scan the barcodes of the new passenger airbag using the button "Scan new component" (figure 13).

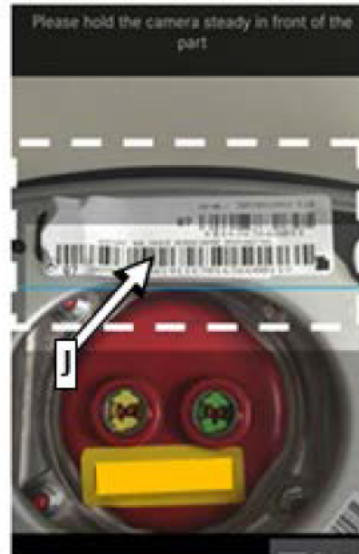
Figure 14

**i** Ensure that the lower barcode (J, figure 14) is scanned.

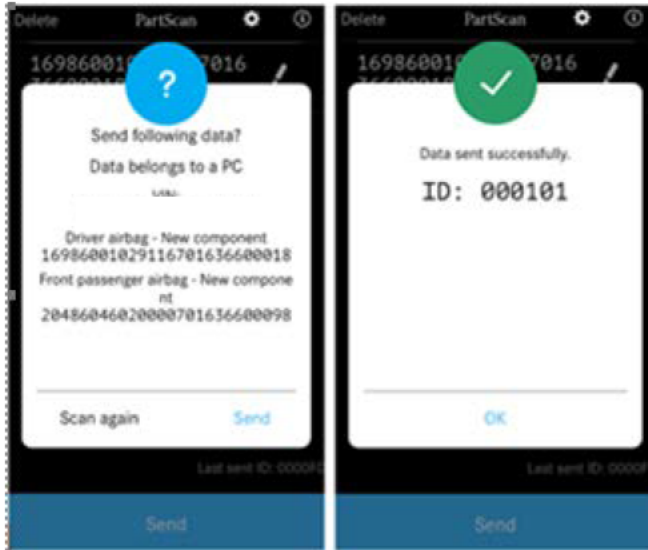
Figure 15

**18.** Create a scan ID via the "Send" button (figure 15).

**i** The generated scan ID (figure 16) must be recorded in writing in the workshop order and then stored in a tamper-proof manner.

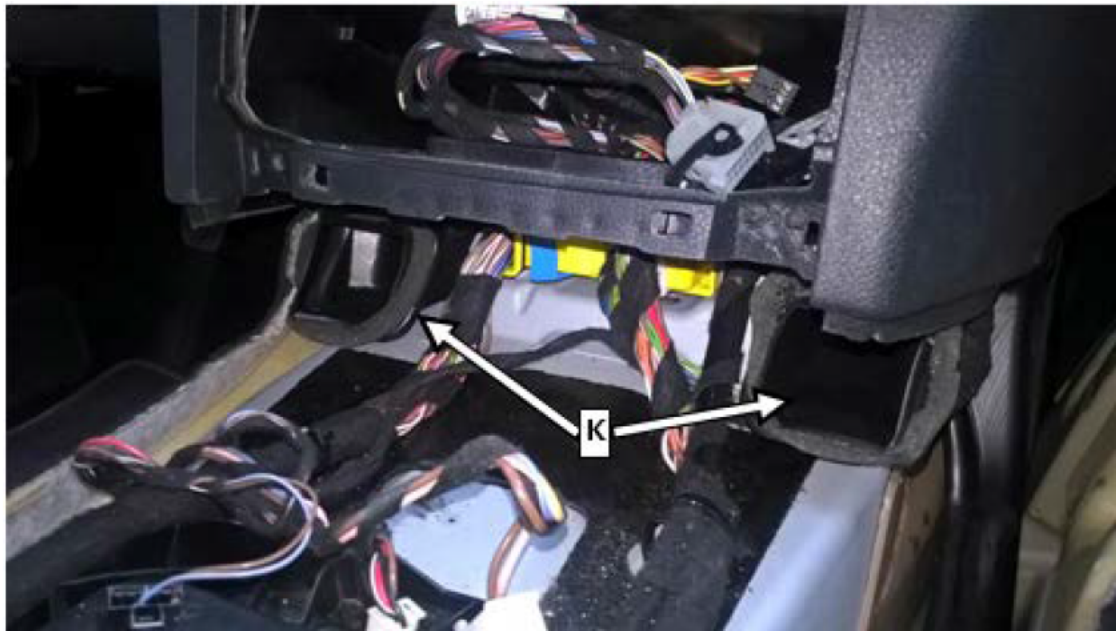
Figure 17

20. Place instrument panel back into position and install the air ducts (**K**, figure 17) correctly.

**i** The air ducts are pulled out when the instrument panel is raised.

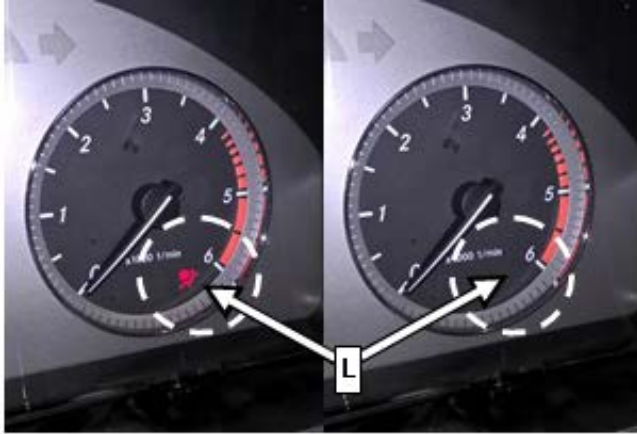
Figure 18

23. Turn the transmitter key in the electronic ignition lock to **position 1** and check whether the airbag indicator lamp (**L**, **figure 18 or 19**) correctly switches off after a few seconds.

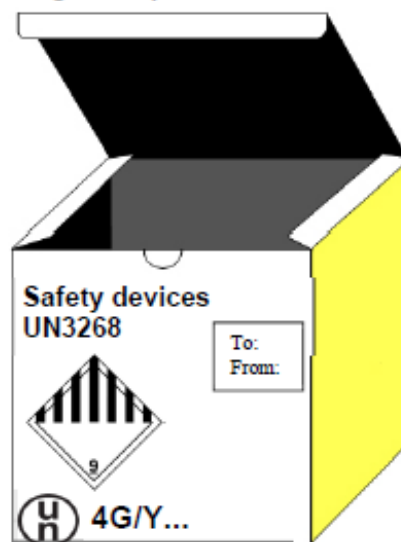
- Carefully open received box and remove new airbag. Keep box intact & save all contents!
- Place used airbag into replacement airbag box, re-using any packaging material (e.g., cardboard inserts) used for the new airbag. Package as the new airbag was packaged.
- Use plastic adhesive tape 50 mm wide to secure the box closed. Do not obscure labels or text on the box with the tape.
- Ensure that the 4G fiberboard box is not ripped or damaged.

- A Class 9 Miscellaneous label must be clearly visible on one side of the box.

- The following words ("marking") must also be clearly visible on the same side of the box as the Class 9 label:  
**Safety devices**  
**UN3268** (font size must be  $\geq \frac{1}{2}$  inch)
- Affix "To/From" address label to same or adjacent packaging face as the hazardous markings/labels.
- The UN 4G code preprinted near the bottom edge of the box must also be clearly visible.

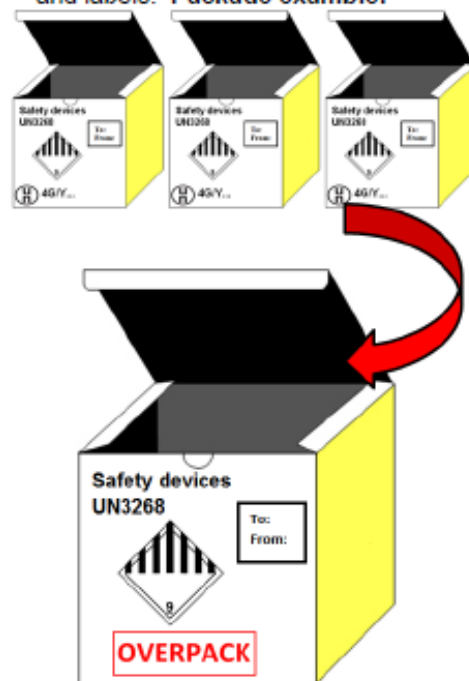
- Package each airbag in a separate UN spec box prepared with the labels/markings described above.
- Place each individual airbag box inside a larger non-UN spec box to keep the shipment together.
- This larger box is called an "OVERPACK."

- The OVERPACK must have the identical markings and label as the boxes contained inside.
- The OVERPACK must have the "OVERPACK" statement on the same face as the hazard markings and labels. **Package example:**
