| RE: <b>Recall Campaign 2018070014 Takata- Priority Group 4++ Ever-Registered in Zone A Replace Driver-side Airbags – Certain MY08-09 W204 (C-Class)</b> | DATE: August 28, 2018 |

# RECALL CAMPAIGN LAUNCH

SUBJECT: **Model 204 Model Years 2008 and 2009**  
**Replace Driver-Side and Front Passenger-side Airbag**

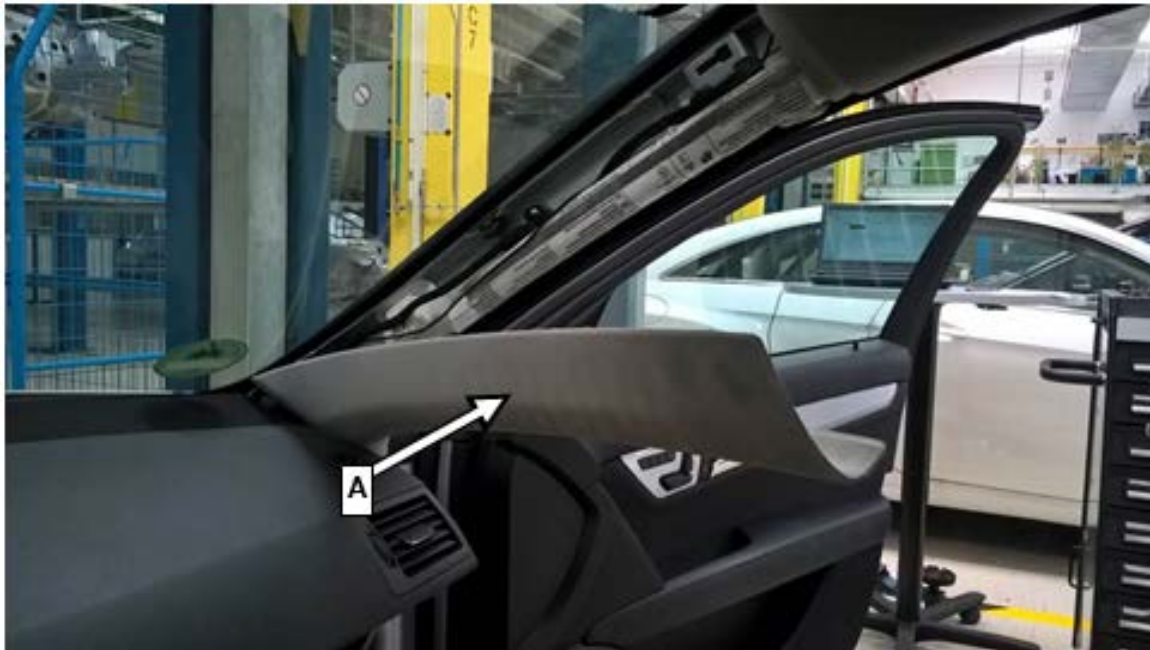
Figure 2

3. Remove right A-pillar trim (**A**, figure 2).

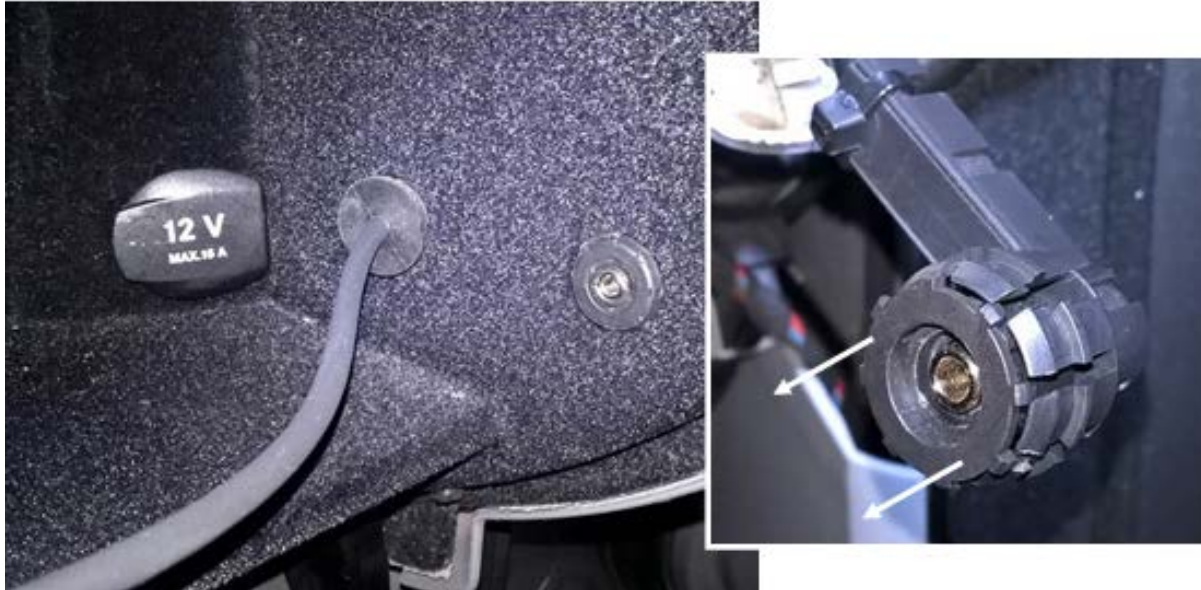
Figure 3

**i** Pull iPod cable **with** rubber grommet out of glove box housing until the connector plug makes contact with the housing. **Do not pull cable out of rubber grommet** because it is bonded to the rubber grommet and will otherwise be damaged!

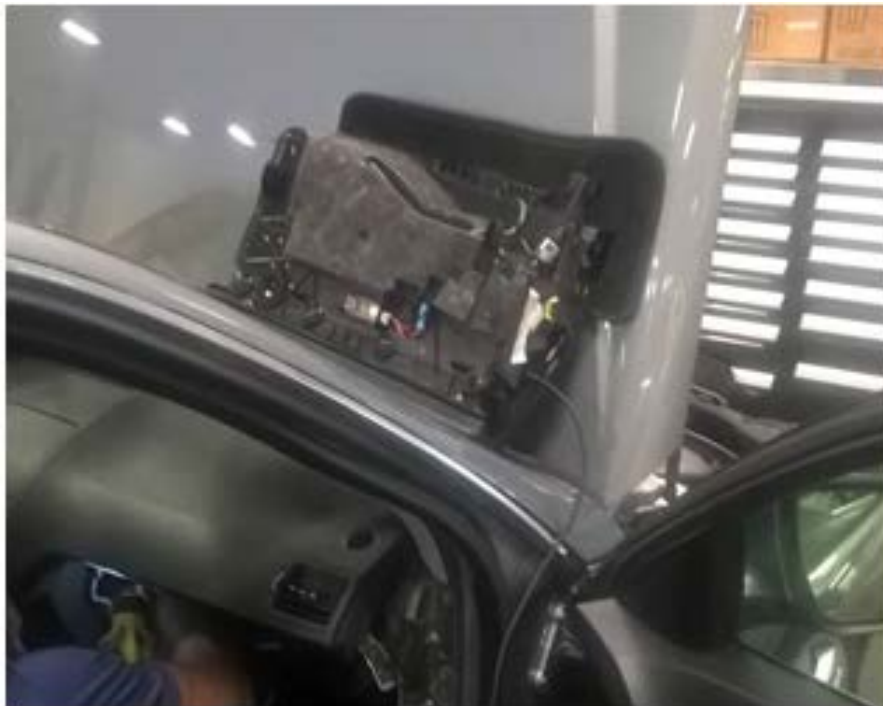
Figure 4

**i** Pull out the iPod cable as far as possible and set down glove box housing on the windshield **with** exterior iPod cable connected (**figure 4**).

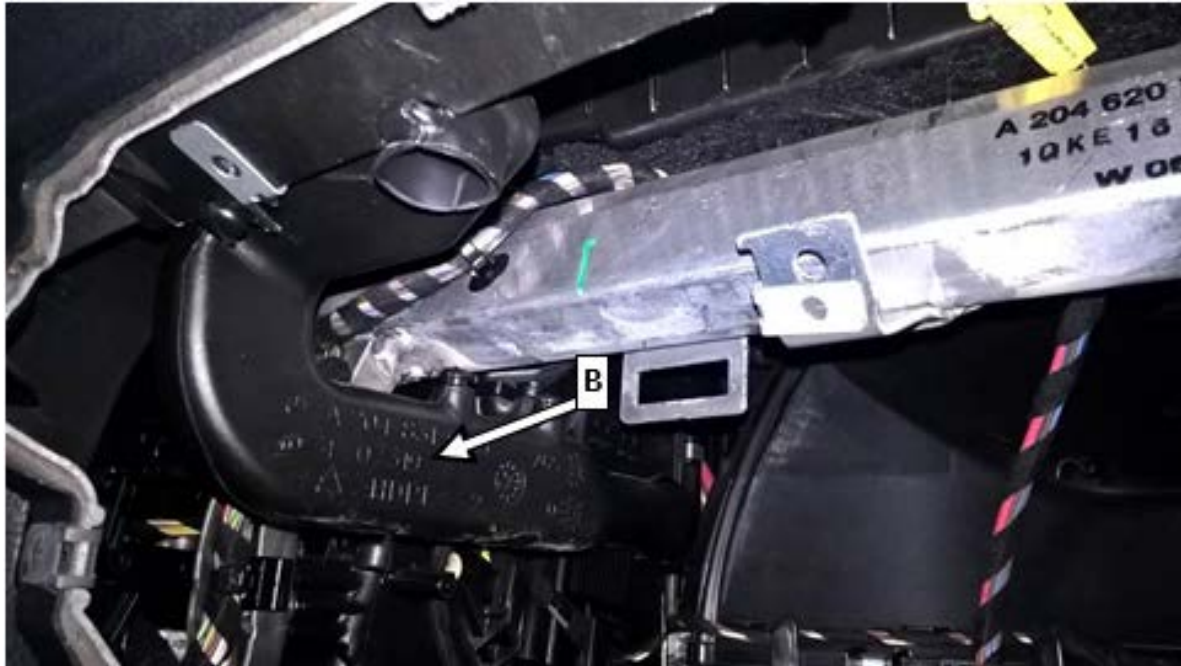
Figure 5

5. Remove air duct (**B**, **figure 5**) above the glove compartment.

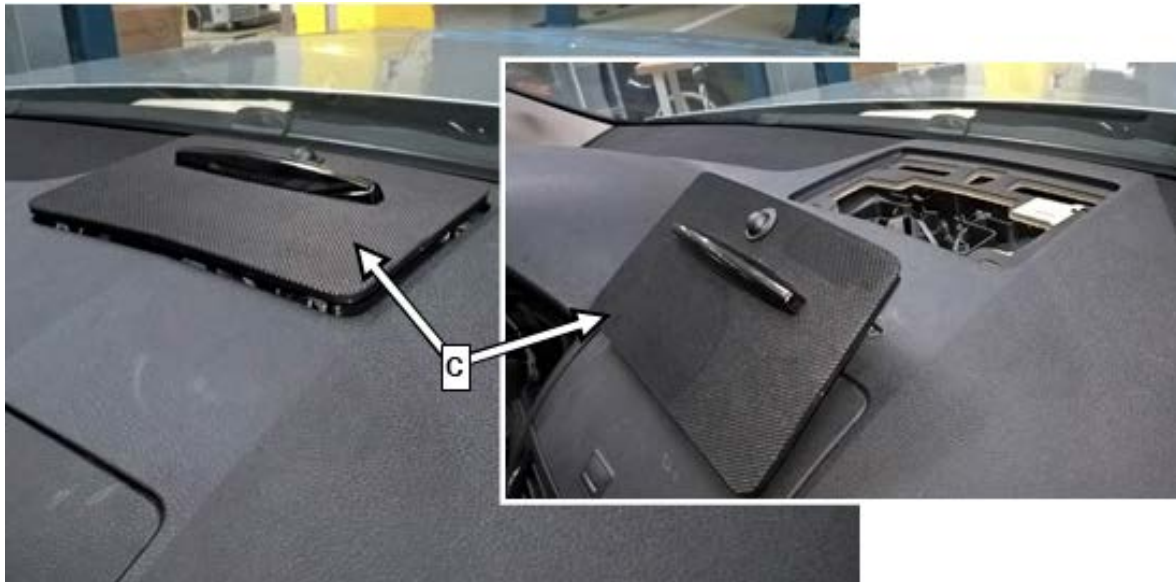
Figure 6

6. Unclip and remove cover (**C**, **figure 6**) at the instrument panel on top.

**i** With a sound system, also remove speaker under the cover.

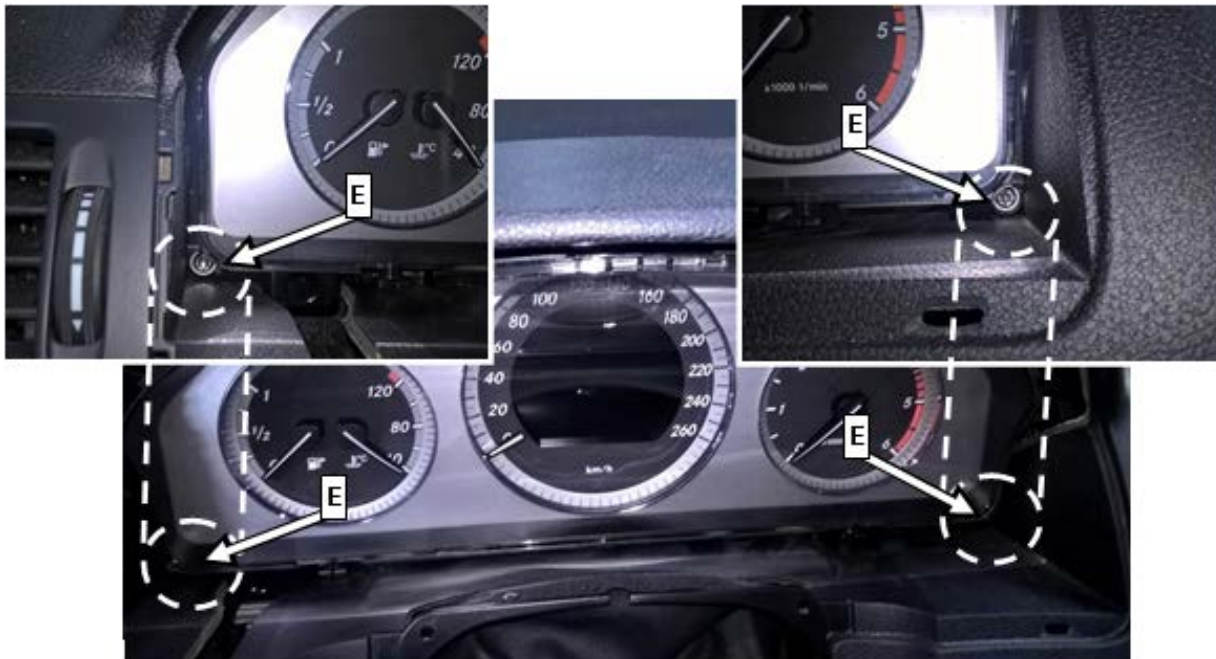
**Figure 8**

10. Remove the two bottom threaded connections (**E**, **figure 8**) of the instrument cluster.

**i** These screws are simultaneously fasteners for the instrument panel.

**i** The upper two screws do not need to be removed.

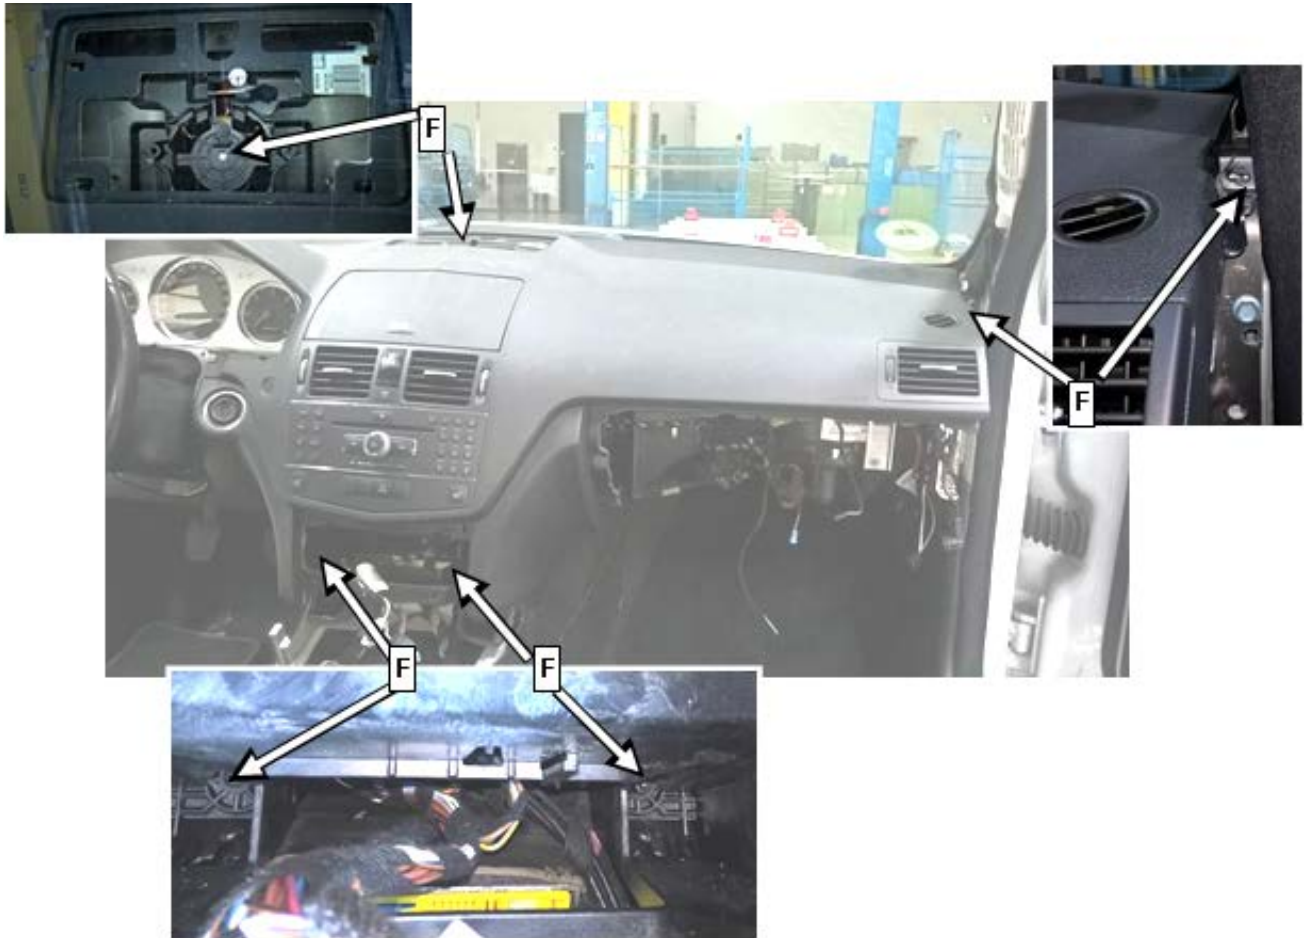
Figure 9

11. Remove four screws (F, figure 9) for fastening the instrument panel

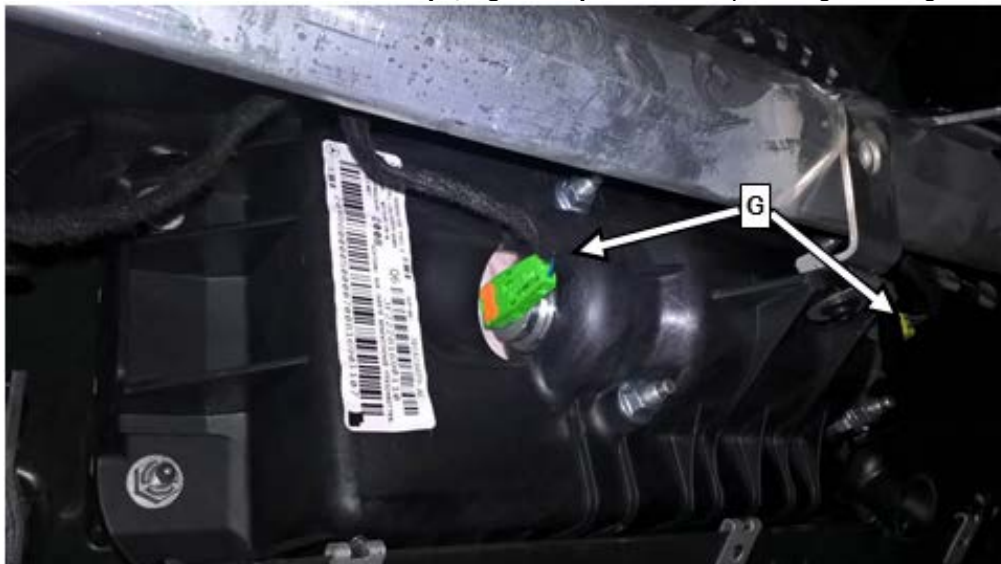
Figure 10

12. Disconnect electrical contacts (G, figure 10) at the front passenger airbag.

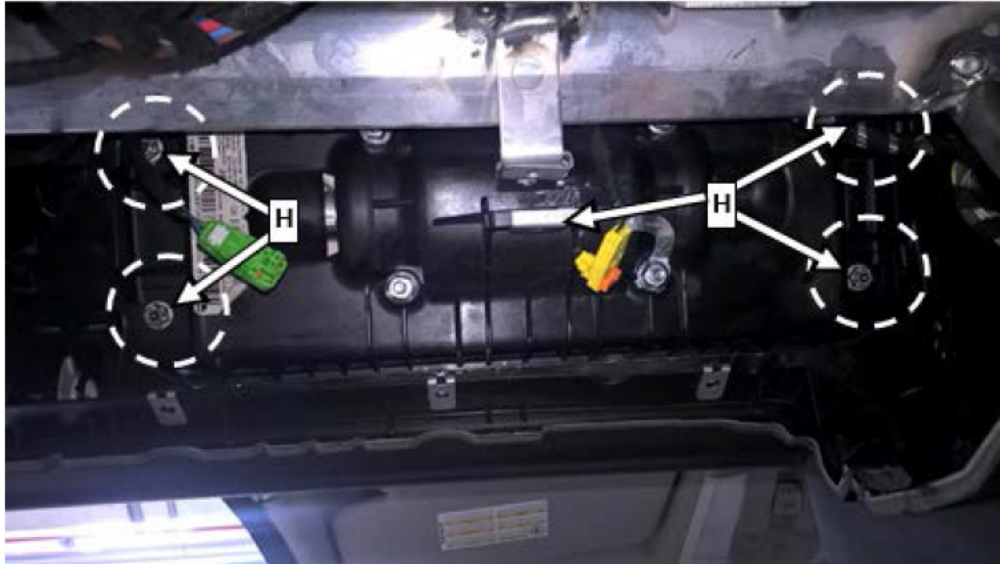
Figure 11

13. Remove lock nuts (**H**, **figure 11**) for the front the passenger airbag.

**i** Lock nuts should only be replaced if they are damaged. For more info see:  
**AH00.00-N-0001-01A / Modification notes 27.10.2016**

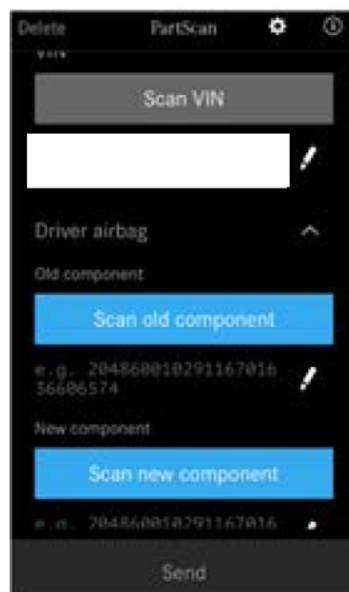
Figure 13

16. Scan barcodes of the removed driver airbag using the button "Scan old component" (figure 13).
  -

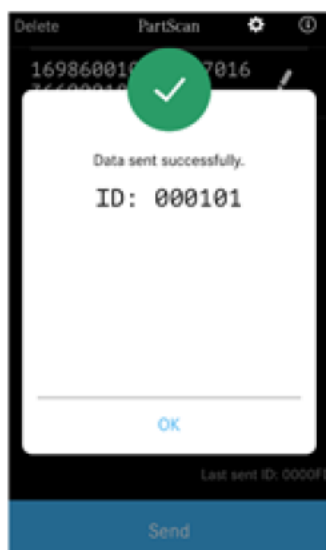
Figure 16

The generated scan ID (figure 16) must be recorded in writing in the workshop order and then stored in a tamper-proof manner.

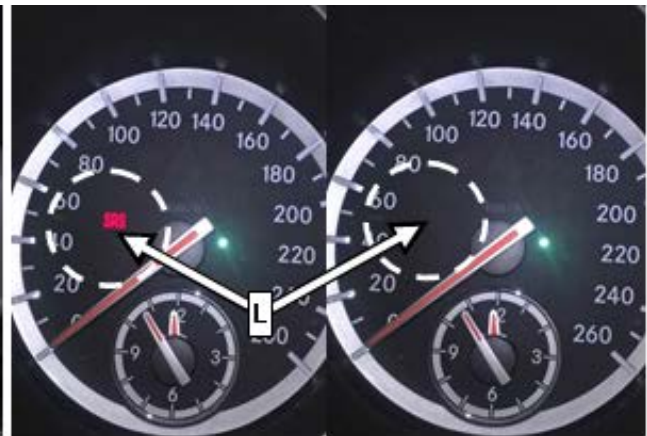
Figure 18

25. Turn the transmitter key in the electronic ignition lock to **position 1** and check whether the airbag indicator lamp (**L**, **figure 18 or 19**) remains on after a few seconds.

**i** The SRS check is thus completely ensured after airbag replacement.

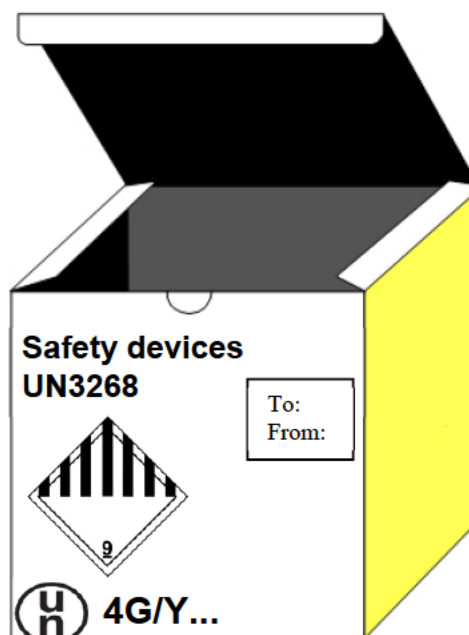
- The following words ("marking") must also be clearly visible on the same side of the box as the Class 9 label:  
**Safety devices**  
**UN3268** (font size must be  $\geq \frac{1}{2}$  inch)
- Affix "To/From" address label to same or adjacent packaging face as the hazardous markings/labels.
- The UN 4G code preprinted near the bottom edge of the box must also be clearly visible.

- Note:** The Packing Group and the EX# are no longer required to be printed on the HAZMAT bill of lading.
- Package example:**

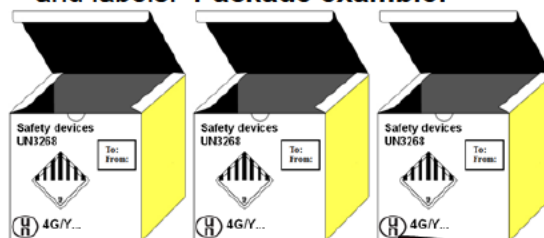
- Package each airbag in a separate UN spec box prepared with the labels/markings described above.
- Place each individual airbag box inside a larger non-UN spec box to keep the shipment together.
- This larger box is called an "OVERPACK."

- The OVERPACK must have the identical markings and label as the boxes contained inside.
- The OVERPACK must have the "OVERPACK" statement on the same face as the hazard markings and labels. **Package example:**
