TO: Mercedes-Benz Dealer Principals, General Managers, Sales Managers, Service Managers, Parts Managers	FROM: Thomas Brunner, Department Manager, Vehicle Compliance and Analysis, Engineering Services
RE: Recall Campaign 2017060001 MY17 CLA-Class, GLA-Class, E-Class (117, 156, 213) Replace Passenger Airbag	DATE: July 26, 2017

Campaign No. 2017060001, June 2017

SUBJECT: **Model 117, 156, 213 Model Year 2017**
Replace Passenger-side Airbag

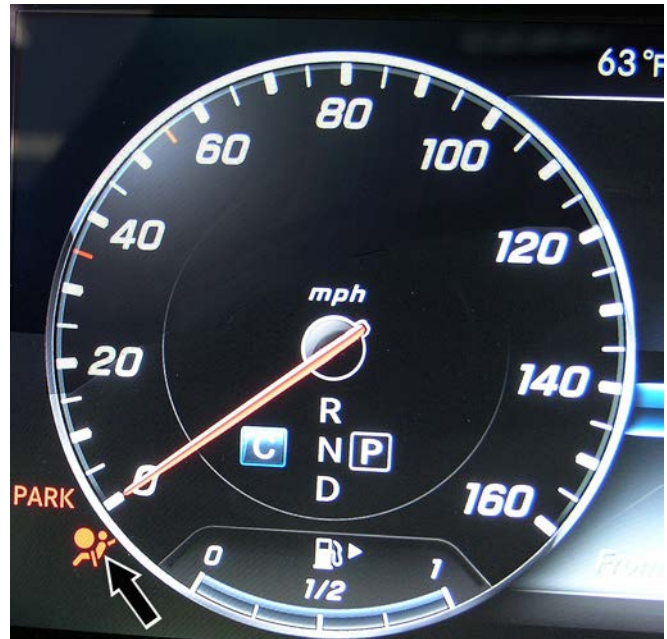
Figure 1 (Shown on model 213)

Start engine and check whether Supplemental Restraint System (SRS) indicator lamp (arrow, Figure 1) goes out after a few seconds.

After installation of new airbag be sure to start engine and check whether SRS indicator lamp goes out after a few seconds (arrow, Figure 1).

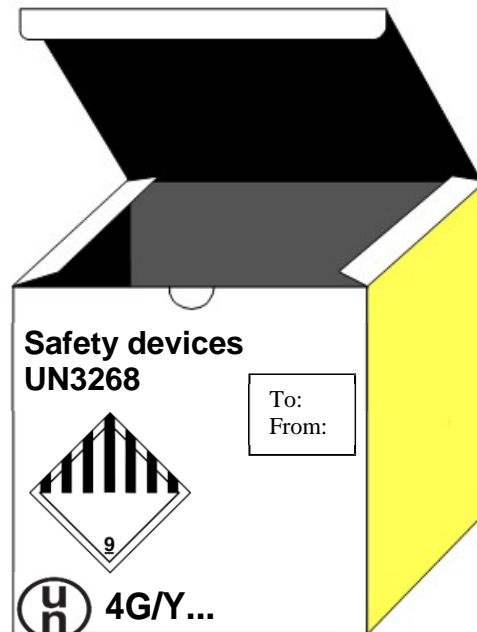
- A **Class 9 Miscellaneous** label must be clearly visible on one side of the box.

- The following words ("marking") must also be clearly visible on the same side of the box as the Class 9 label:
Safety devices
UN3268 (font size must be $\geq \frac{1}{2}$ inch)
- Affix "**To/From**" address label to same or adjacent packaging face as the hazardous markings/labels.
- The UN 4G code preprinted near the bottom edge of the box must also be clearly visible.

- **Note:** The Packing Group and the EX# are no longer required to be printed on the HAZMAT bill of lading.
- **Package example:**

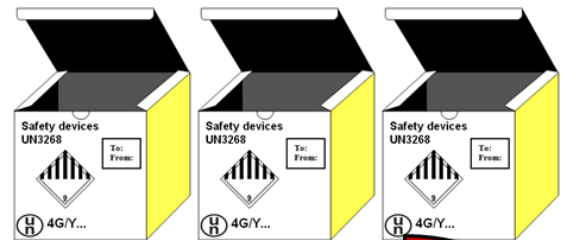
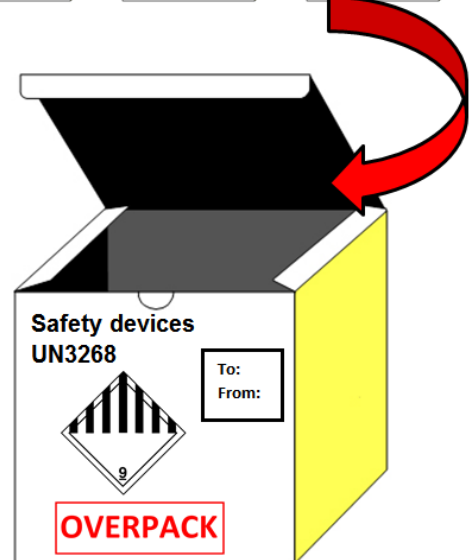
Package example:

- Package each airbag in a separate UN spec box prepared with the labels/markings described above.
- Place each individual airbag box inside a larger non-UN spec box to keep the shipment together.
- This larger box is called an "OVERPACK."
- The OVERPACK must have the identical markings and label as the boxes contained inside.

- The OVERPACK must have the "OVERPACK" statement on the same face as the hazard markings and labels.
