TO: Mercedes-Benz Dealer Principals, General Managers, Sales Managers, Service Managers, Parts Managers	FROM: Thomas Brunner, Department Manager, Vehicle Compliance and Analysis, Engineering Services
RE: <b>Recall Campaign</b> <b>2017050018 Window Bag (R)</b> <b>2017050019 Window Bag (L)</b> <b>2017050020 Window Bag (L + R)</b> <b>MY17 CLA-Class, GLA-Class (117, 156)</b> <b>Replace Window Bag</b>	DATE: July 26, 2017

# RECALL CAMPAIGN NOTIFICATION UPDATE

SUBJECT: **Model 156, Model Year 2017**  
**Replace Right Window Airbag**

SUBJECT: **Model 156, Model Year 2017**  
**Replace Left Window Airbag**

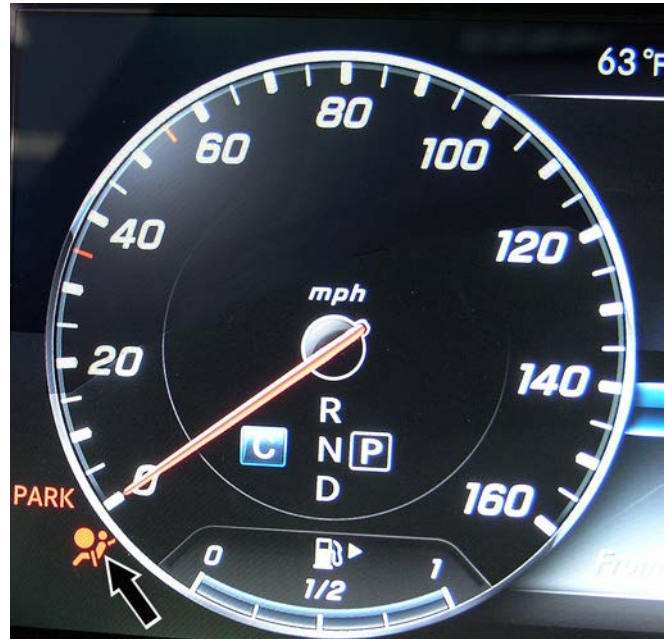
**Figure 1** (Shown on model 213)

Start engine and check whether Supplemental Restraint System (SRS) indicator lamp (arrow, Figure 1) goes out after a few seconds.

After installation of new airbags be sure to start engine and check whether SRS indicator lamp goes out after a few seconds (arrow, Figure 1).

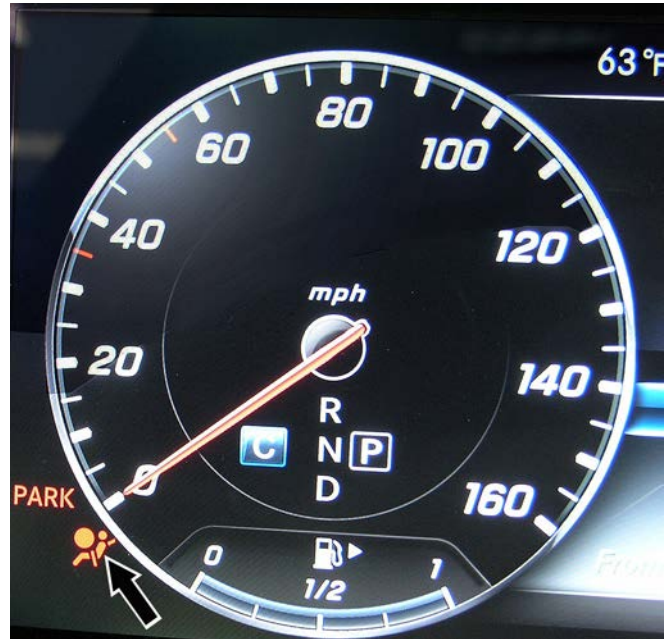
**Figure 1** (Shown on model 213)

Start engine and check whether Supplemental Restraint System (SRS) indicator lamp (arrow, Figure 1) goes out after a few seconds.

After installation of new airbag be sure to start engine and check whether SRS indicator lamp goes out after a few seconds (arrow, Figure 1).

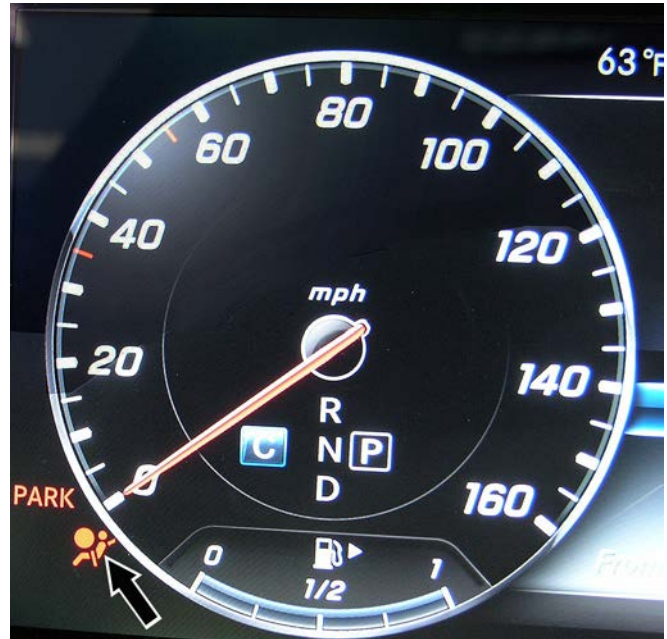
**Figure 1** (Shown on model 213)

- No errors are active in the SRS system (as described in this step).
- No SRS error messages are active in the instrument cluster (as described in this step).
- If an SRS error message is pending before start of work, it must be corrected. Fault corrections (repairs) are not claimable under this campaign.

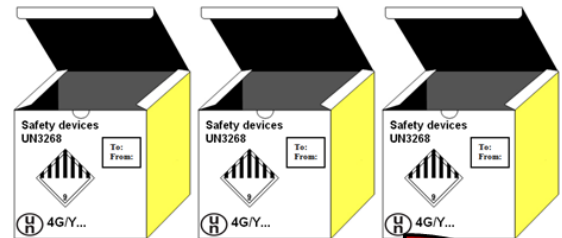
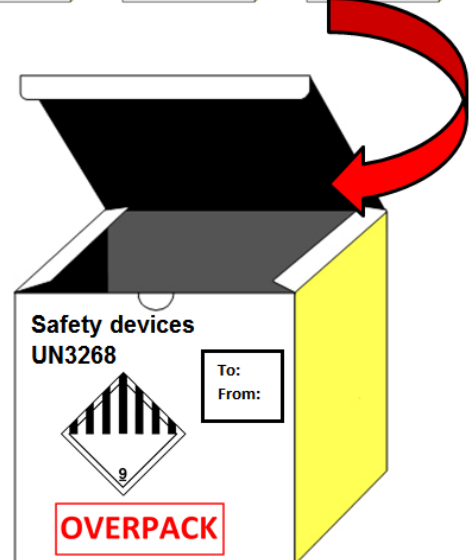
### Package example:

- The OVERPACK must have the "OVERPACK" statement on the same face as the hazard markings and labels.
