TO: Mercedes-Benz Dealer Principals, General Managers, Sales Managers, Service Managers, Parts Managers	FROM: Thomas Brunner, Department Manager, Vehicle Compliance and Analysis, Engineering Services
RE: Recall Campaign 2017080002 MY15-17 CLA-Class (117 platform), GLA-Class (156 platform), C-Class (205 platform), E-Class (213 platform) and GLC (253 platform) Retrofit Fuse on Starting Current Limiter	DATE: September 1, 2017

Campaign No. 2017080002, September 2017

SUBJECT: **Models 117, 156, 205, 213, and 253; Model Years 2015-2017**
Retrofit Fuse on Starting Current Limiter

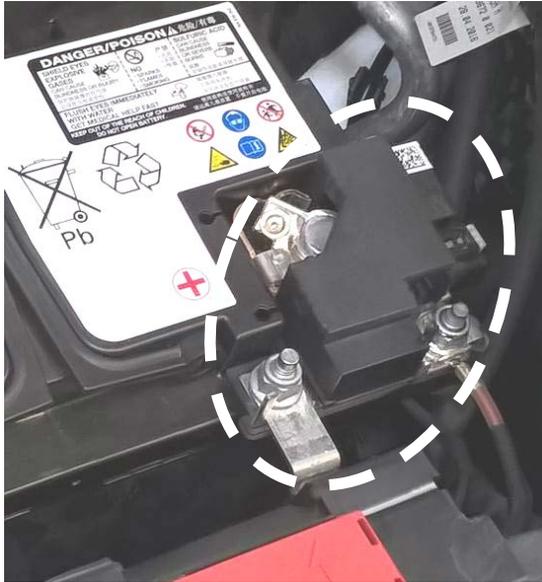
Figure 1 (front-end relay)

1. Check whether a front-end relay or a voltage dip limiter is installed.
 - a. If the **front-end relay** (figure 1) is positioned horizontally on the positive pole, continue below with the work instruction for the appropriate model. .
 - b. If the **voltage dip limiter** (figure 2) is positioned **laterally** in a vertical position **at the battery**, the procedure is complete – no further action needed..
Do not install the electrical fuse on the **voltage dip limiter**!

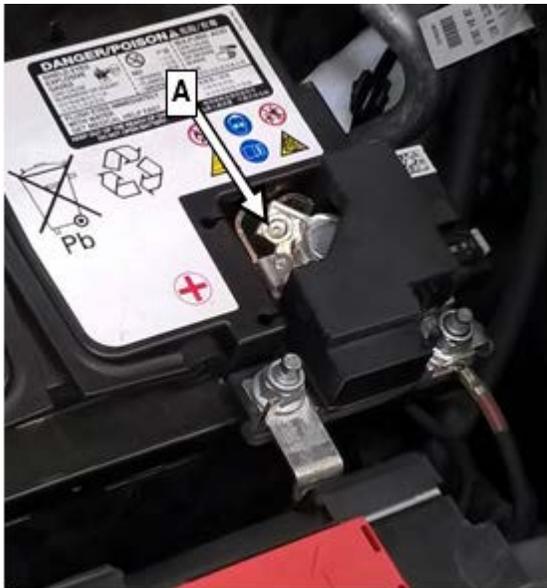
Figure 3

2. Loosen the nut (A, figure 3) of the battery clamp on the positive pole.

i After loosening, the battery clamp must **rotate freely on the pole!**

Nm Nut of battery clamp for front-end relay to positive pole **6 Nm**

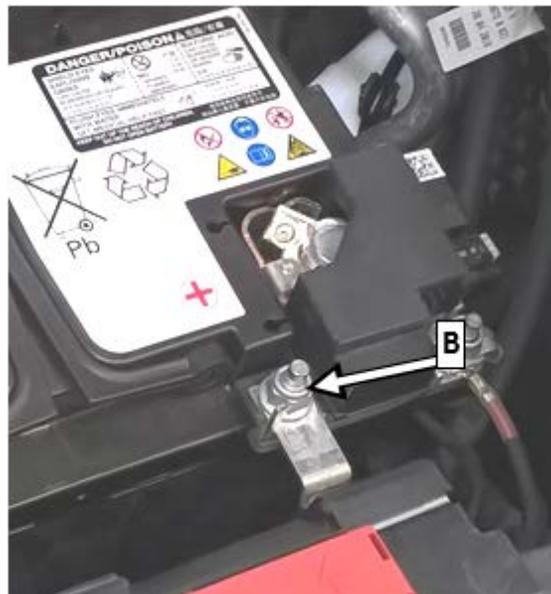
Figure 4

3. Unscrew the nut (B, figure 4) and remove the line.

Nm Nut of positive line/starter wiring harness to front-end relay **16 Nm**

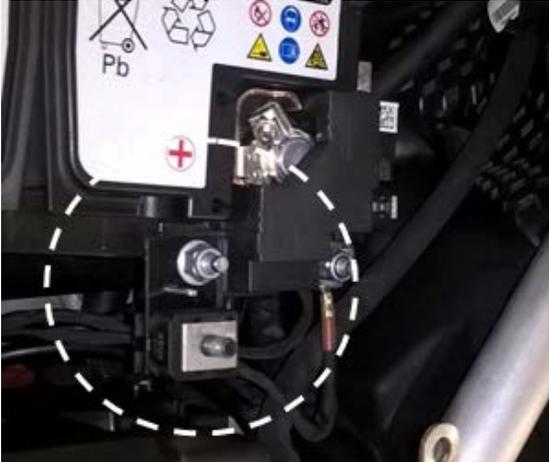
Figure 5

4. Subsequently installing the electrical fuse between the front-end relay and starter line. (figure 5)

Nm Nut for electrical additional fuse to front-end relay **16 Nm**

i When tightening the additional fuse, ensure the front-end relay has a uniform distance to the battery!

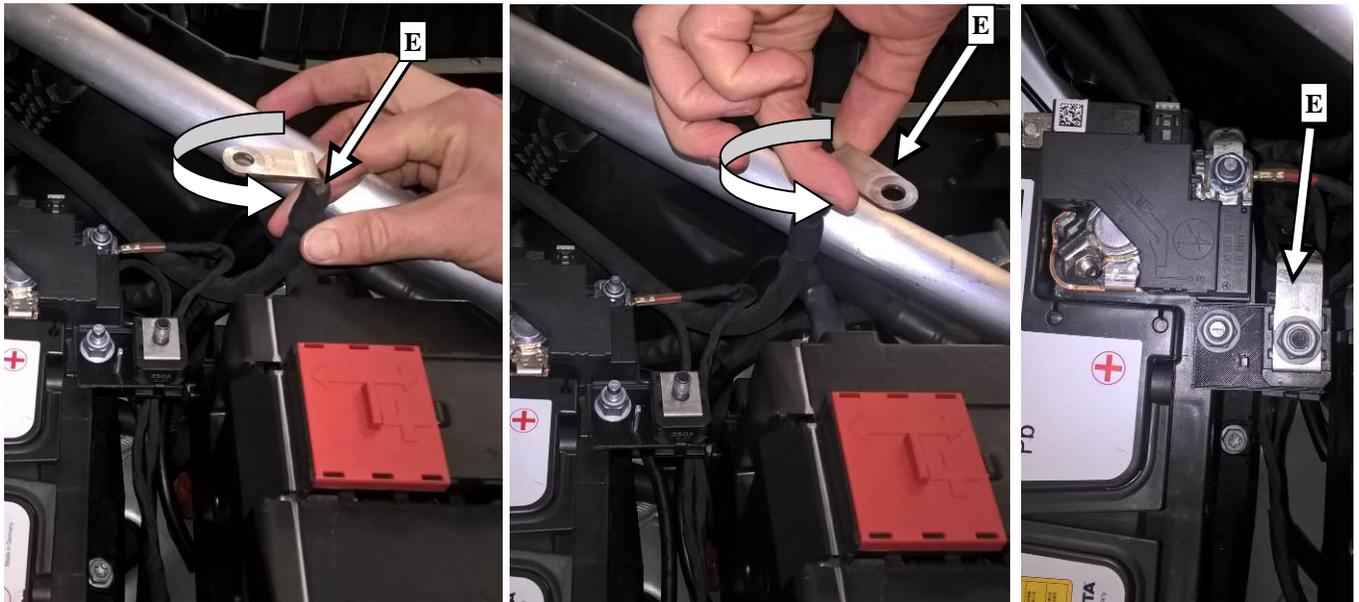
Figure 6

5. On models **205, 253, and 213**, attach the starter line (E, figure 6) to the electrical additional fuse and tighten.

i The starter line must be **turned by 90° degrees** before fastening tight.

Nm Nut for starter line to front-end relay **16 Nm**

i When tightening the starter line, ensure the front-end relay has a uniform distance to the battery!

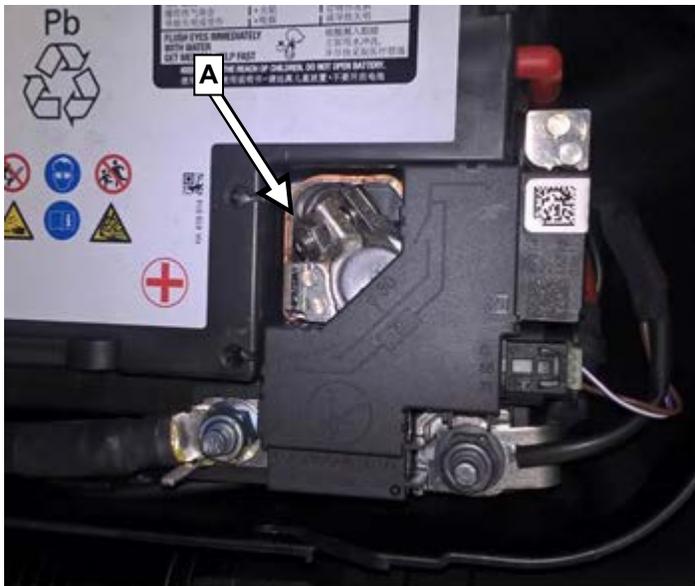
Figure 2

1. Disconnect negative battery cable at on-board electrical system battery.
 - i** Model 117 and 156 see AR54.10-P-0003NKB
 - Nm** Nut of battery cable to negative pole/positive pole of on-board electrical system battery **6 Nm**
 - i** Secure the disconnected negative battery cable against unwanted contact.
2. Loosen the nut (A, figure 2) of the battery clamp on the positive pole.
 - i** After loosening, the battery clamp must ***rotate freely on the pole!***
 - Nm** Nut of battery clamp for front-end relay to positive pole **6 Nm**
 - i** **Tightening torque must be strictly observed!**

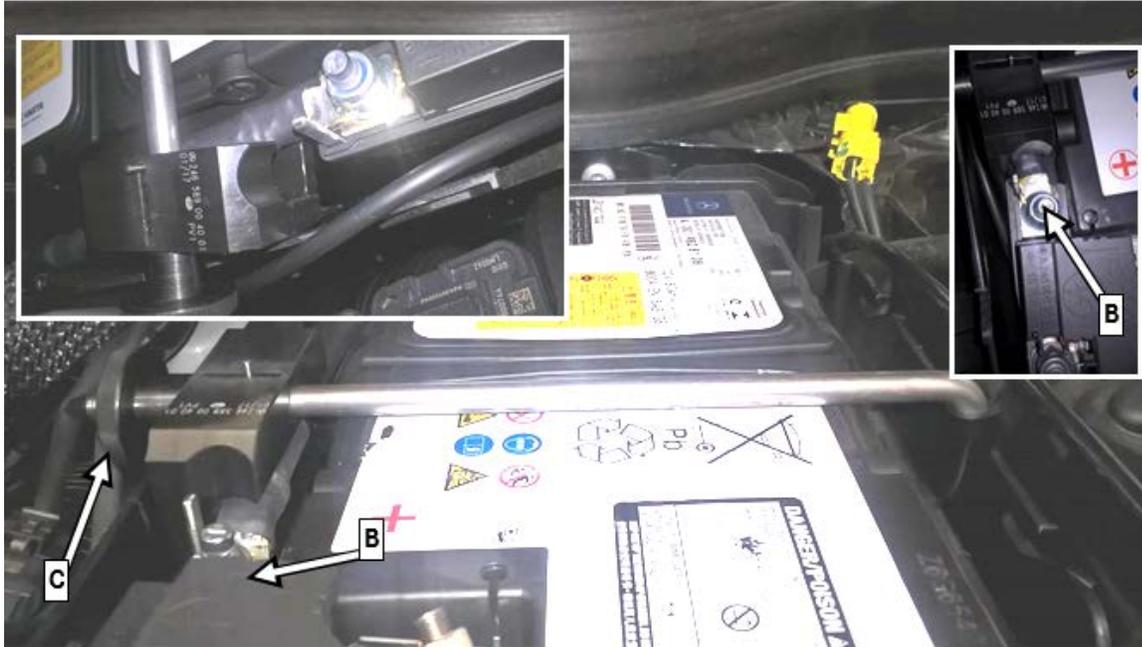
Figure 3

Attach special tool **W 246 589 00 40 00** to the **starter line** and battery.

- i** Attach special tool **only on the cable** and **not on the front-end relay!**
- i** The special tool prevents the transfer of the loosening torque to the front-end relay when opening the screwed connection of the starter line (B, figure 3).
- i** **Carefully tighten the knurled nut** (C, figure 3) until the front-end relay lightly contacts the battery (D, figure 4).
- i** Do not over **tighten the knurled nut too much** so as to prevent damage to the front-end relay

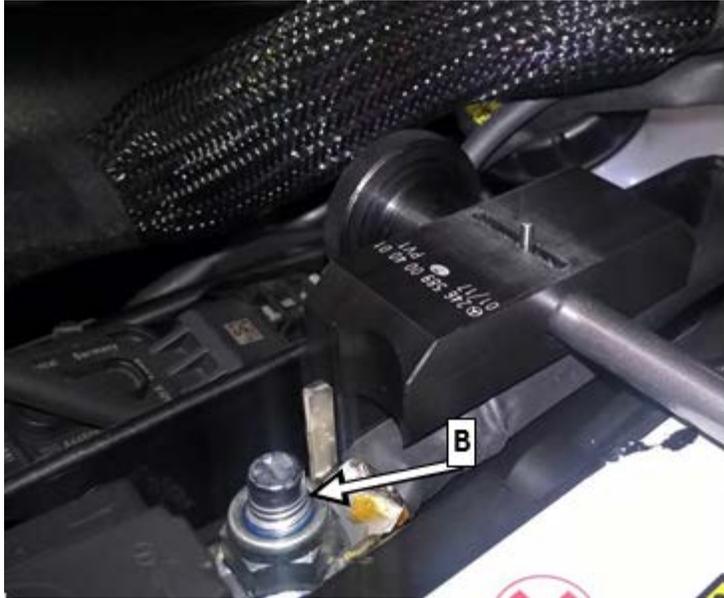
Figure 5

4. Unscrew the nut (B, figure 5) and remove the line, including the special tool.

Hm Nut of positive line/starter wiring harness to front-end relay **16 Nm**

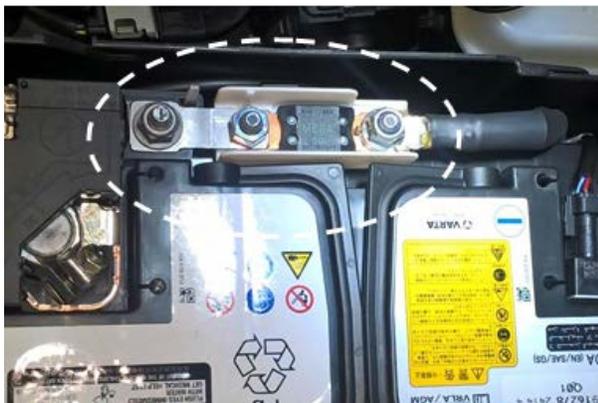
Figure 6

5. Subsequently install the electrical fuse between the front-end relay and starter line.

Hm Nut for electrical additional fuse to front-end relay **16 Nm**

i When tightening the additional fuse, ensure the front-end relay has a uniform distance to the battery!

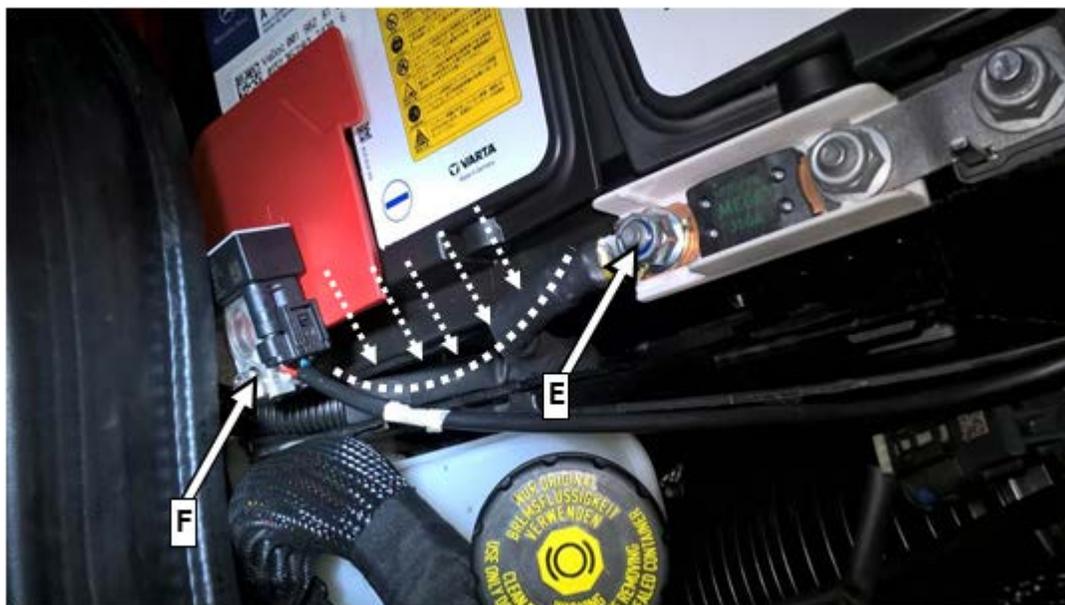
Figure 7

6. On models **117 and 156** attach the starter line (E, figure 8) to the electrical additional fuse and tighten.

i Install excess cable on models 117 and 156 as a downward U between the battery and the battery box.

The starter line **may not be pushed backward out of the battery box** as otherwise the chafe protection (F, figure 8) is moved.

i **Route the starter line free of tension.**

Hm Nut for starter line to front-end relay **16 Nm**
