TO: Mercedes-Benz Dealer Principals, General Managers, Sales Managers, Service Managers, Parts Managers	FROM: Thomas Brunner, Department Manager, Vehicle Compliance and Analysis, Engineering Services
RE: Recall Campaign UPDATE 2017050023 (Passenger), 2017050024 (Driver), or 2017050025 (Driver & Pass) MY17 205, 222, 253 (C-Class, S-Class, GLC-Class) Replace Front Seatbelts (Left, Right, Both)	DATE: July 26, 2017

RECALL CAMPAIGN NOTIFICATION UPDATE

SUBJECT: **Model 205, 253, and 222, Model Year 2017**
Replace Right Front Seat Belt

SUBJECT: **Model 205, 253, and 222, Model Year 2017**
Replace Left Front Seat Belt

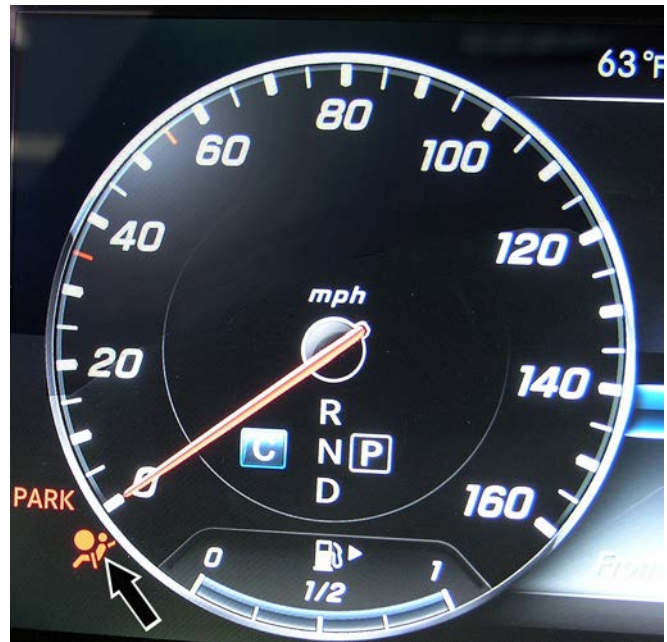
Figure 1 (shown on model 213)

Start engine and check whether Supplemental Restraint System (SRS) indicator lamp (arrow, Figure 1) goes out after a few seconds.

After installation of new seat belt be sure to start engine and check whether SRS indicator lamp goes out after a few seconds (arrow, Figure 1).

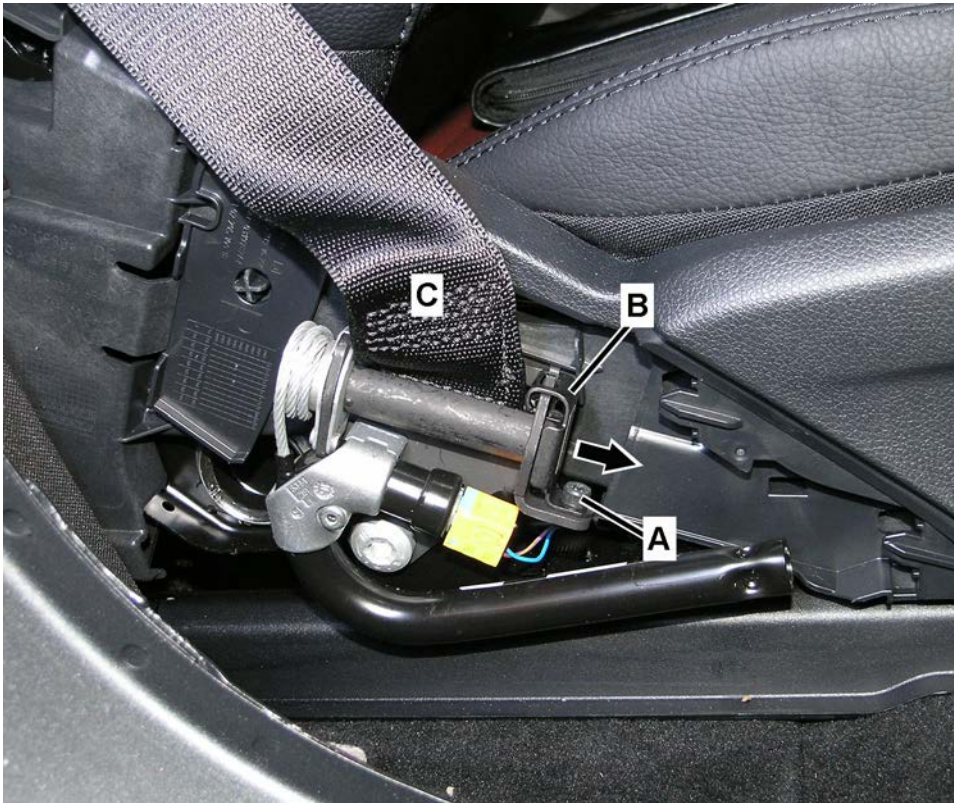
Figure 2 (shown on right front seat belt)

- Remove screw (A, Figure 2).
- **Hm** Upon installation, torque screw (A) to: 4 Nm.
- Remove retaining clamp (B).
- Pull seat belt (C) toward front (arrow) out of guide at front seat.

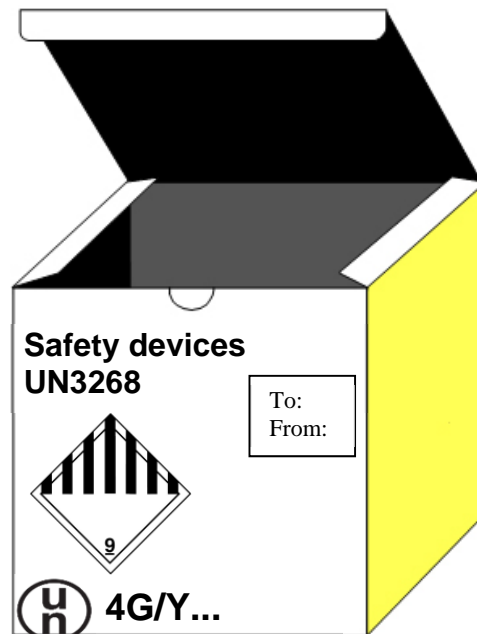
- Carefully open received box and remove new airbag. Keep box intact & save all contents!
- Place used airbag into replacement UN specified 4G fiberboard box, re-using any packaging material (e.g., cardboard inserts) used for the new airbag. Package exactly as the new airbag was packaged.
- Use plastic adhesive tape 50 mm wide to secure the box closed. Do not obscure labels or text on the box with the tape.
- Ensure that the 4G fiberboard box is not ripped or damaged.

- The following words ("marking") must also be clearly visible on the same side of the box as the Class 9 label:
Safety devices
UN3268 (font size must be $\geq 1/2$ inch)
- Affix "**To/From**" address label to same or adjacent packaging face as the hazardous markings/labels.
- The UN 4G code preprinted near the bottom edge of the box must also be clearly visible.

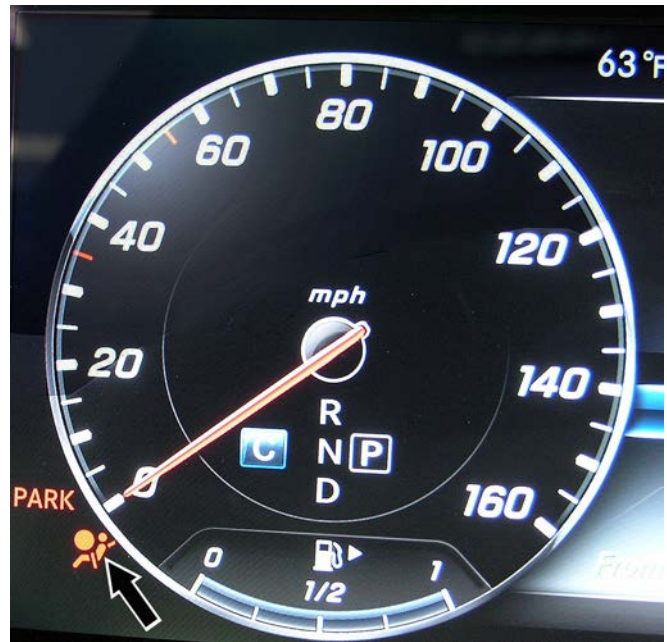
Figure 1 (shown on model 213)

Start engine and check whether Supplemental Restraint System (SRS) indicator lamp (arrow, Figure 1) goes out after a few seconds.

5. **i** After installation of new seat belt be sure to start engine and check whether SRS indicator lamp goes out after a few seconds (arrow, Figure 1).

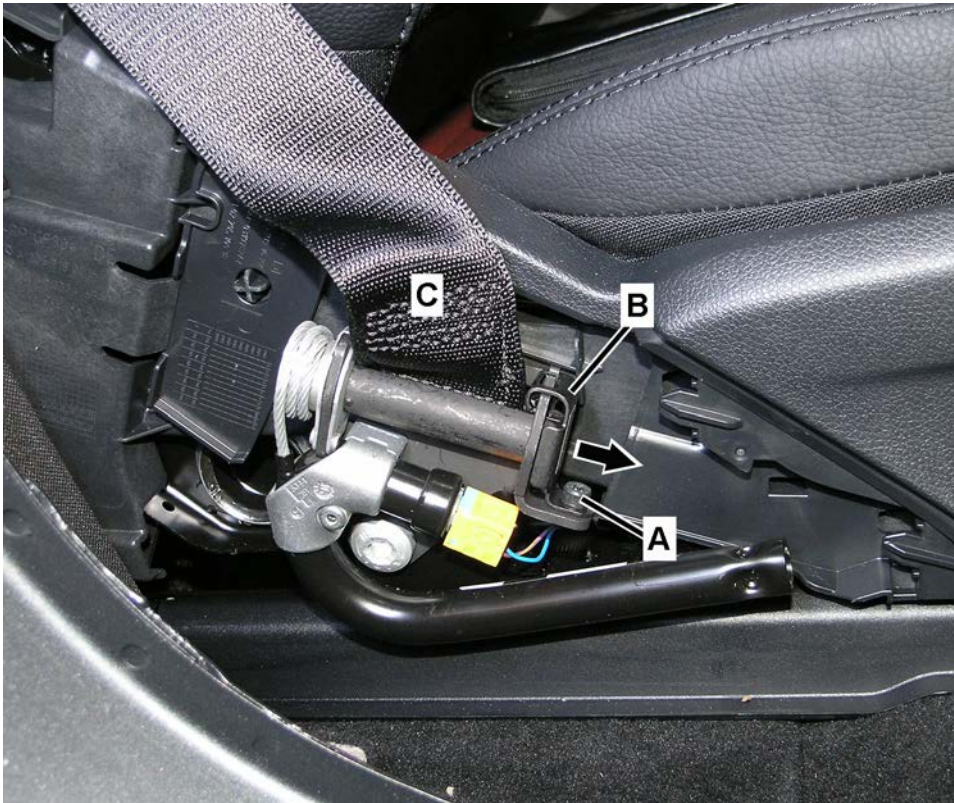
Figure 2 (shown on right front seat belt)

- Remove screw (A, Figure 2).
- **Hm** Upon installation, torque screw (A) to: 4 Nm.
- Remove retaining clamp (B).
- Pull seat belt (C) toward front (arrow) out of guide at front seat.

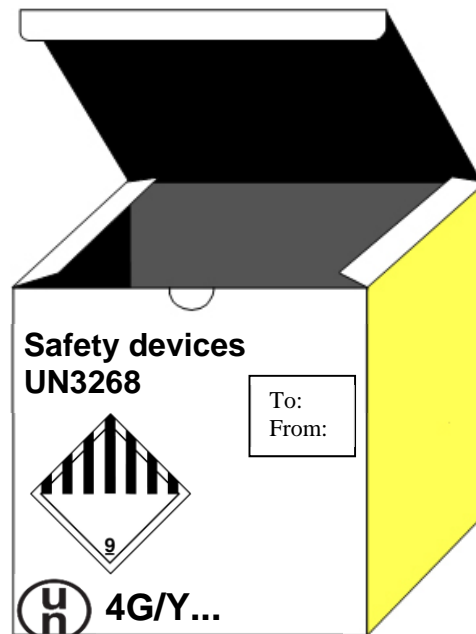
- Note:** The Packing Group and the EX# are no longer required to be printed on the HAZMAT bill of lading.
- Package example:**

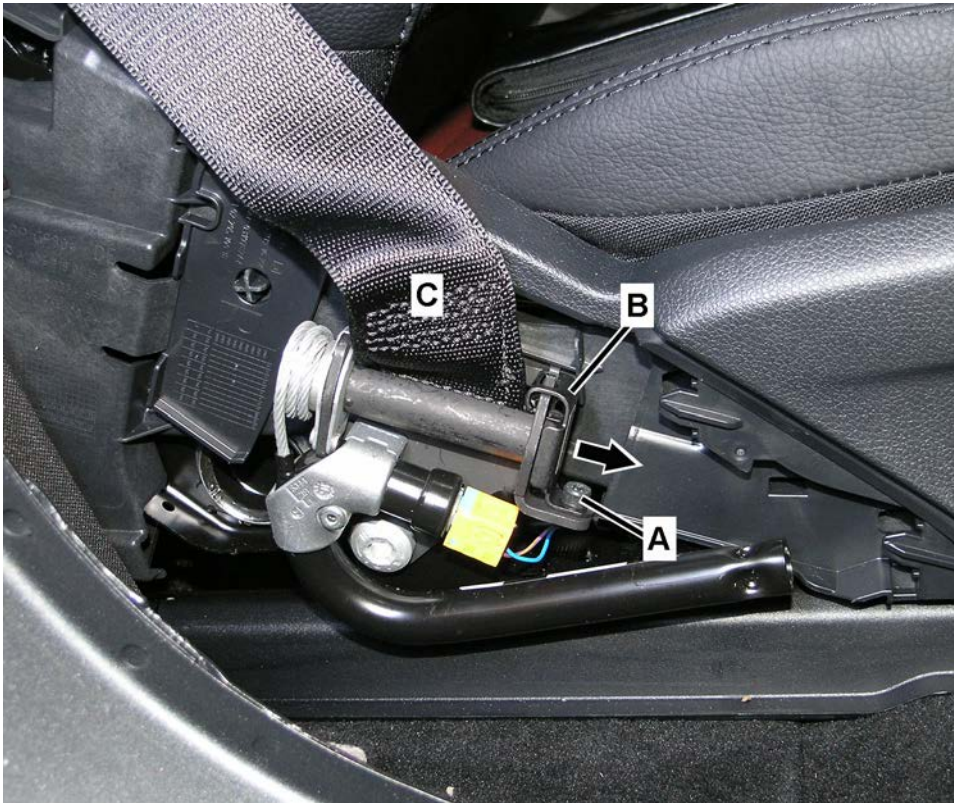
Figure 2

3. Supplemental information to above WIS instructions:

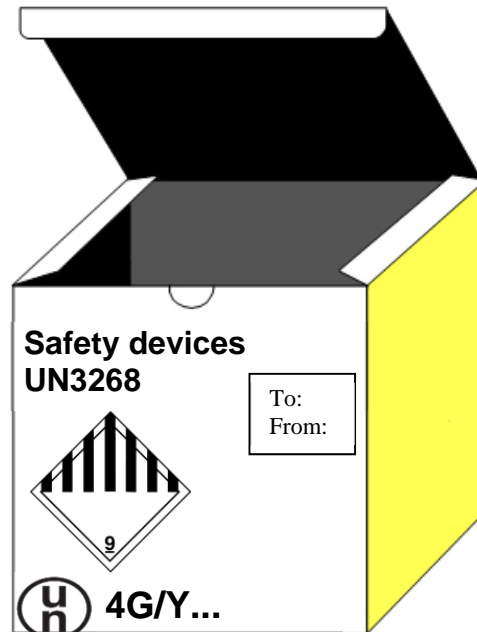
- Note:** The Packing Group and the EX# are no longer required to be printed on the HAZMAT bill of lading.
- Package example:**
