Recall Campaign

FL736AB

Subject: TBB Davenport Lap Belt Anchorage

**Models Affected: Specific Saf-T-Liner HDX buses
manufactured October 28, 2011, through January 9, 2017.**

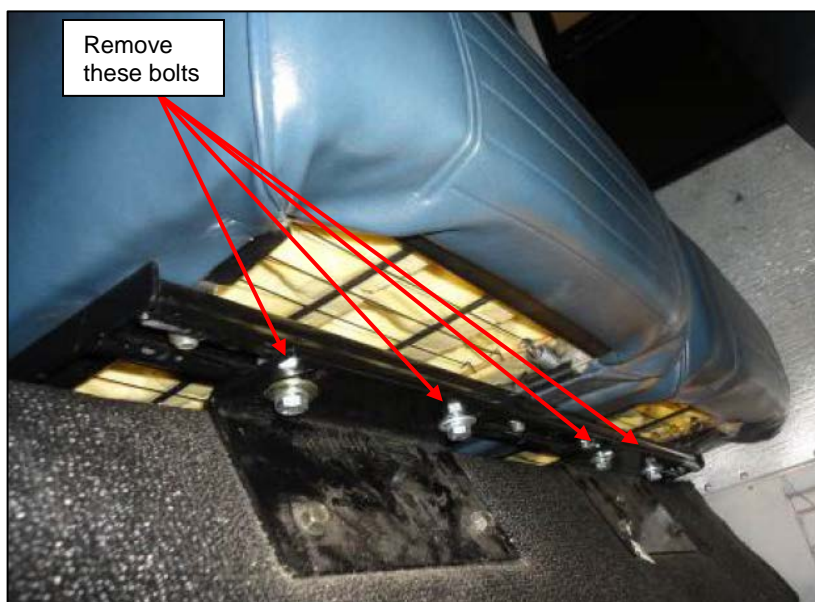
1. Park the vehicle, shut down the engine, place in Park, and chock the wheels.
2. Using a 9/16 in. wrench, remove the 2 seat bolts from underneath the seats for each of the 4 davenport seats. Retain the 8 bolts. See **Figure 1**.

Figure 1: Bolt Location

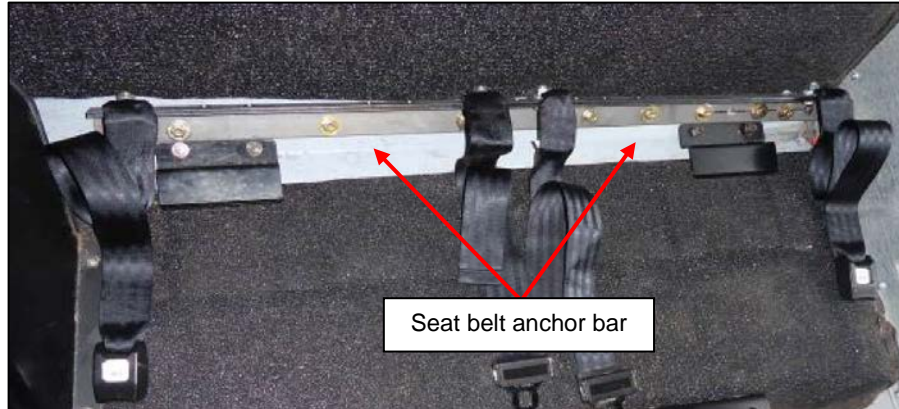
3. Slide the seat assembly out from underneath the rear brackets.
4. Inspect for the seat belt anchor bar behind each davenport seat. See **Figure 2** for correct installation.
 - 4.1 If the seat belt anchor bar is not present, go to *Seat Belt Anchor Bar Installation* before continuing with this procedure.
 - 4.2 If the seat belts are attached to the seat belt anchor bar, the installation is correct. Go to step 12.
 - 4.3 If the seat belt is attached to the seat, the installation is incorrect. Go to the next step.
5. Turn the seat upside down and loosen all 9/16 in. nuts.

Figure 2: Seat Belt Anchor Bar

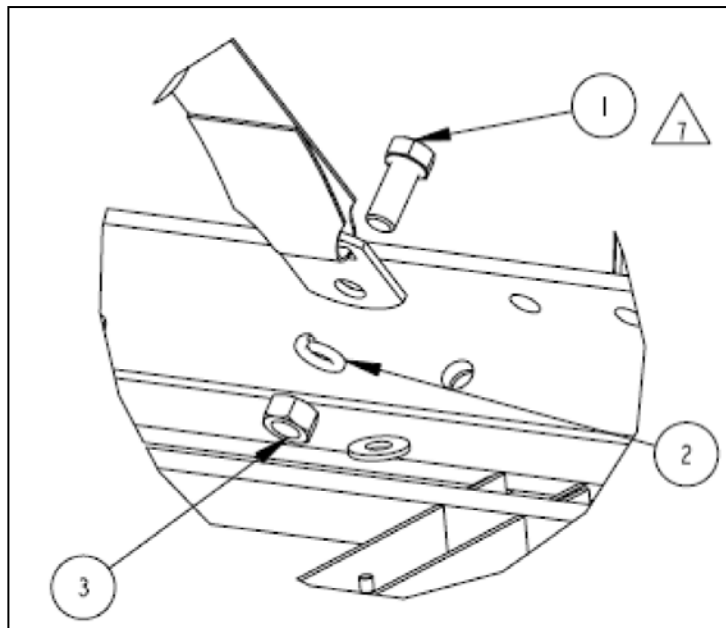
10. Install each belt to the seat belt anchor bar using the hardware from kit TBB 217213 (use 8 sets to anchor the seat belts), as shown in **Figure 3**.

Figure 3: Installation of Seat Belts

11. Align the belt mount to the forward position and tighten the bolt and nut using a 5/8 in. and a 11/16 in. wrench until the lock washer is compressed and the assembly is tight.
12. Once all seating position belts are installed, extend the lap belts and lay them on the davenport shelf as shown in **Figure 4**.

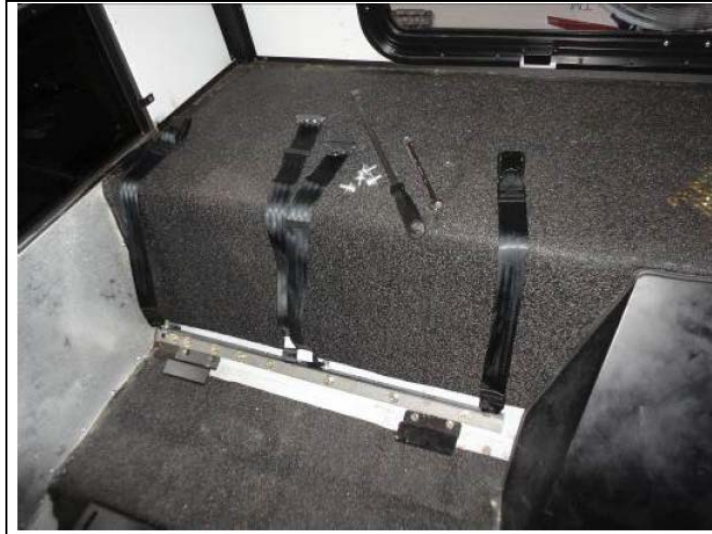
Figure 4: Seat Belts Extended on Davenport Shelf

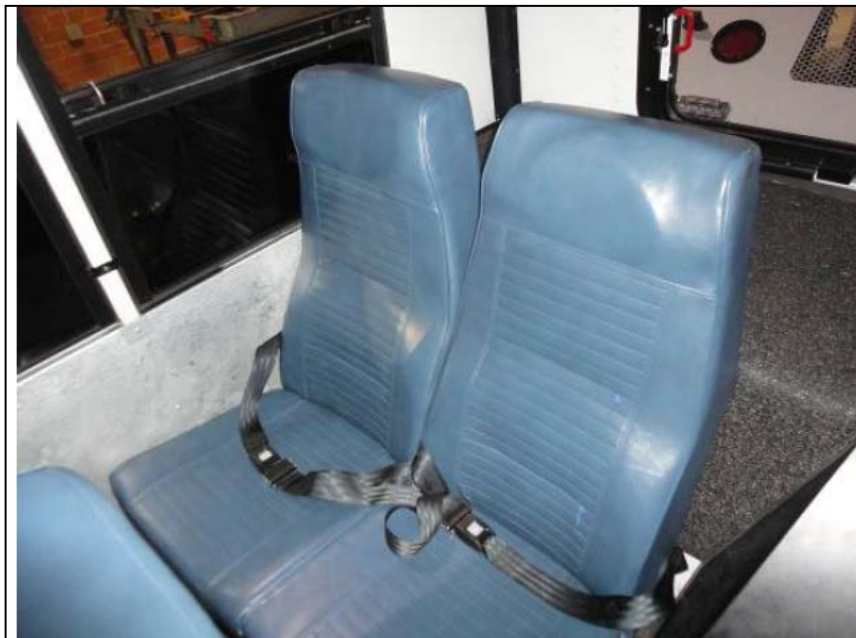
14. Place the lap belts on the seat and buckle as shown in **Figure 5**.

Figure 5: Belts Buckled on Seats

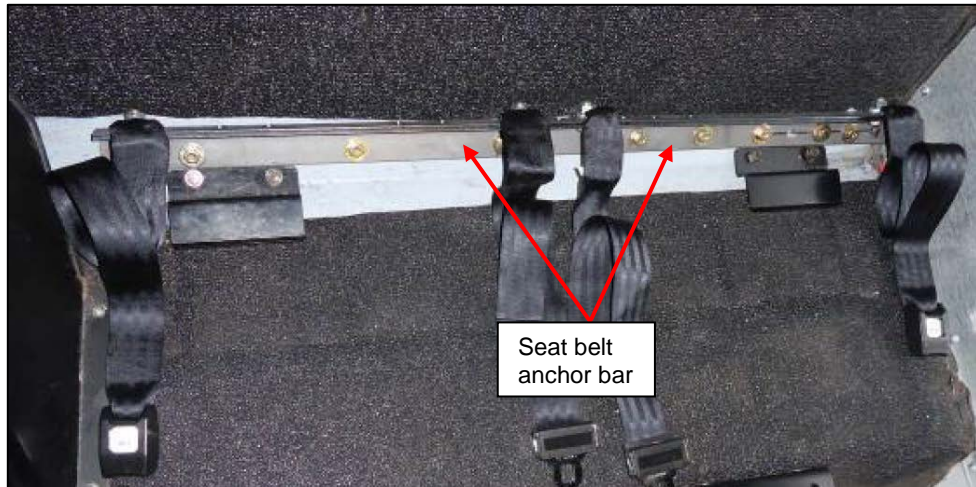
NOTE: For the location of the seat belt anchor bar (TBB 183431) behind the davenport seats see **Figure 6**.

Figure 6: Location of the Seat Belt Anchor Bar

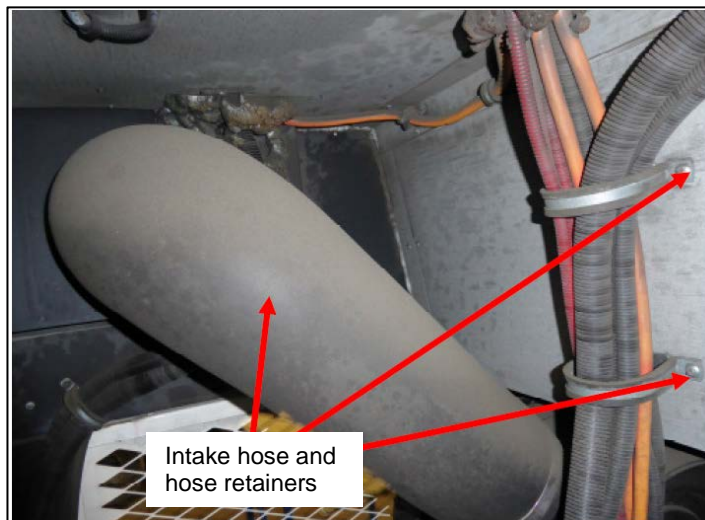
1. Disconnect the battery.
2. Remove the air intake hose and hose retainers as shown in **Figure 7**. Retain all parts. Cover the air intake with a large towel to prevent contamination.

Figure 7: Removal of the Intake hose and hose retainers

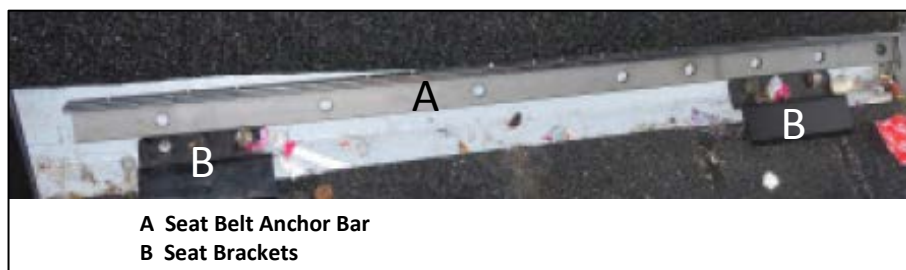
4. Position the inside half of the seat belt anchor bar as shown in **Figure 8**. Use a grease pen to mark the location of each hole. (The bracket should sit on the two brackets that hold the rear of seats, with the 8 holes each against the davenport wall and the angle on top of the seat belt anchor bar.)

Figure 8: Seat Belt Anchor Bar Location on the Davenport

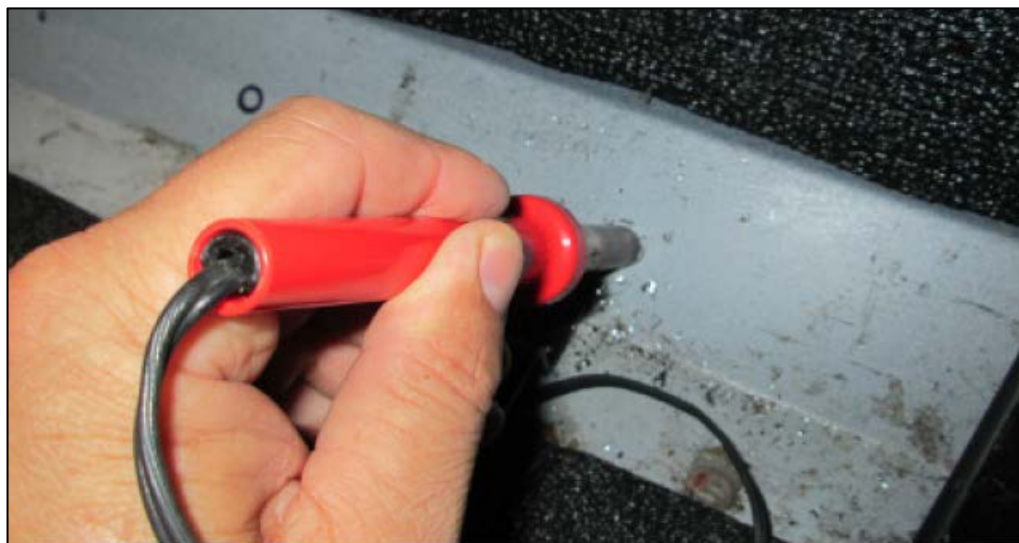
NOTE: When drilling through the davenport panels, there is insulation between panels which will wrap around the drill bit. Use a hot iron or soldering iron to melt any material in each hole. See **Figure 9**.

Figure 9: Removing Davenport Insulation

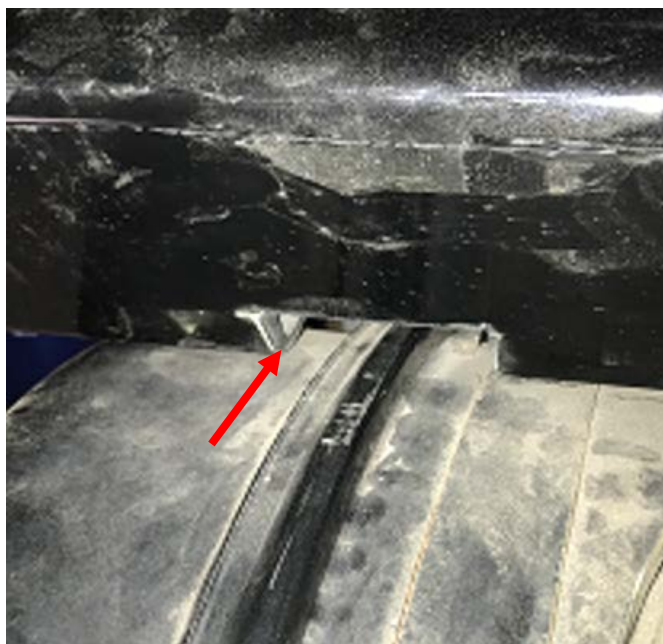
10. Remove the davenport support bracket and use a drill press to drill 8- 7/16 in. holes all the way through the bracket as marked in step 9.
11. Remount the davenport support bracket with the 2 self-tapping screws. If the bracket does not allow the air filter canister cover to open properly, create a notch in the bracket wide enough so the cover can be removed when the ring is loosened. See **Figure 10**. This will require removing bracket from bus. Use of a cutting wheel is recommended.
12. Remount the bracket if needed and verify the canister cover can be removed.

Figure 10: Notch for air filter canister cover

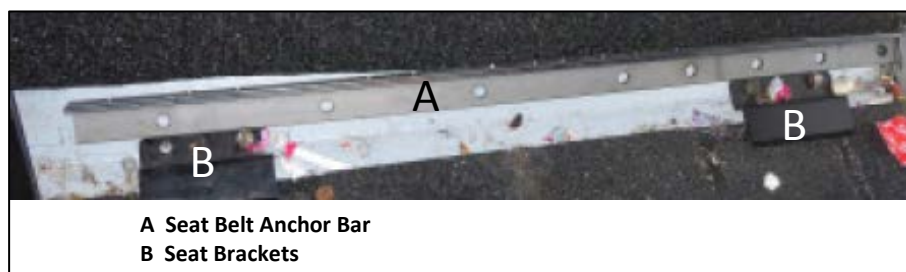
1. Install the other half of the seat belt anchor bar (TBB 183431), cut in step 3 of *Driver's Side Installation*, as shown in **Figure 11**. Use a grease pen to mark 8 holes. (It should sit on the two brackets that hold the rear of seats with the 8 holes each against the davenport wall and the angle on top.)

Figure 11: Seat Belt Anchor Bar Location on the Davenport

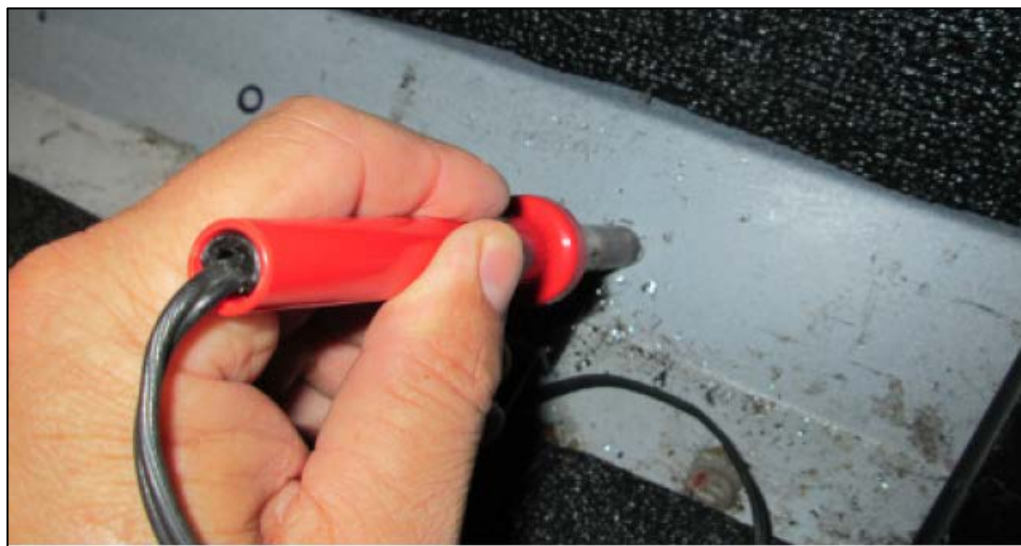
NOTE: When drilling through the davenport panels, there is insulation between panels which will wrap around the drill bit. Use a hot iron or soldering iron to melt any material in each hole. See **Figure 12**.

Figure 12: Removing Davenport Insulation

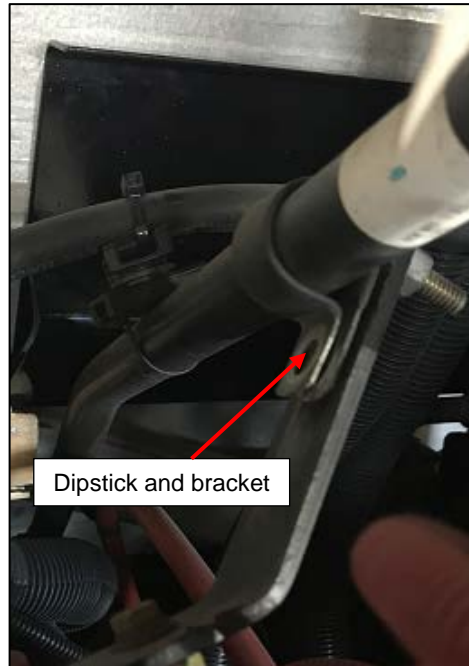
3. Unbolt the transmission dipstick from its mounting bracket as shown in **Figure 13**. Retain the parts.

Figure 13: Dipstick and Bracket

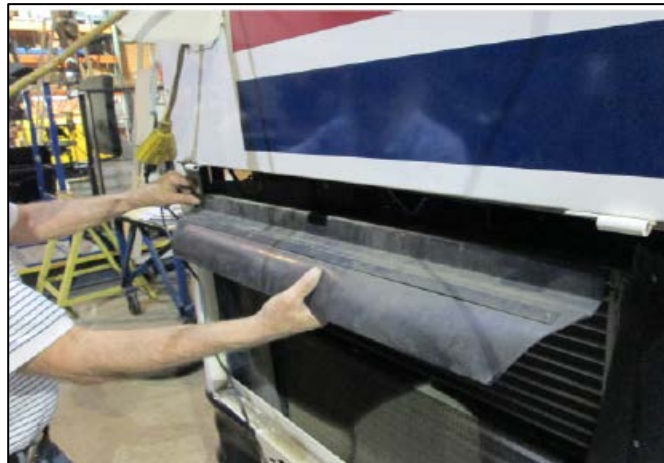
4. Remove the upper radiator shroud, see **Figure 14**. Retain the screws and shroud.

Figure 14: Upper Radiator Shroud

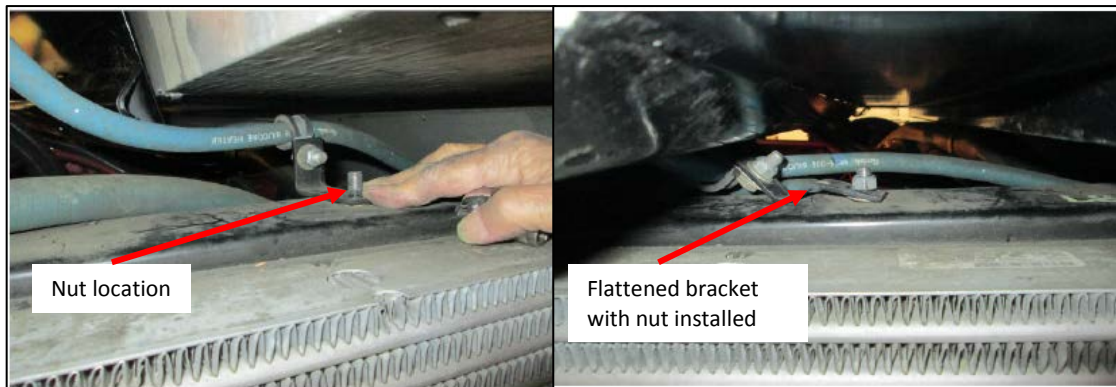
5. Remove the nut, flatten the bracket, then reinstall the nut as shown in **Figure 15**.

Figure 15: Nut and Flattened Bracket

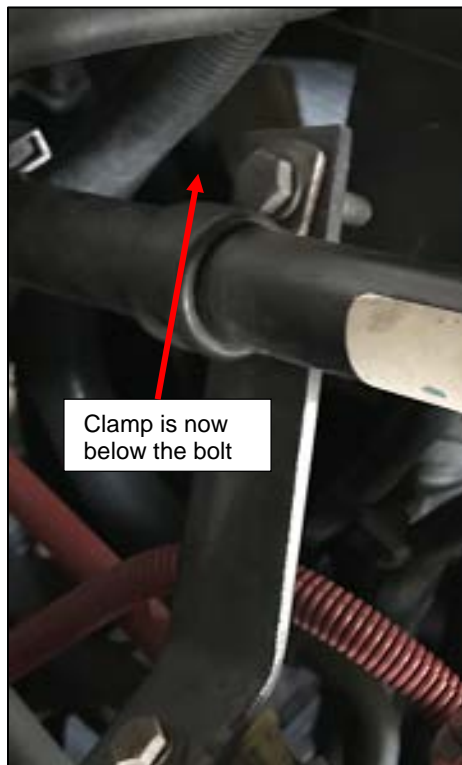
11. Install the radiator shroud using the fasteners previously removed.
12. Mount the transmission dipstick to the bracket with the parts previously removed, but this time flip the clamp 180 degrees so that it pulls the tube down away from the davenport support bracket. See **Figure 16**.

Figure 16: Dipstick Mounted Lower on the Bracket
