TECHNICAL
SERVICE
BULLETIN:

TS A18-1

Models Affected:
Ascape

Subject:
LP Gas Tray
Reinforcement

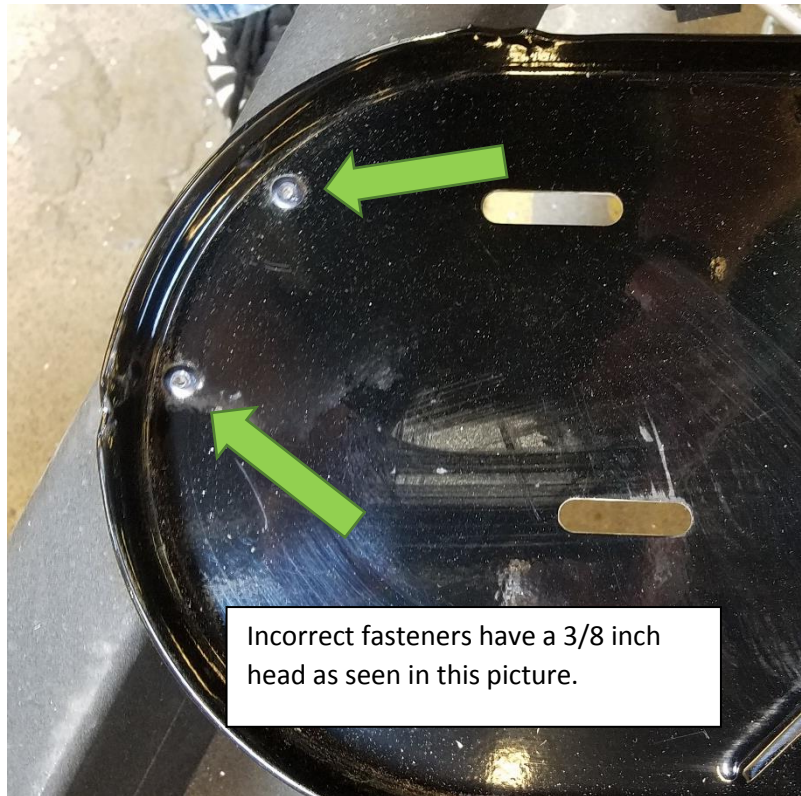
1. If smaller rivets with 3/8" head are found (as seen in picture), they must be removed by using a 3/16" drill bit.

Repeat procedure on the other side of the tray

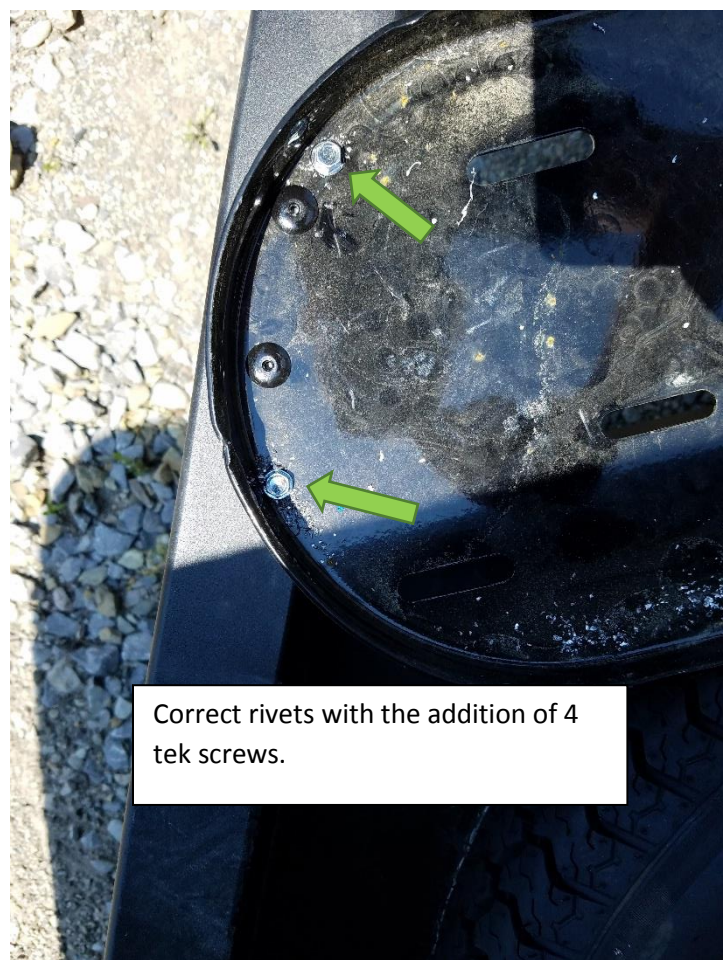
2. Replace two smaller rivets with new 5/8" headed rivets and add two tek screws as seen in picture.

Repeat procedure on the other side of the tray.
