SUBJECT: NEW VEHICLE DEMONSTRATION / DELIVERY HOLD - Compliance Recall 17C08
Certain 2017 Model Year Explorer, F-Super Duty, and F-150 Vehicles Equipped with
Manual Seat Backrest Recliner
Driver Seat Backrest Frame Inspection and Replacement

**NEW VEHICLE DEMONSTRATION / DELIVERY HOLD -
Compliance Recall 17C08**

Certain 2017 Model Year Explorer, F-Super Duty, and F-150 Vehicles Equipped with
Manual Seat Backrest Recliner
Driver Seat Backrest Frame Inspection and Replacement

CERTAIN 2017 MODEL YEAR EXPLORER, F-SUPER DUTY, AND F-150 VEHICLES EQUIPPED WITH MANUAL SEAT BACKREST RECLINER — DRIVER SEAT BACKREST FRAME INSPECTION AND REPLACEMENT

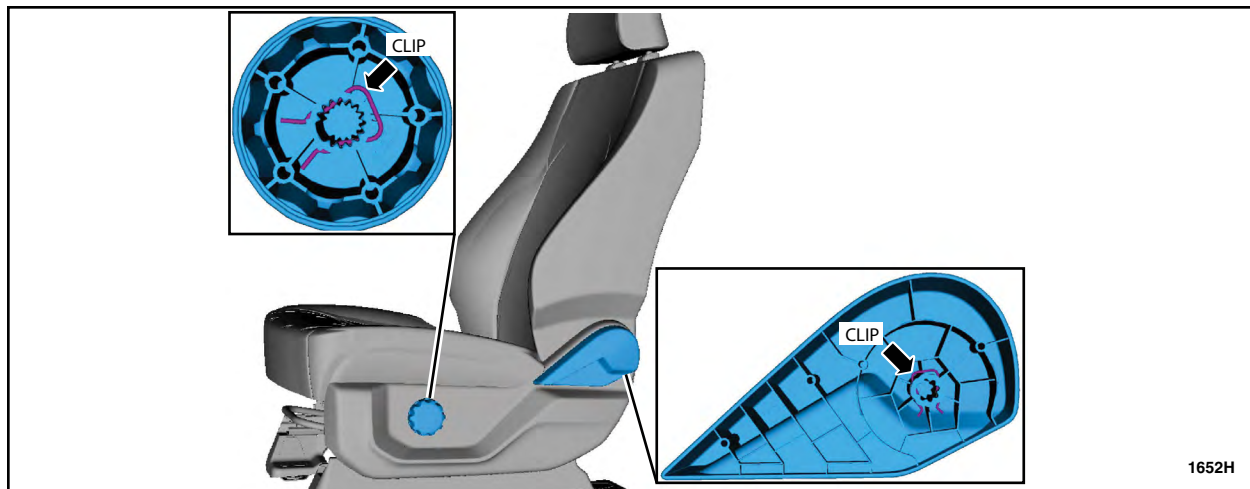
FIGURE 1

1. If equipped with manual lumbar, adjust the lumbar to the fully relaxed position.
2. Remove the recline handle and lumbar knob (if equipped). See Figure 1.

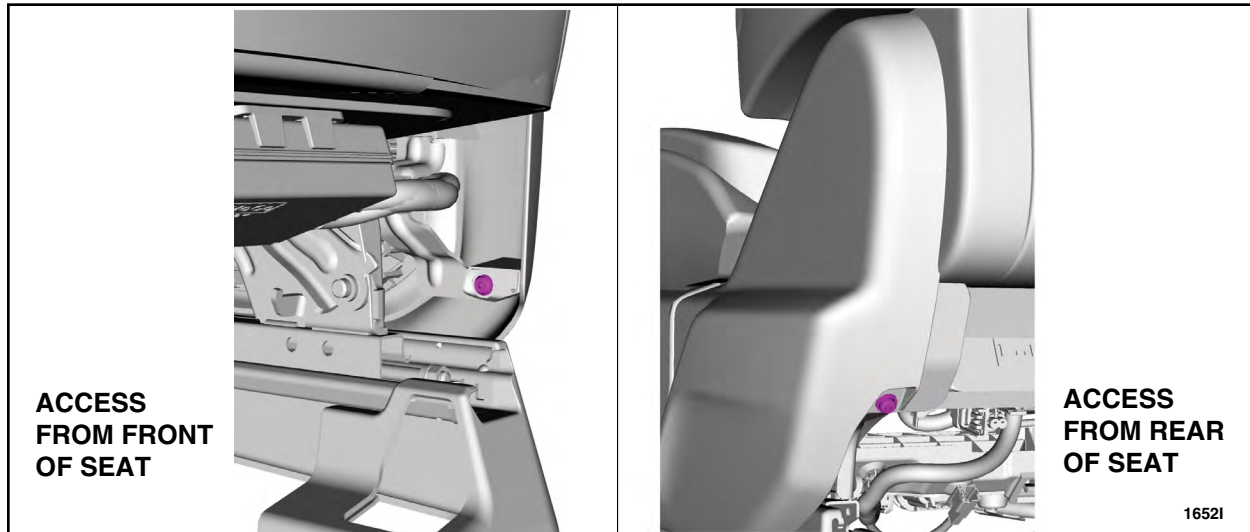
FIGURE 2

3. Remove the two side shield screws. See Figure 2.

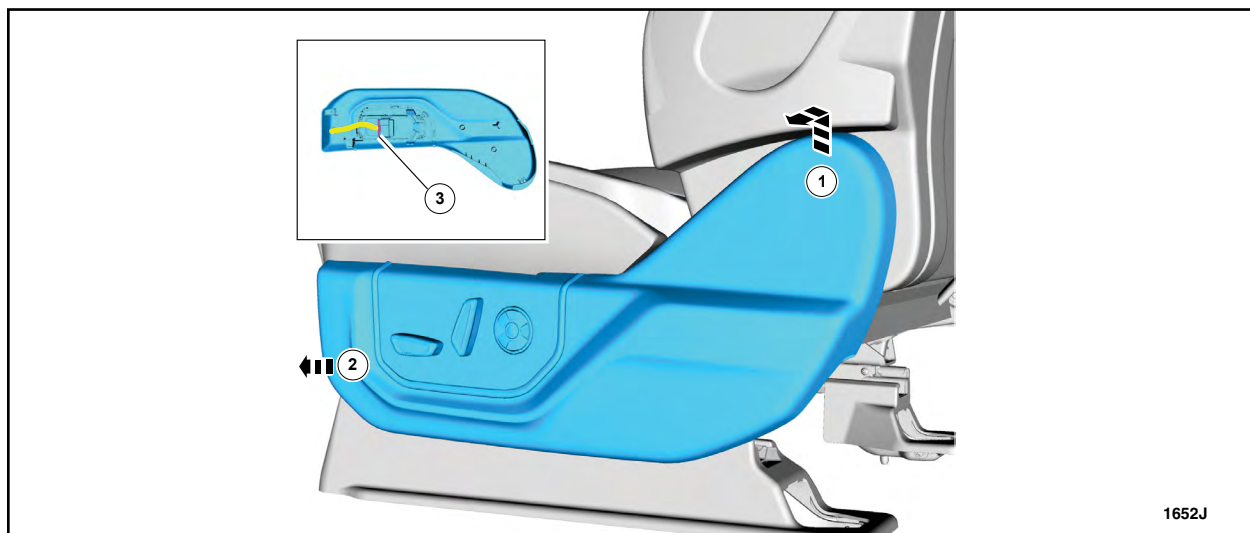
FIGURE 3

4. Position aside the side shield. See Figure 3.

1. Lift up on the rear of the side shield and pull outward.
2. Push the side shield forward.
3. If equipped, do not disconnect the electrical connector at this time in case seat movement is later needed for inspection or seat removal.

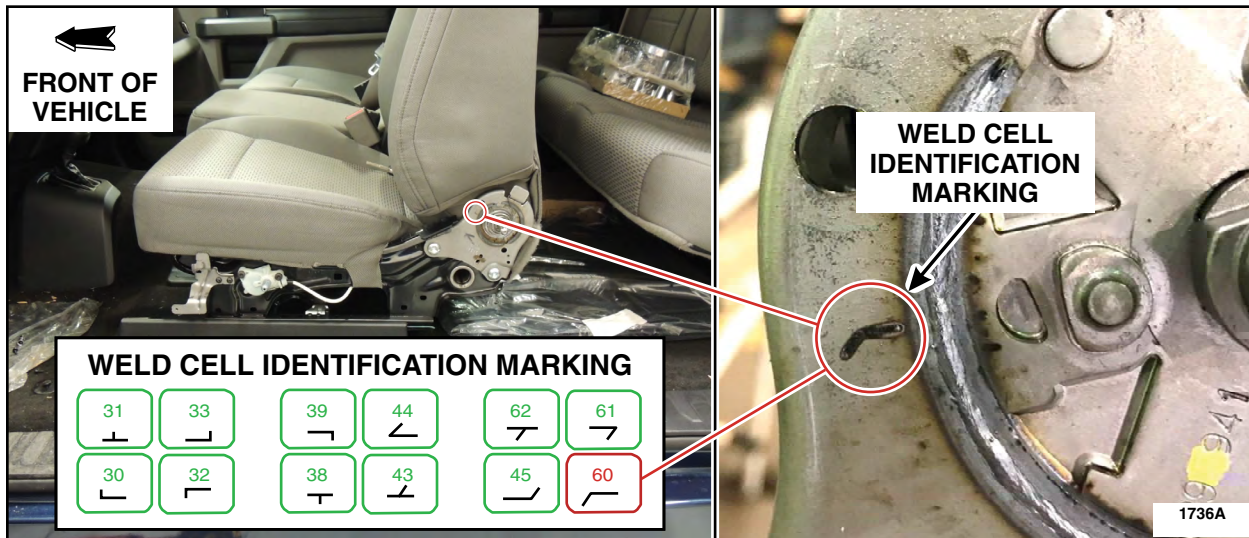
FIGURE 4a

NOTE: This inspection procedure will determine the driver seat backrest frame weld cell identification marking, build date, and shift build to determine if replacement is required. The weld cell identification marking is located on the outboard side of the driver backrest frame. The build date and shift build information is located at the lower rear portion of the backrest frame.

5. Inspect the outboard driver seat backrest frame weld cell identification marking. See Figure 4a and 4b.

- If the weld cell identification marking on the frame **matches** the identification marking shown in Figure 4b for weld cell 60, proceed to Step 6.
- If the weld cell identification marking on the frame **does not match** the identification marking shown in Figure 4b for weld cell 60, the driver seat backrest frame **PASSES** inspection and replacement is not required. Reverse removal steps to install the driver seat side shield.

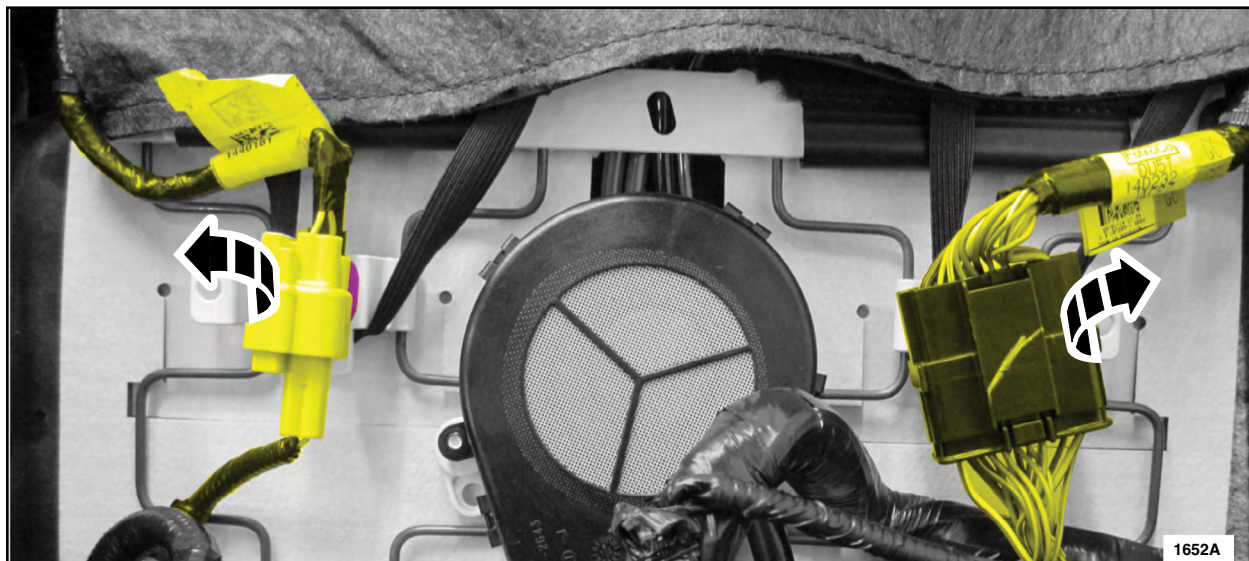
FIGURE 5

6. From behind the driver seat, release both electrical connector retainers from under the seat and position the wire harnesses aside. See Figure 5.

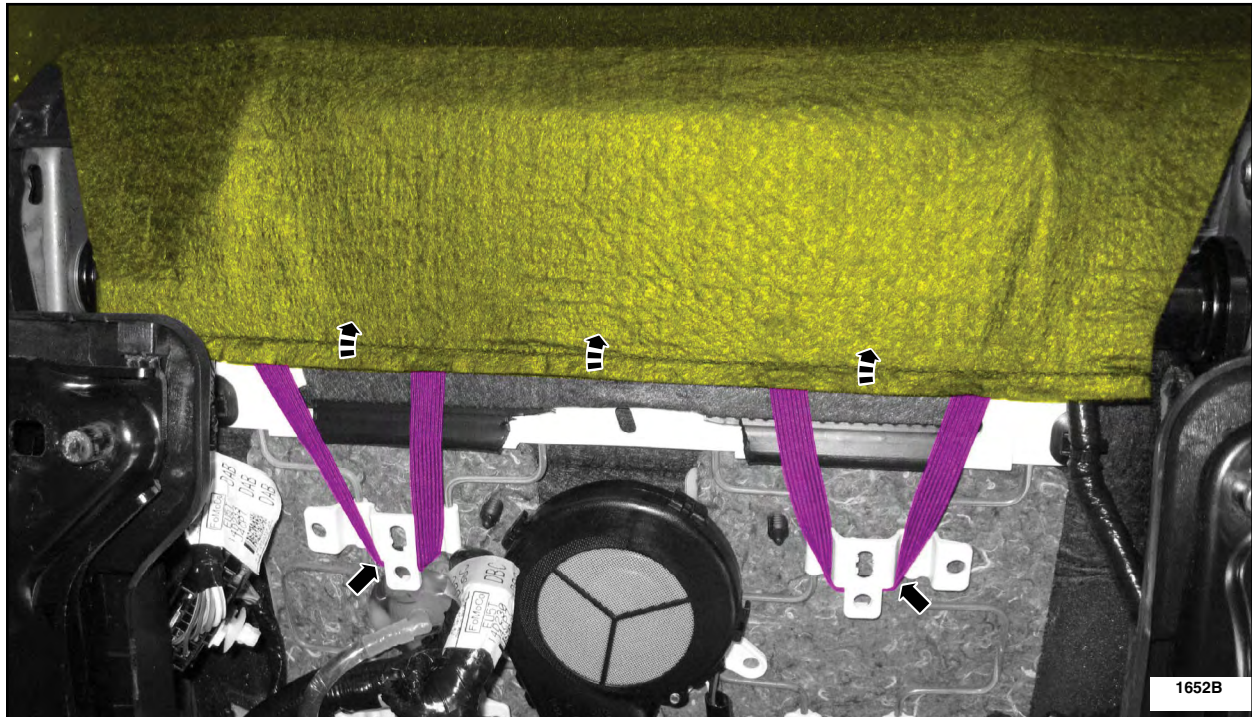
FIGURE 6

7. Detach the two backrest cover straps and position the backrest cover upward. See Figure 6.

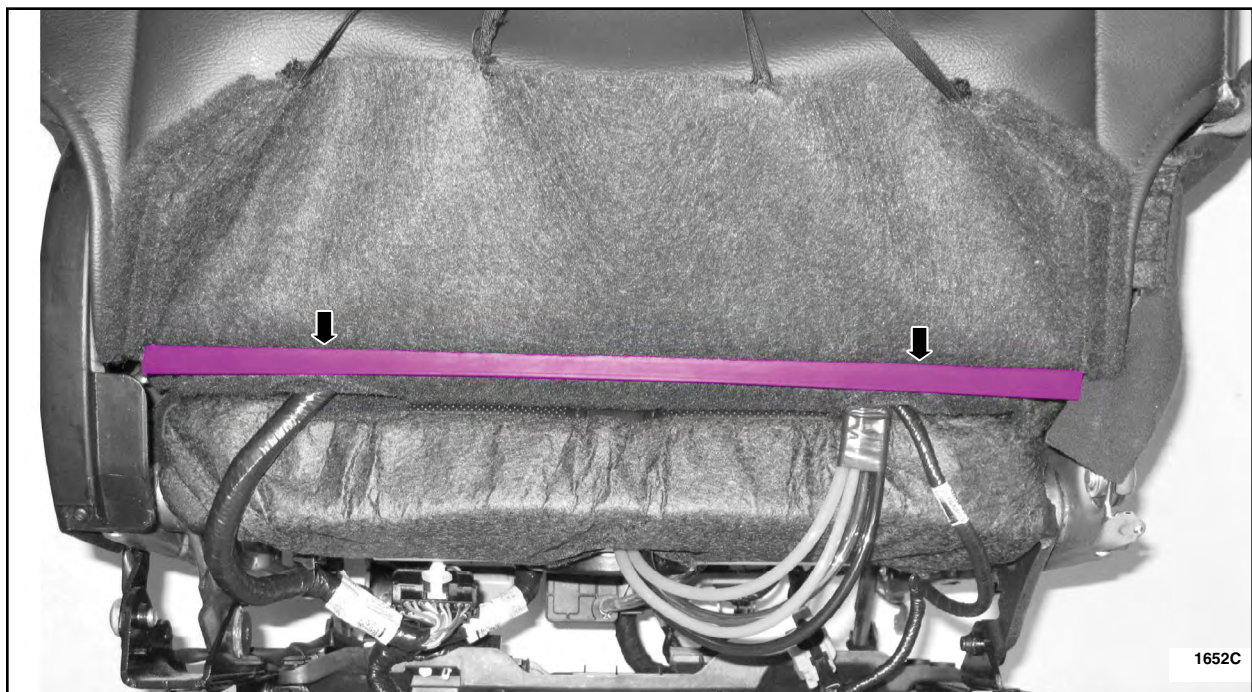
FIGURE 7

8. Detach the backrest cover lower J-clip. See Figure 7.

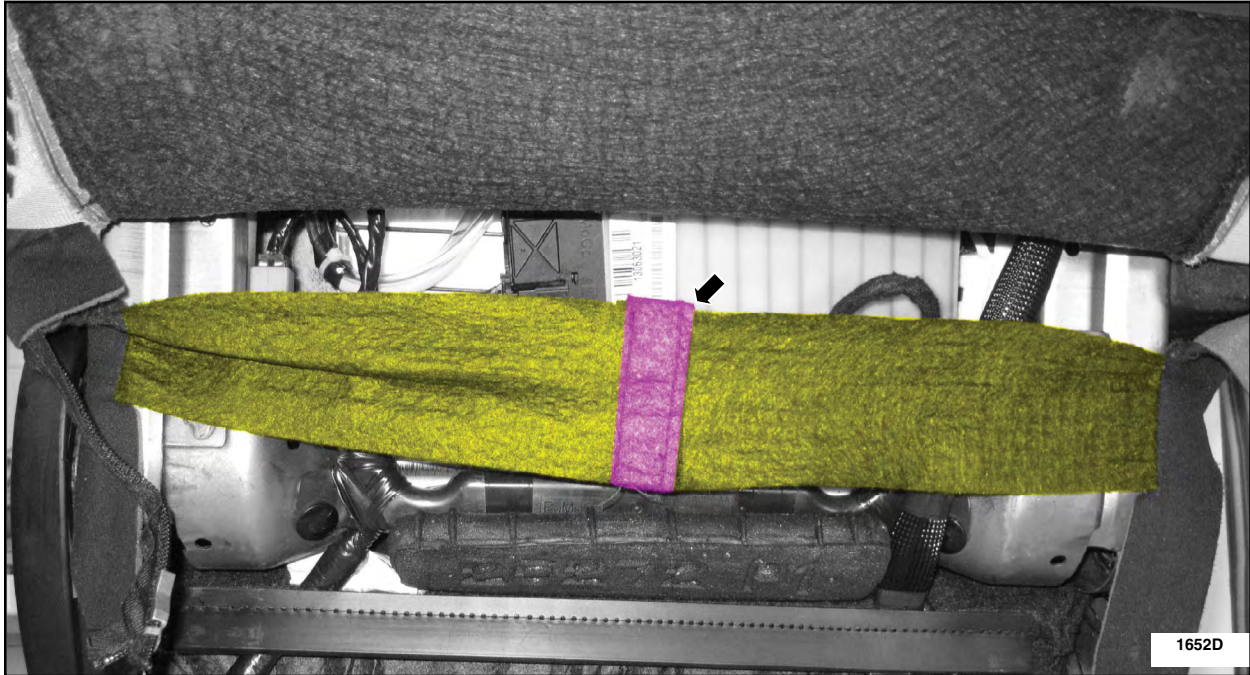
FIGURE 8

9. Detach the hook-and-loop retainer and position the backrest cover strap aside. See Figure 8.

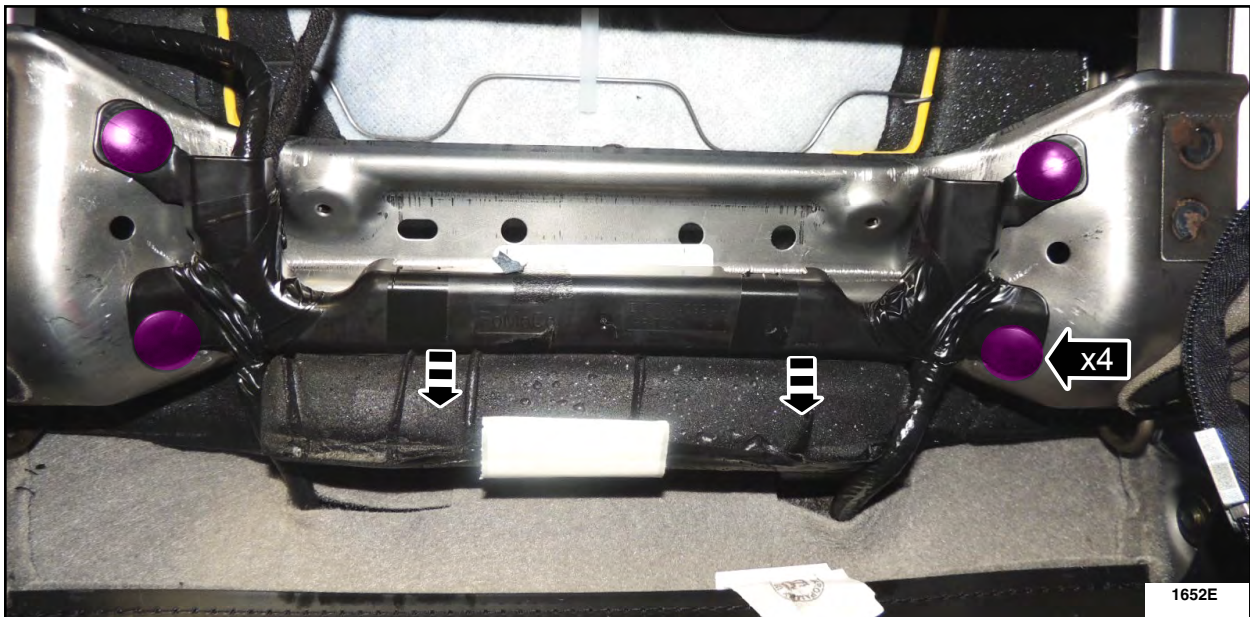
FIGURE 9

10. Remove the four push-pin retainers and position aside the wire harness to access the driver seat backrest frame label or engraved part information. See Figure 9.

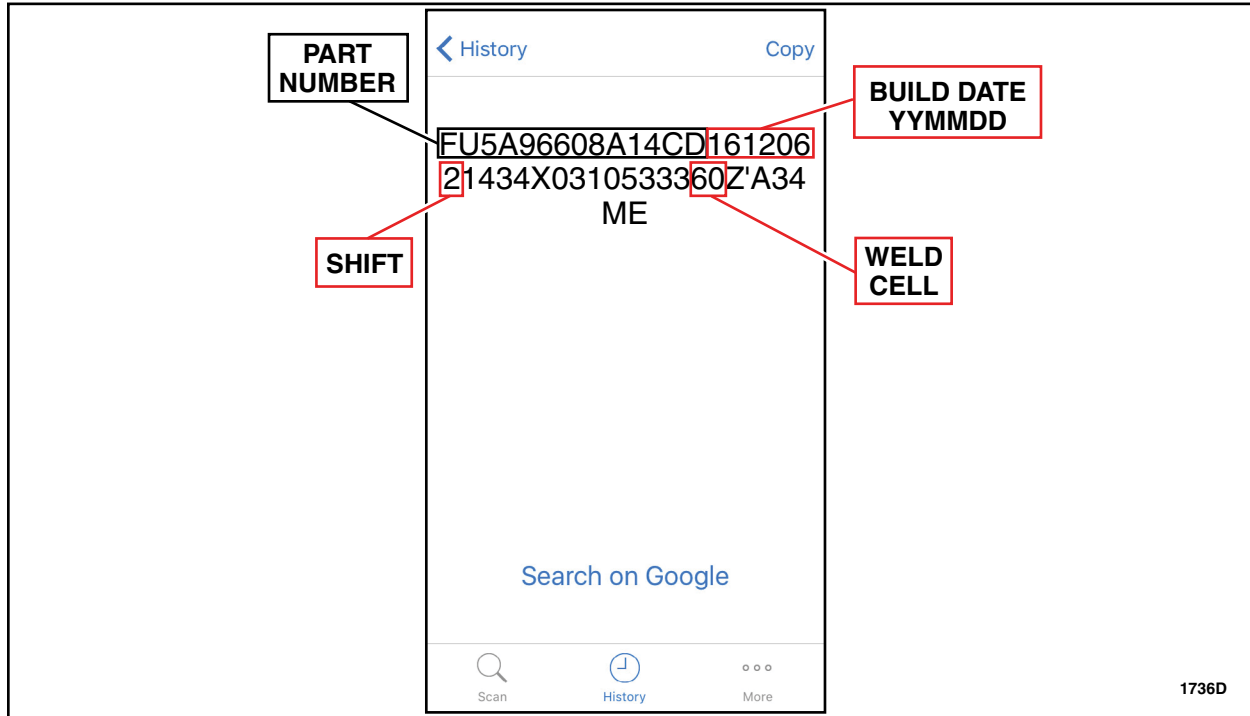
FIGURE 12

- The build date code will be listed in YYMMDD format after the fourteen character engineering part number. See Figure 12.

12. Was the driver seat backrest frame built on December 6, 2016 (161206) **and** built during the second shift?

NOTE: Second shift is indicated by the number 2 next to the build date.

NO - The driver seat backrest frame **PASSES** inspection and no further action is required.
Reverse the removal steps to reassemble the vehicle.

YES - The driver seat backrest frame **DOES NOT PASS** inspection and must be replaced.
Proceed to the Driver Seat Backrest Frame Replacement Procedure on Page 8.

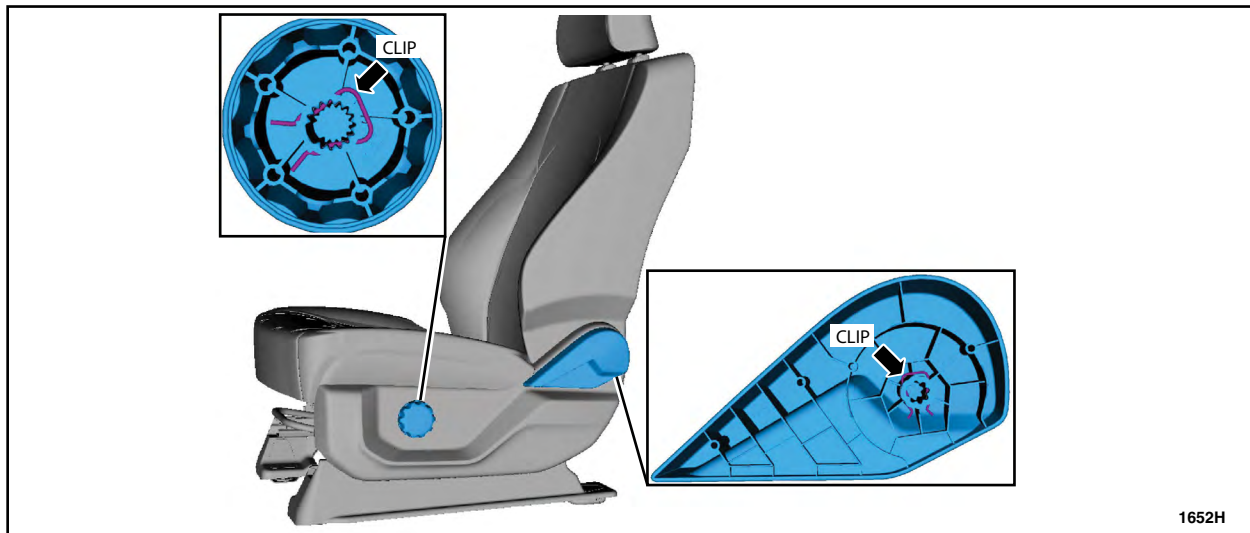
FIGURE 13

1. Remove the driver front seat. Please follow the Workshop Manual (WSM) procedures in Section 501-10A.
2. If equipped with manual lumbar, adjust the lumbar to the fully relaxed position.
3. Remove the recline handle and lumbar knob (if equipped). See Figure 13.

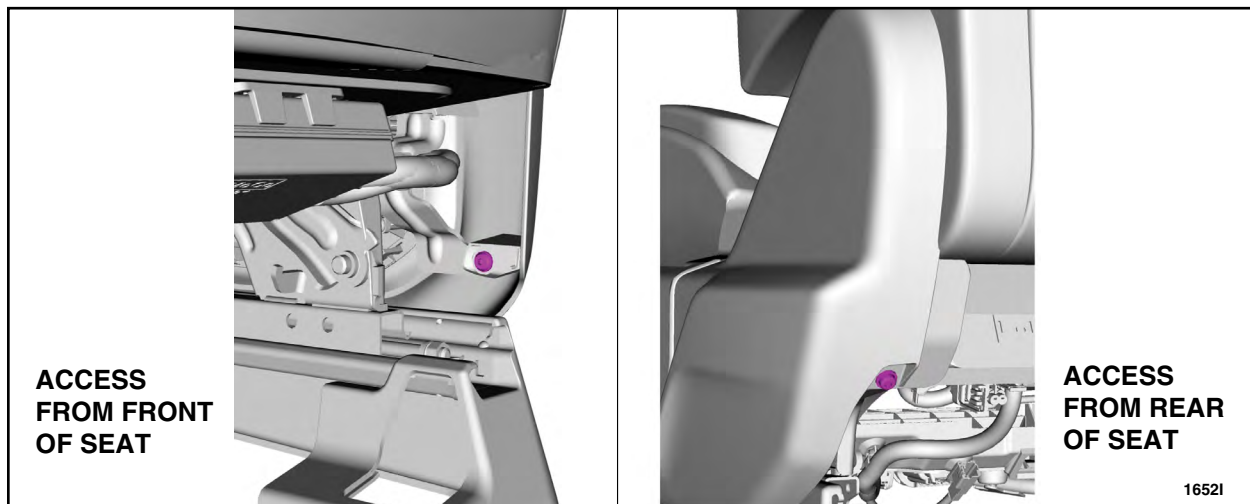
FIGURE 14

4. Remove the two head restraint guide sleeves. Please follow the WSM procedures in Section 501-10A.
5. Remove the two side shield screws. See Figure 14.

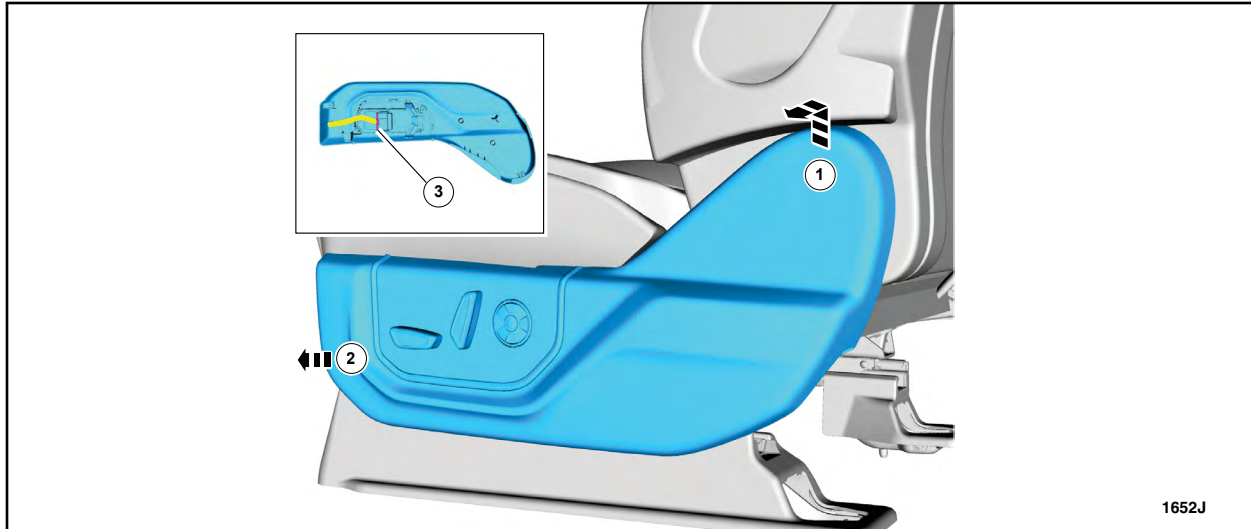
FIGURE 15

6. Remove the side shield. See Figure 15.

1. Lift up on the rear of the side shield and pull outward.
2. Push the side shield forward.
3. Disconnect the electrical connector.

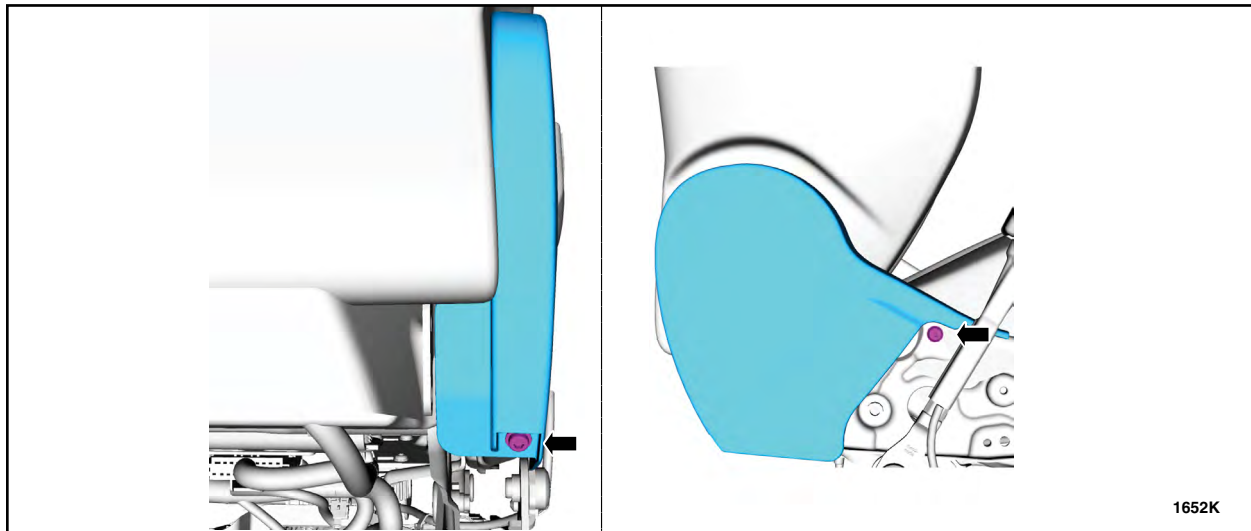
FIGURE 16

7. Remove the two screws and the inboard recline cover. See Figure 16.

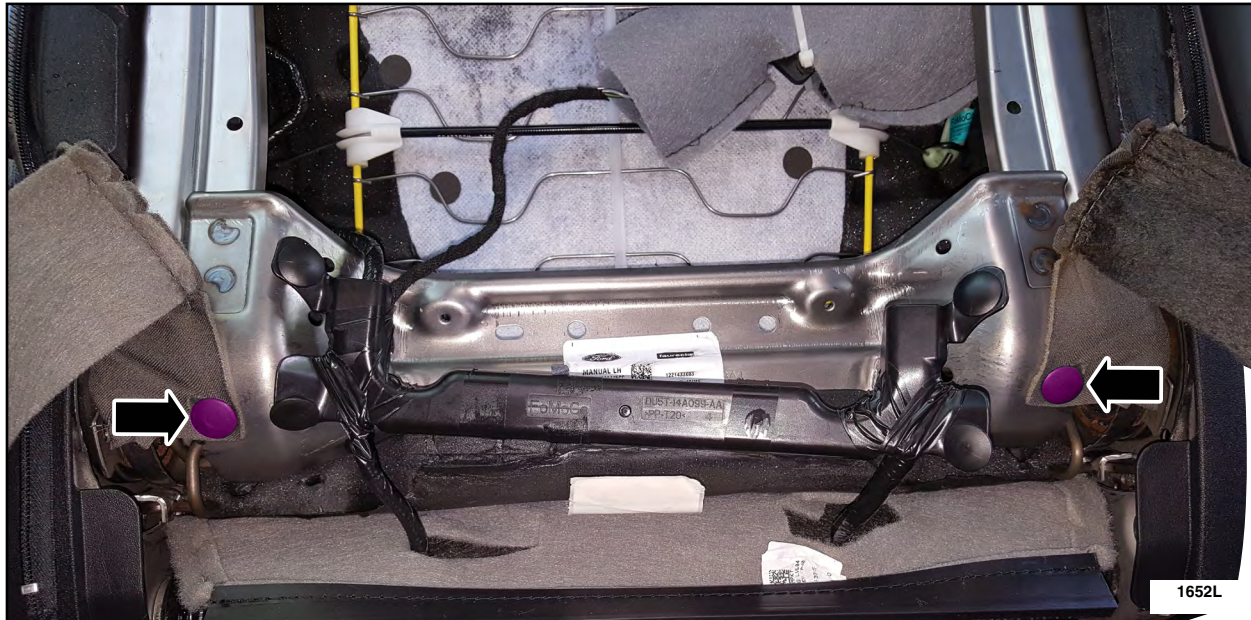
FIGURE 17

8. Remove the two seat cover side push-pins. See Figure 17.

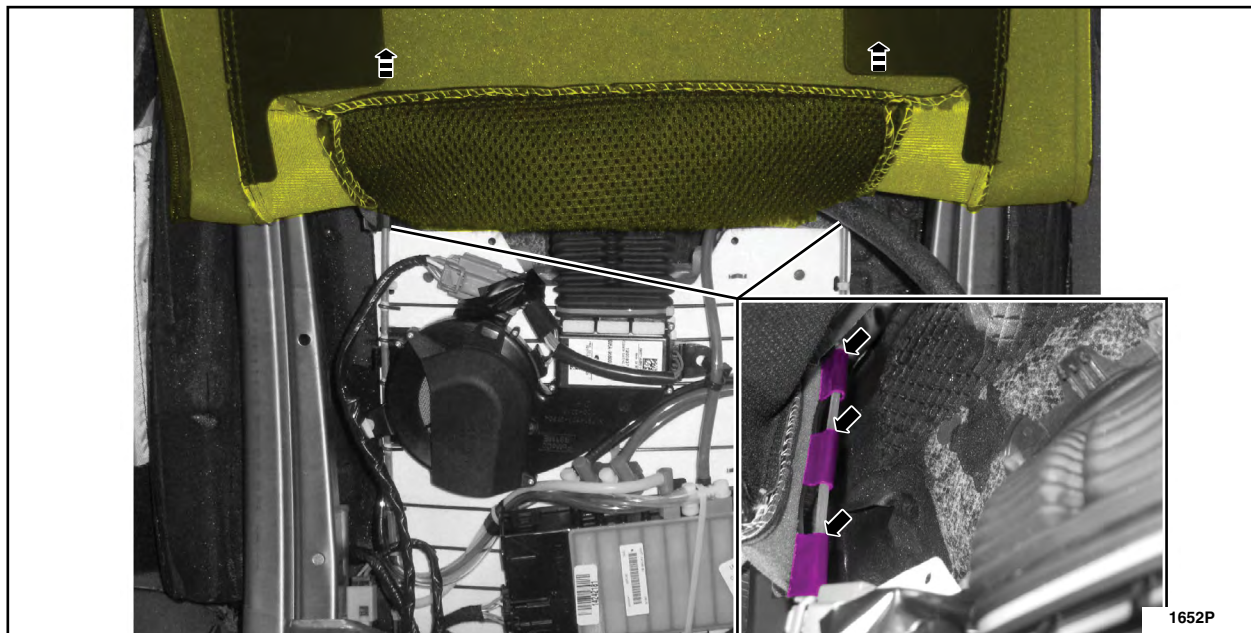
FIGURE 18

10. If equipped, detach the backrest cover J-clips from the lumbar support wire and position the backrest cover up. See Figure 18.

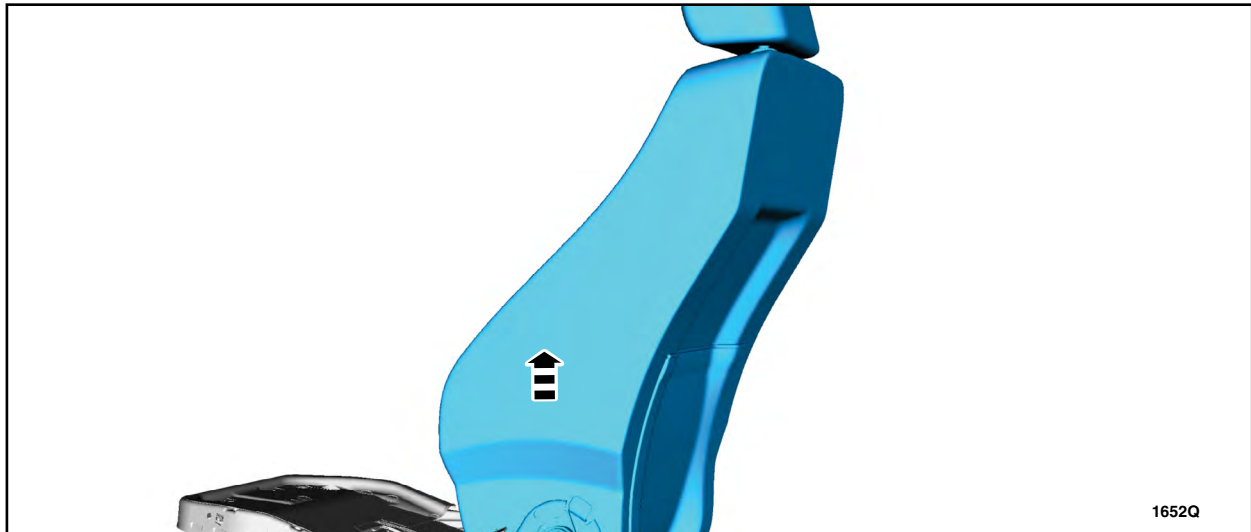
FIGURE 19

11. Remove the seat backrest cushion, cover, and the side airbag as an assembly. See Figure 19.

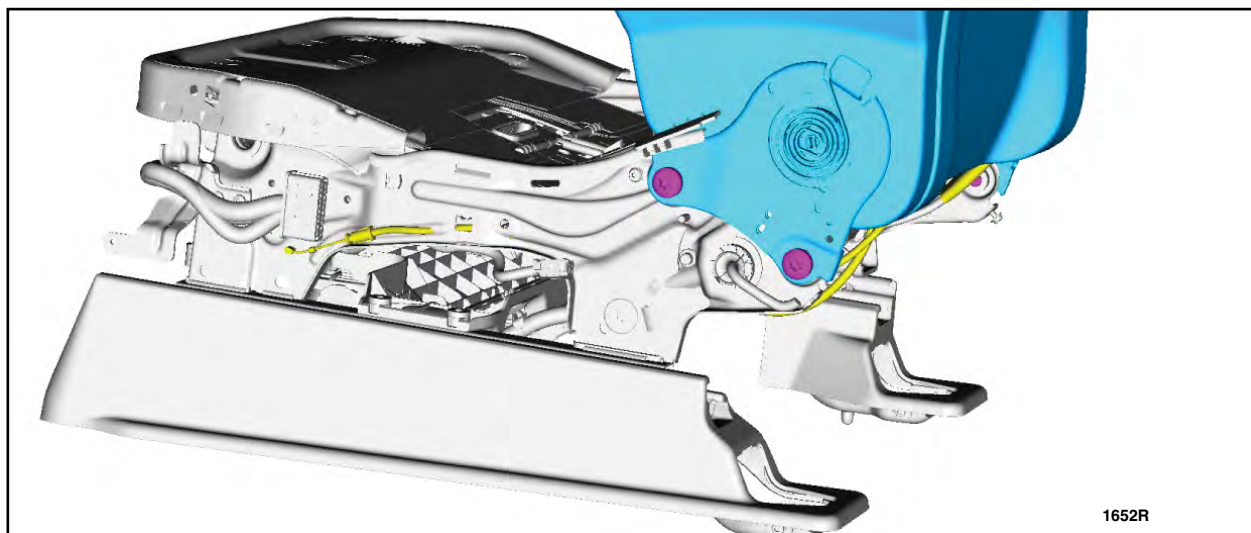
FIGURE 20

12. Remove and discard the four bolts and remove the front seat backrest. Disconnect the lumbar cable if equipped. See Figure 20.

- Torque: 33 lb.ft (45 Nm).

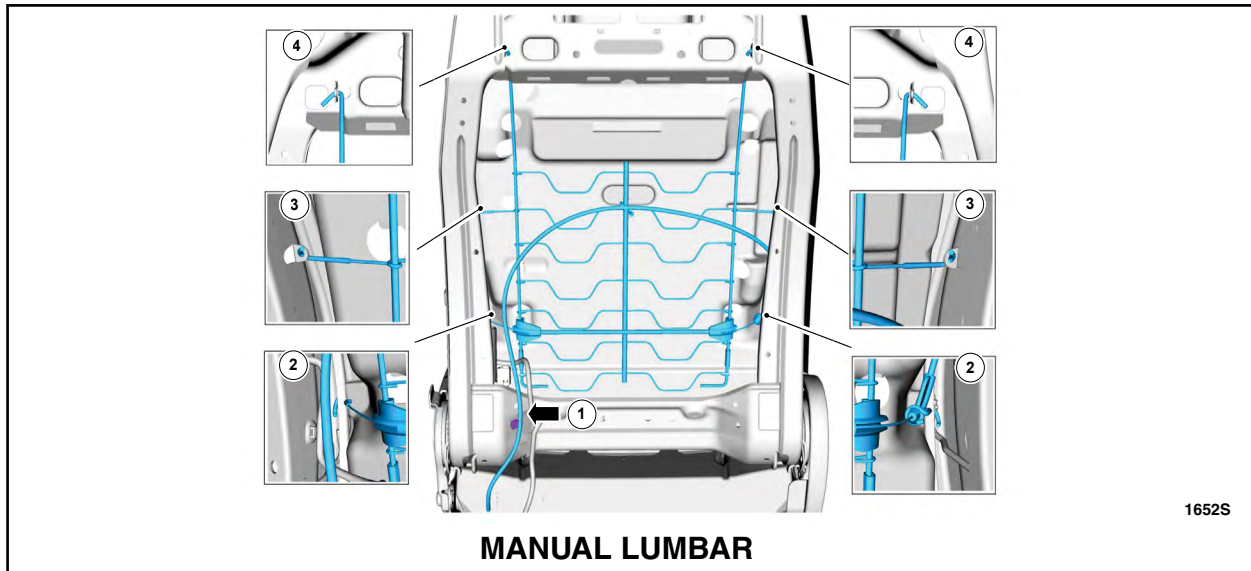
FIGURE 21

13. Remove the lumbar assembly. See Figures 21 and 22.

1. Release the lumbar assembly cable retainer (manual lumbar only).
2. Detach the lumbar assembly cable (manual lumbar only).
3. Detach the lumbar assembly J-hooks.
4. Detach the lumbar assembly upper J-hooks.
5. Disconnect the electrical connector (power lumbar only).

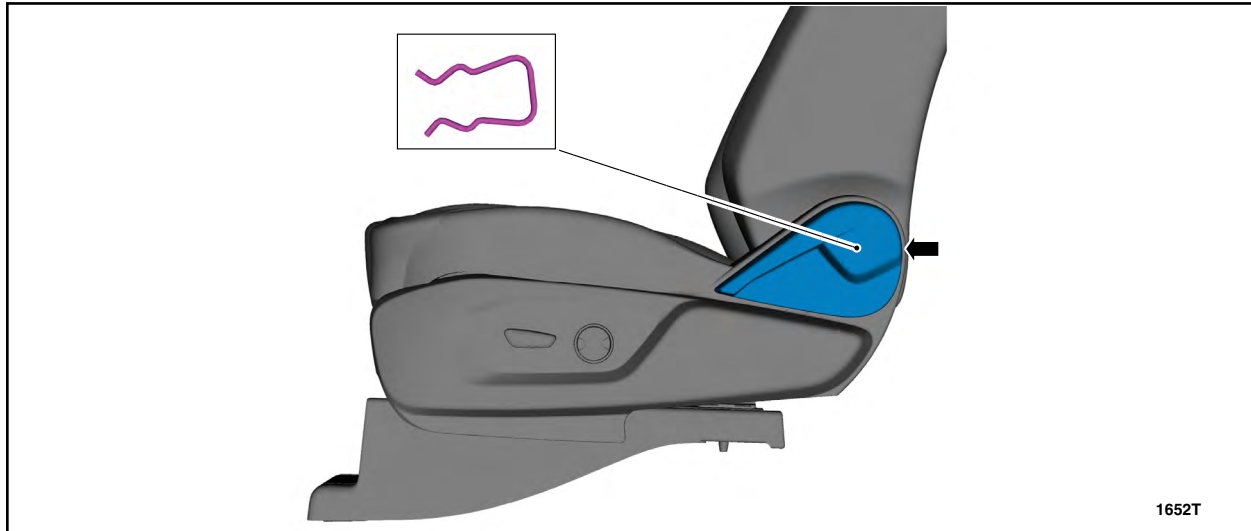
FIGURE 23

1. Remove the driver front seat. Please follow the Workshop Manual (WSM) procedures in Section 501-10A.
2. Remove the two front head restraint guide sleeves. Please follow the WSM procedures in Section 501-10A.
3. If equipped, remove the recline handle. See Figure 23.

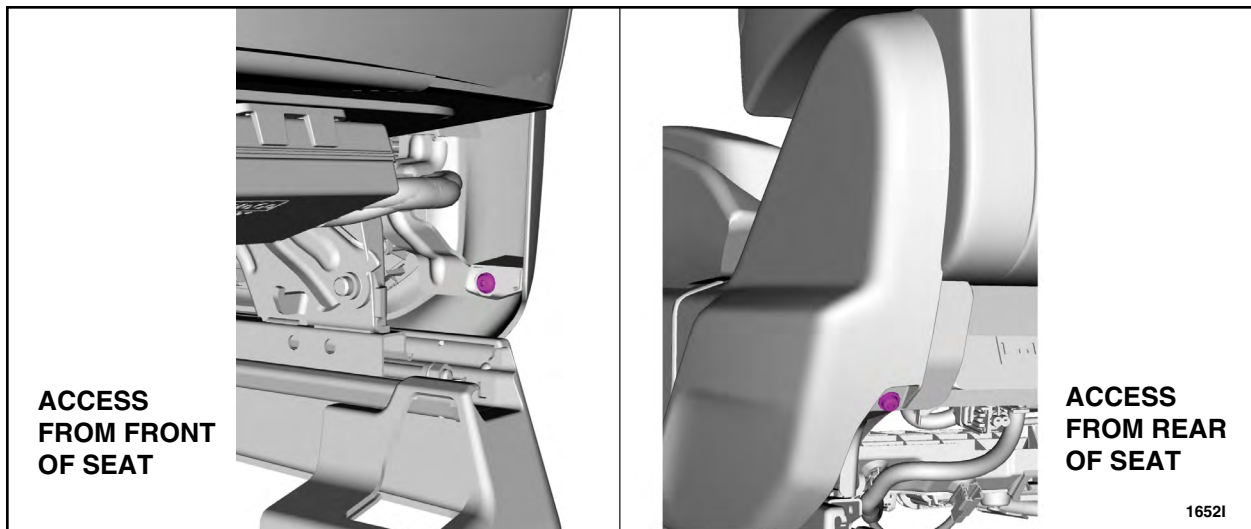
FIGURE 24

4. Remove the two side shield screws. See Figure 24.

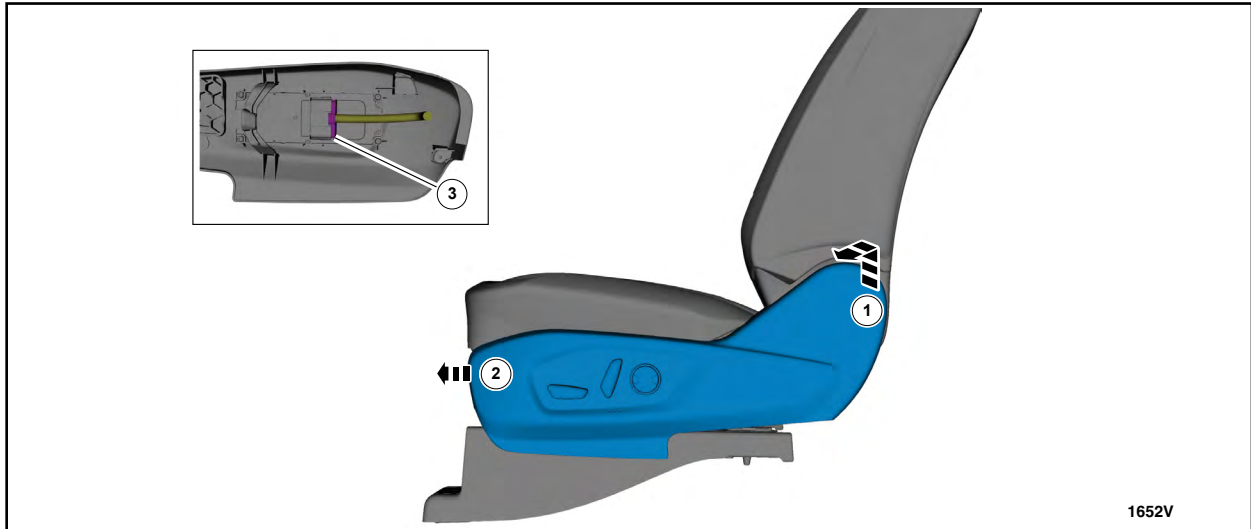
FIGURE 25

5. Remove the side shield. See Figure 25.

1. Lift up on the rear of the side shield and pull outward.
2. Push the side shield forward.
3. Disconnect the electrical connector.

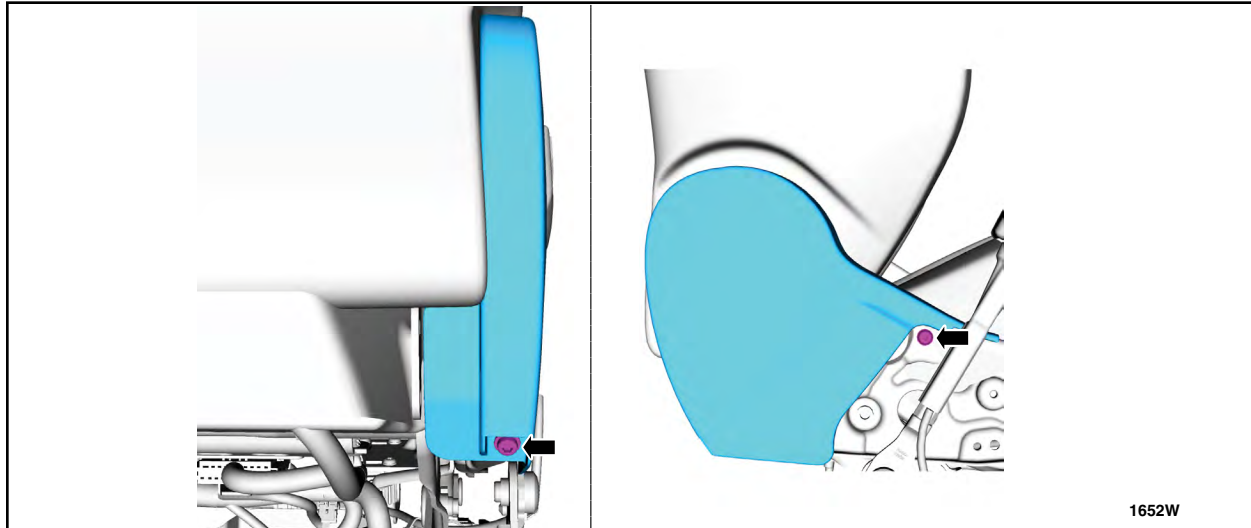
FIGURE 26

6. Remove the two screws and the inboard recline cover. See Figure 26.

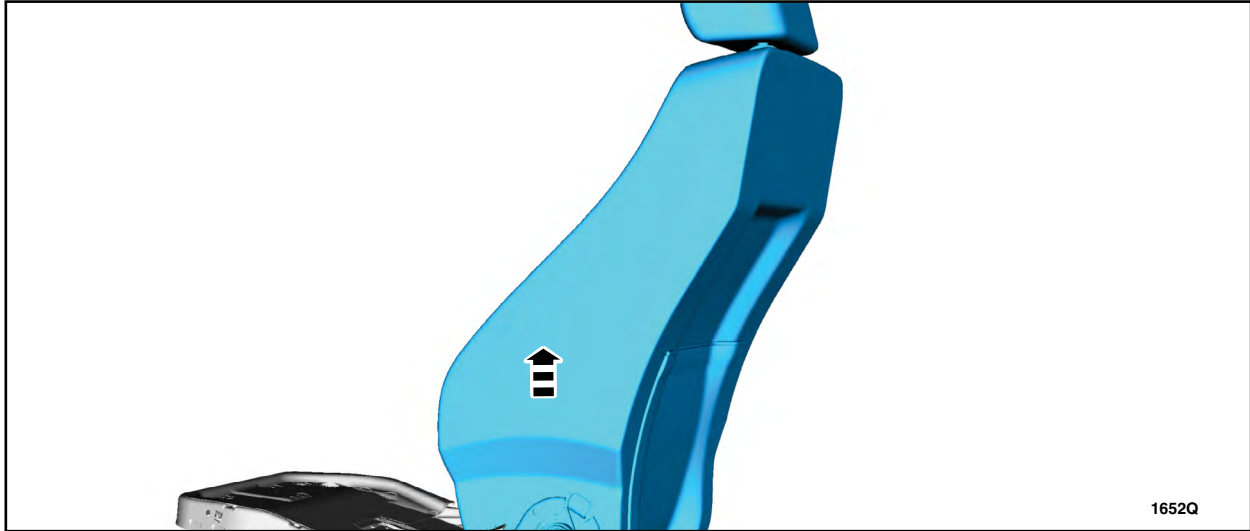
FIGURE 27

7. Remove the side airbag. Please follow the WSM procedures in Section 501-20B.
8. Remove the seat backrest cushion, cover, and the side airbag as an assembly. See Figure 27.

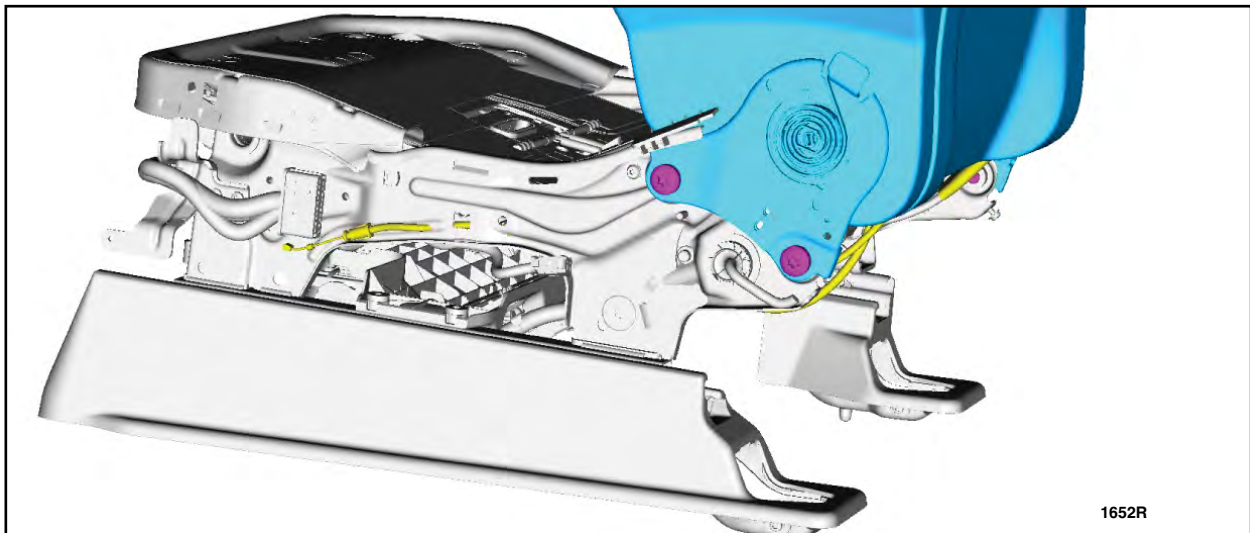
FIGURE 28

9. Remove and discard the four bolts and remove the front seat backrest. See Figure 28.
 - Torque: 33 lb.ft (45 Nm).

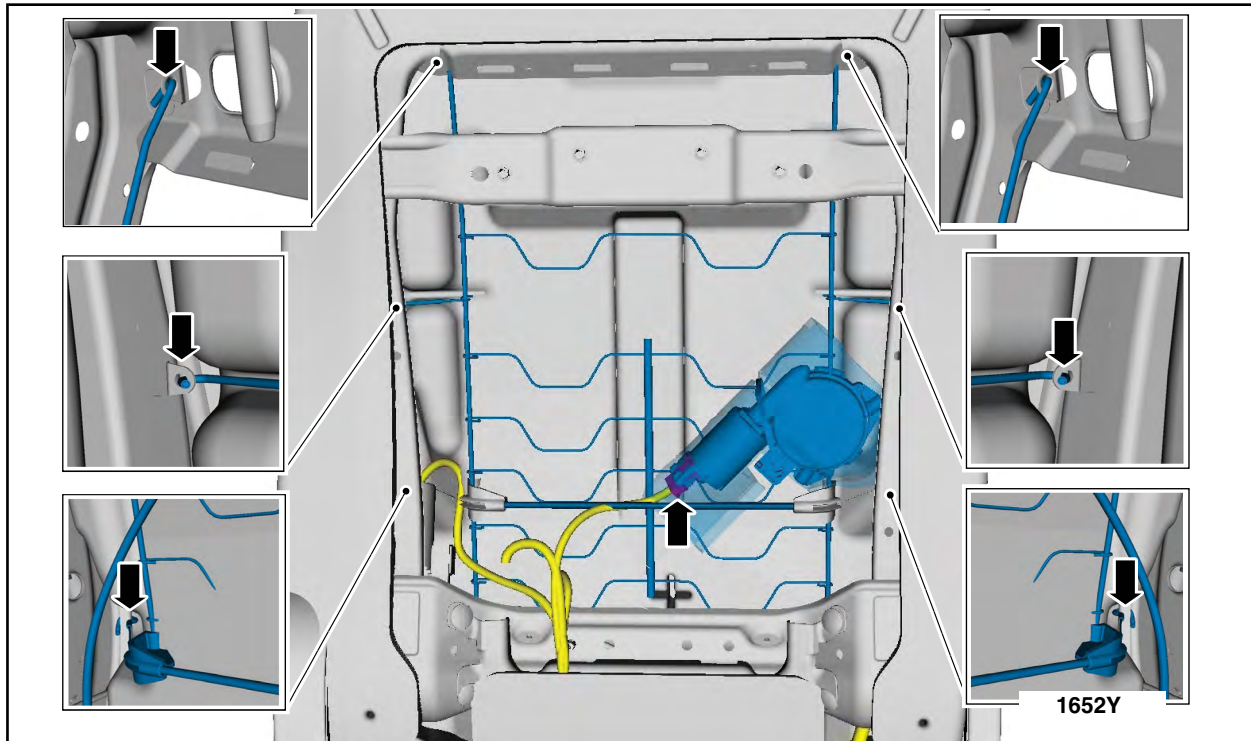
FIGURE 29

10. Disconnect the electrical connector, release the J-hooks, and remove the power lumbar assembly.
See Figure 29.
