| RE: Recall Campaign 2017070004 MY 2016 Model 906 Tire Pressure Label | DATE: August 4, 2017 |

RECALL CAMPAIGN LAUNCH NOTIFICATION

SUBJECT: **Models 906 Model Year 2016**
Check/replace tire pressure table information label

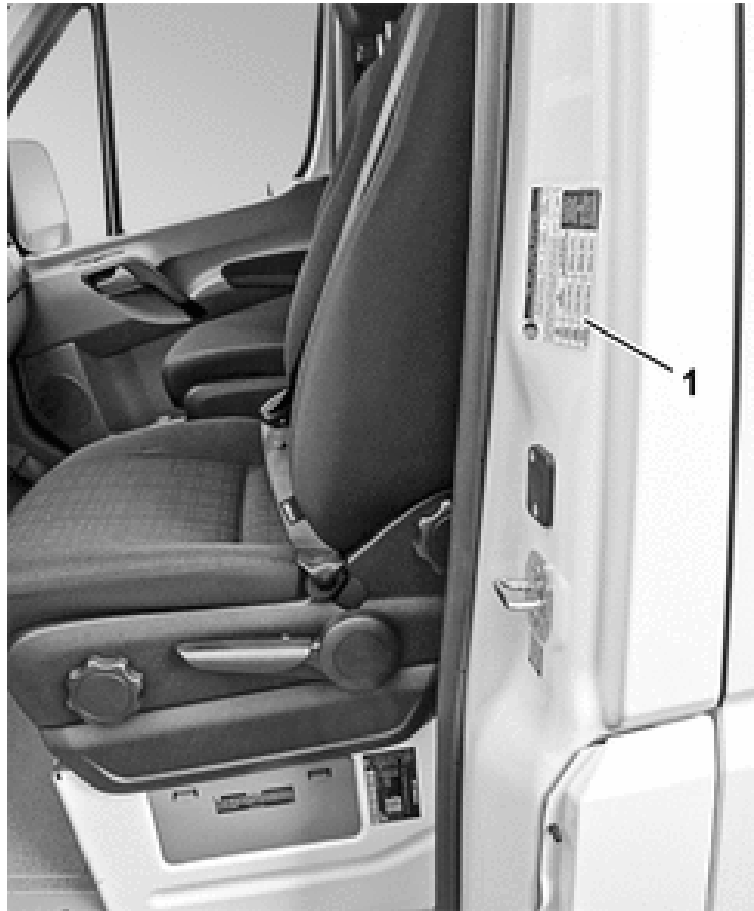
Figure 1

Check if the correct tire pressure value for the wheels on the front axle are listed on the vehicle's information label (1)

To do so, check tire pressure value of information label (Figure 1)(1) against (Figure 2) pictures A and B.

Specified value for front axle
61 psi
If the correct tire pressure value is listed then procedure is complete.
If the correct tire pressure value is not listed continue to step 2.

2. Replace information label (1)

The bonding surface must be free of grease. Also check tire pressure value on new information label (1). If the correct tire pressure value is not listed. Order information label again.

The replacement tire labels are VIN specific. Ensure that the proper information is indicated on the new label before installing. If the correct information is not listed for that VIN. Order information label again.
