August 2017
FL740A
NHTSA #17V-402
Transport Canada #2017-319
REVISED NOTICE

Subject: Brake Check Valve

Models Affected: Specific Freightliner 108SD, 114SD, and Business Class M2 vehicles manufactured December 16, 2014, through April 27, 2017.

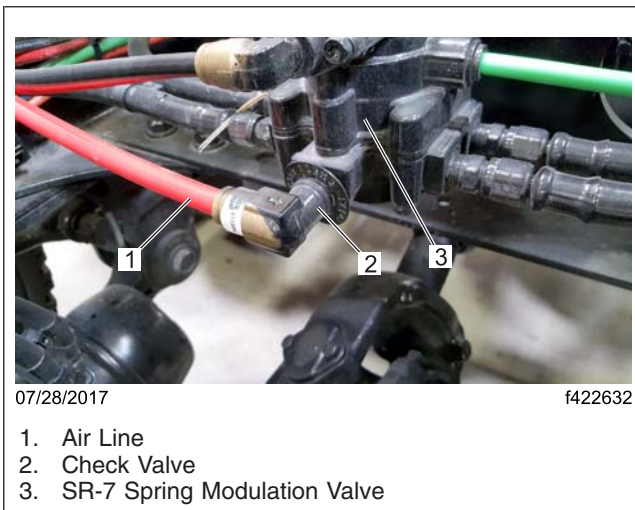
Fig. 1, SR-7 Spring Modulation Valve

3. Locate the SR-7 spring modulation valve, shown in **Fig. 1**, and inspect the secondary air port for a check valve fitting. The check valve is integral to the fitting and will have the plastic tag that says 'check valve' on it. See **Fig. 2** for an example of the check valve.

1. Drain the air from the system.
2. Disconnect the air line. See **Fig. 1**.
3. Remove the fitting.
4. Install the new check valve fitting. See **Fig. 2**.
5. Connect the air line.
6. Start the truck to build air pressure in the system.
7. Using a solution of soap and water, test the air line for leaks. If bubbles appear, repair the leak as needed.
8. Clean a spot on the base label (Form WAR259). Write the recall number, FL740, on a completion sticker (Form WAR260), and attach it to the base label.
