**SUBJECT: NEW VEHICLE DEMONSTRATION / DELIVERY HOLD - Safety Recall 17S15
 – Supplement #7**

Certain 2015-2017 Transit Vehicles Equipped with a Driveshaft Flexible Coupling
 Driveshaft Flexible Coupling Repair

CERTAIN 2015-2017 TRANSIT VEHICLES EQUIPPED WITH A DRIVESHAFT FLEXIBLE COUPLING — DRIVESHAFT FLEXIBLE COUPLING REPAIR

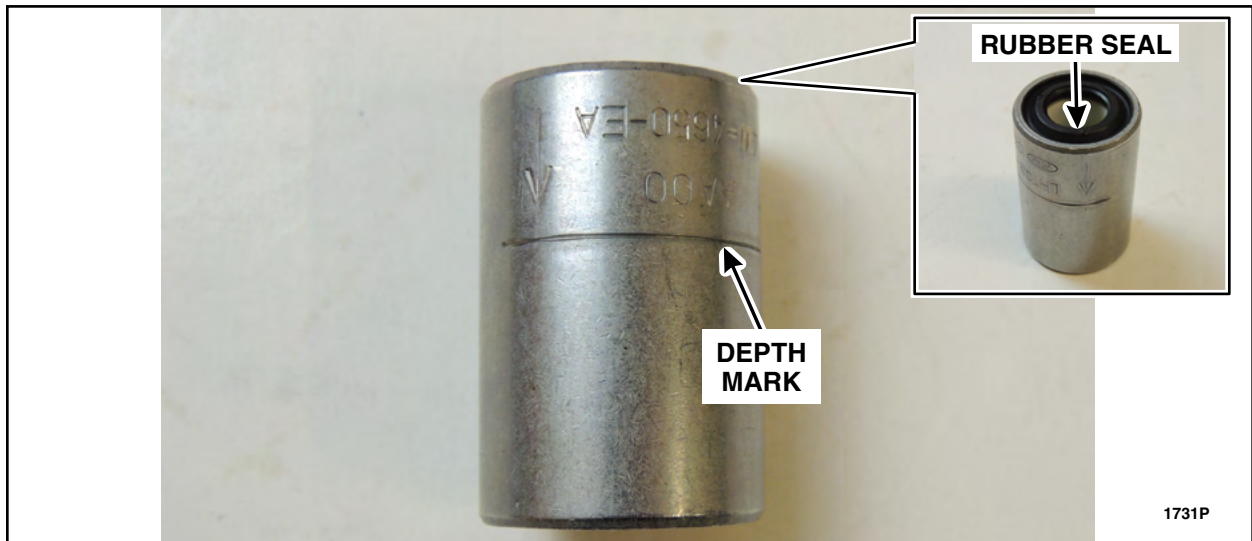
FIGURE 4

- NOTE:** Prior to installation of the *new* driveshaft pilot bushing, make sure the rubber seal end of the bushing is facing outward and the capped end is pressed into the driveshaft. See Figure 4.

Using a 3-jaw puller and a suitable flat piece of metal, press in the *new* pilot bushing until the depth mark on the pilot bushing has been reached. See Figures 4 and 5.

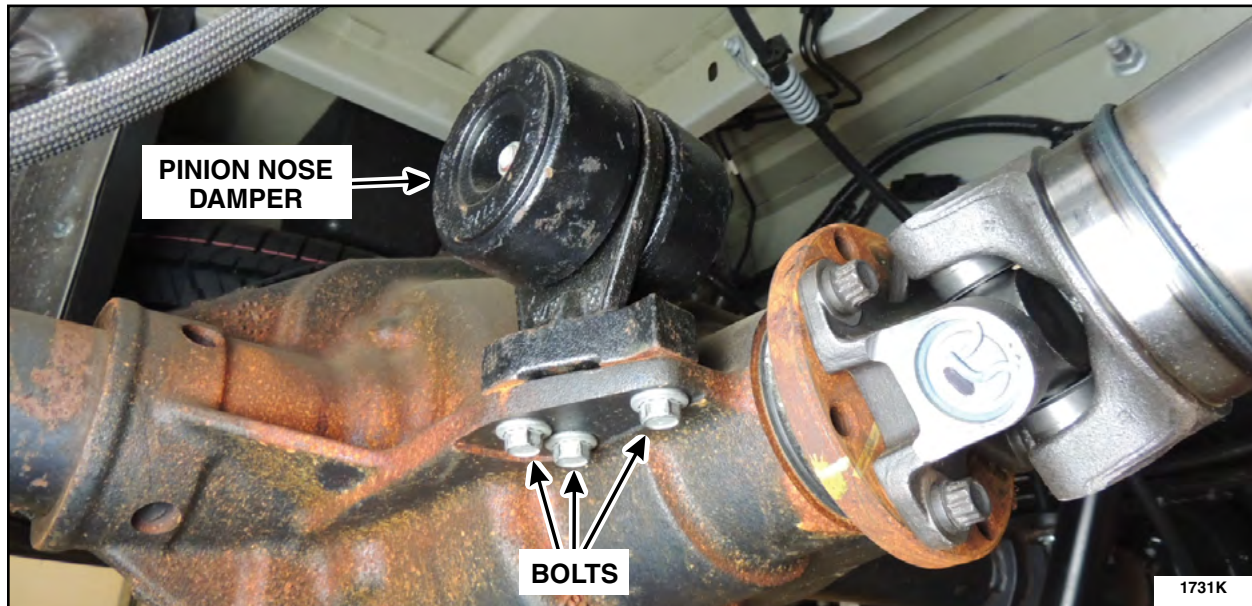
FIGURE 19

1. If a pinion nose damper is present, remove and discard the three bolts and the original pinion nose damper located on the RH side of the rear axle center housing. See Figure 19.
2. Install a *new* pinion nose damper and tighten the three bolts. See Figure 19.
 - Tighten bolts to 46 lb.ft (62 Nm).

NOTE: Original pinion nose damper is shown. *New* pinion nose damper may appear similar to the original (if equipped), but the dampening characteristics have been changed.
