# **Safety Recall R49 / NHTSA **17V-478****

## **Passenger Airbag Module**

**2007 - 2009 (VB) Dodge Sprinter**

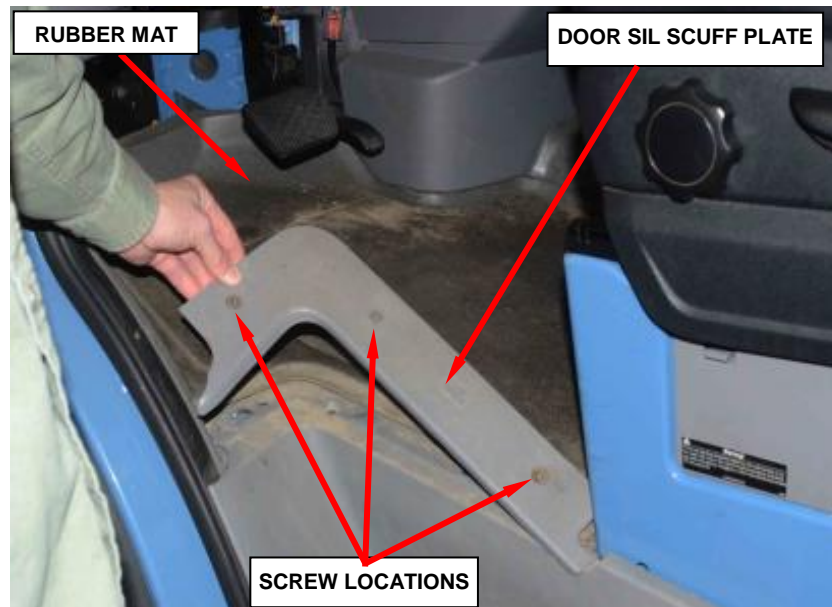
**Figure 1 – Door Sill Scuff Plate**

- a. Remove and save the three screws from the door sill scuff plate and remove the door sill scuff plate (Figure 1).
- b. Remove the rubber mat (Figure 1).

9. Remove the wiTECH micro pod II.
10. Install the battery cover and the four screws then tighten securely (Figure 2).
11. Install the rubber mat (Figure 1).

12. Install the door sill scuff plate and the three screws then tighten securely (Figure 1).
13. Return the original inflator as described on page 3 in the Parts Return section.

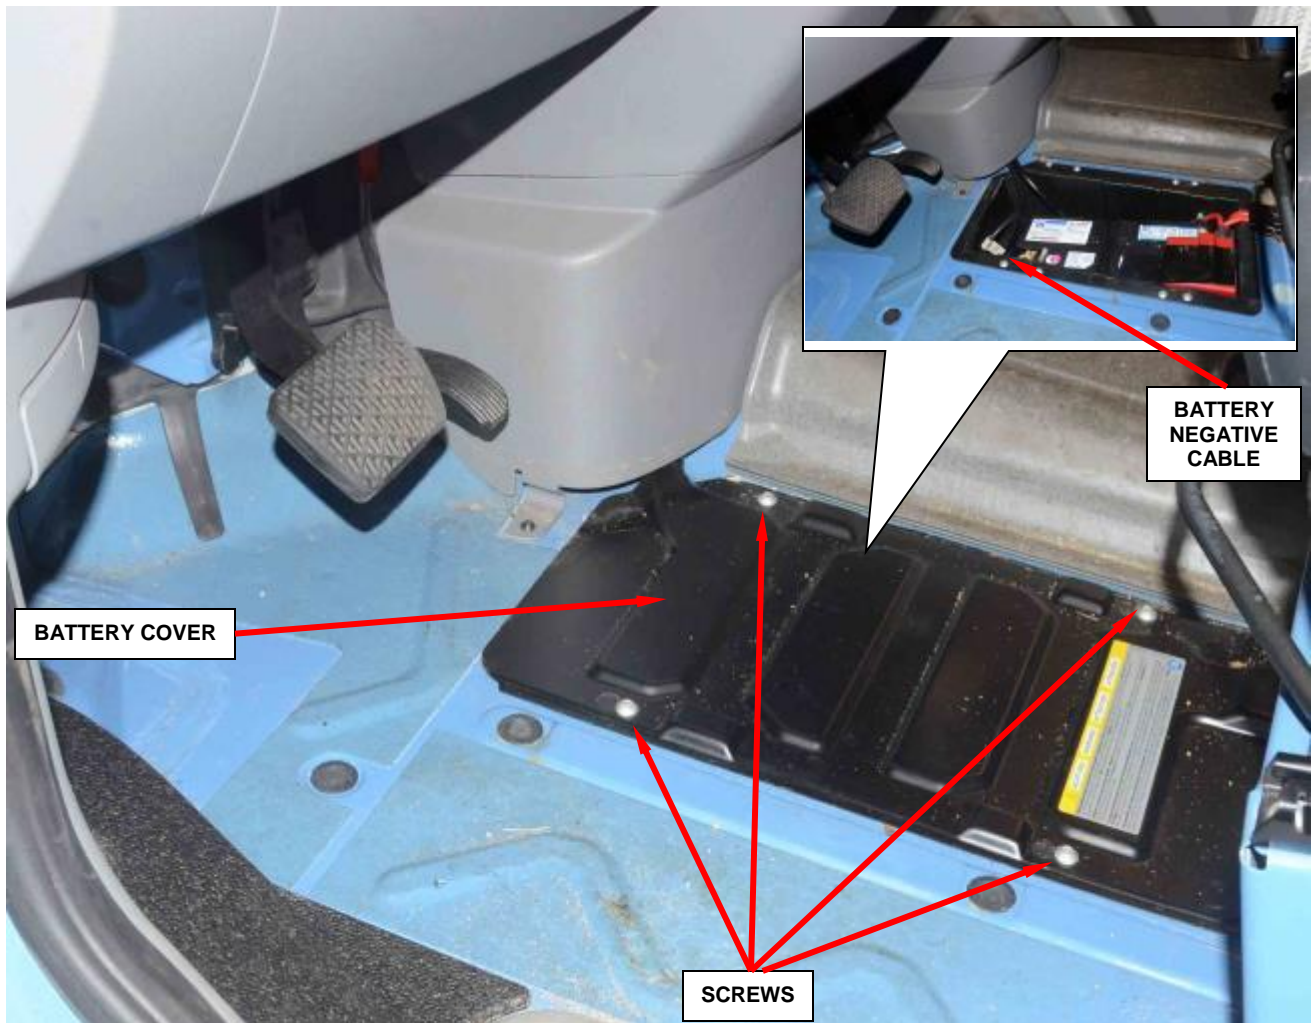
Figure 2 – Battery Location

- c. Remove and save the four screws from the battery cover and remove the battery cover (Figure 2).

- d. Disconnect and isolate the battery negative cable(s). Wait two minutes for the system capacitor to discharge before further service (Figure 2).

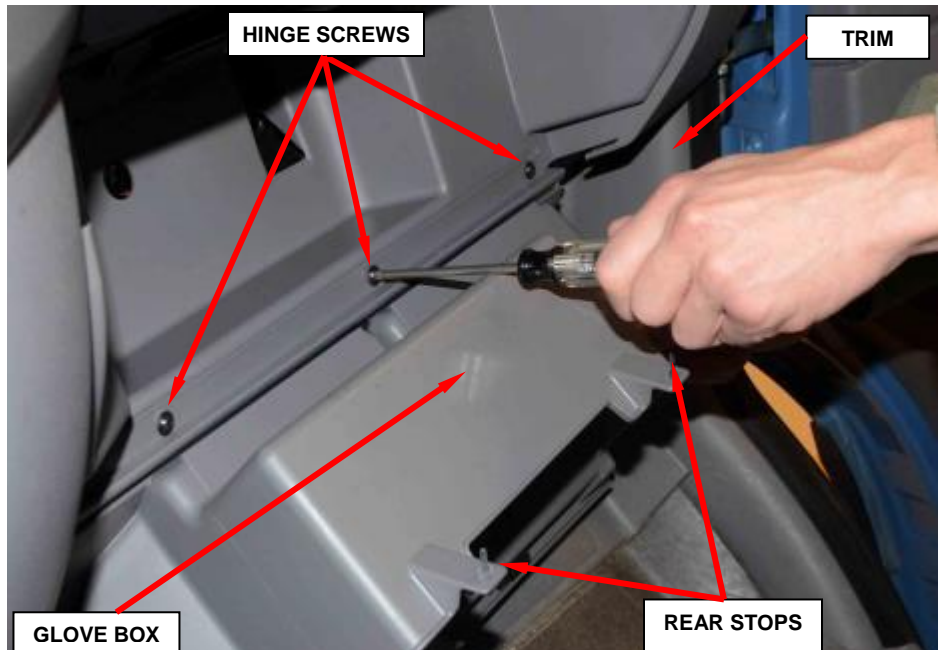
**Figure 3 – Glove Box Hinge Screws**

2. Open the glove box, push up on the two rear stops and fold the box down completely (Figure 3).

3. Remove and save the hinge screws and remove the glove box (Figure 3).

4. Remove and save the screw securing the trim below the right outboard air outlet bezel and remove the trim (Figure 3).

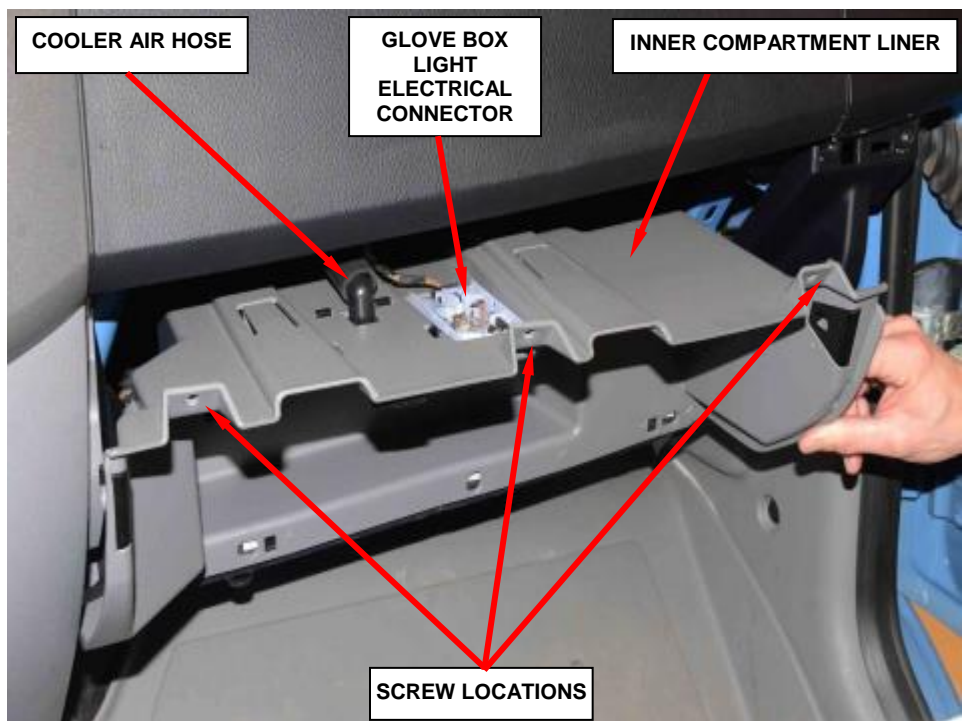
**Figure 4 – Inner Compartment Liner**

5. Remove and save the three inner compartment liner screws and remove the inner compartment liner (Figure 4).

6. Disconnect the glove box light electrical connector and remove the cooler air hose (Figure 4).

37. Install the right front speaker grill (Figure 5).
38. Install the cooler air hose to the inner glove box liner and connect the glove box light electrical connector (Figure 4).
39. Install the inner glove box liner and install the three screws. Tighten the screws securely (Figure 4).
40. Install the glove box and install the three hinge screws then tighten securely (Figure 3).
41. Position the glove box up into the instrument panel and engage the rear retaining stop tabs (Figure 3).
42. Install the trim panel below the air outlet.
43. **Do not connect the battery negative cable at this time.** The supplemental restraint system verification test procedure should be performed following service of any supplemental restraint system component. Continue with **Section B. Supplemental Restraint System (SRS) Verification Test.**

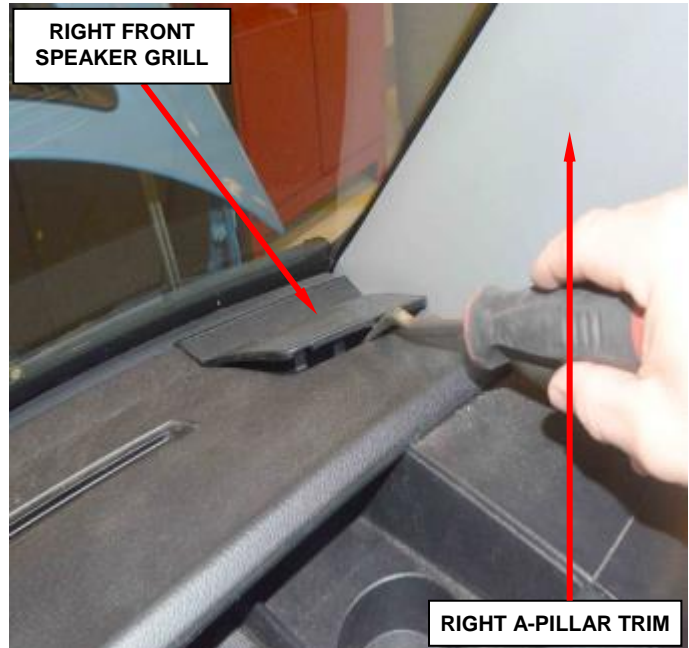
**Figure 5 – Right Front Speaker Grill**

- 7. Remove the right front speaker grill (Figure 5).

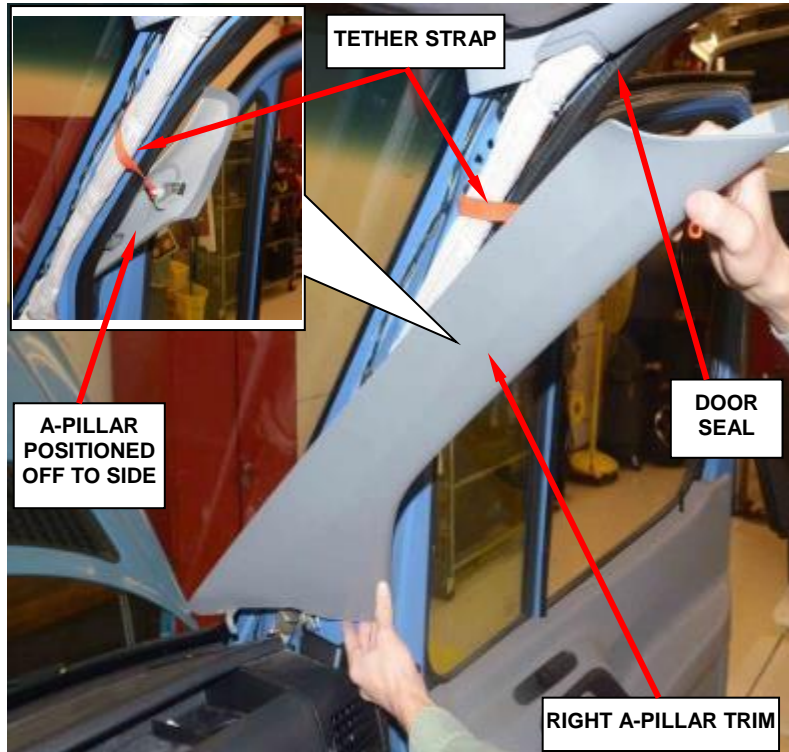
**Figure 6 – Right A-Pillar Trim**

- 8. Partially remove the right front door seal near the A-Pillar (Figure 6).

- 9. Remove the right A-Pillar trim and position off to the side (Figure 6).

**NOTE: The A-Pillar tether strap does not need to be disconnected.**

34. Position the right air outlet bezel to the instrument panel and install the three screws. Tighten the screws securely (Figure 7).
35. Install the A-Pillar trim panel (Figure 6).

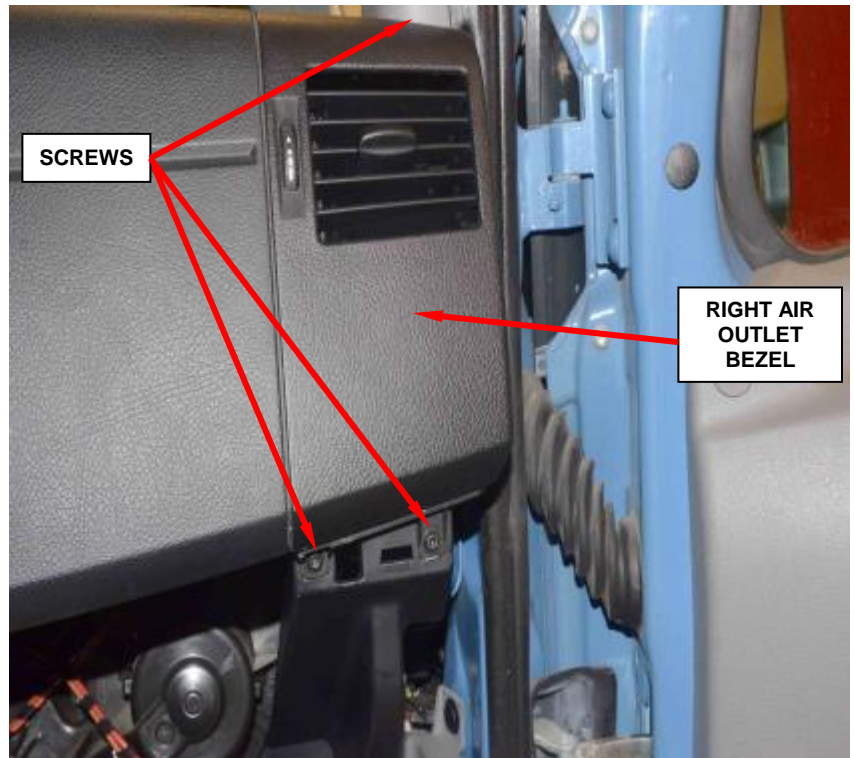
Figure 7 – Right Air Outlet Bezel

10. Remove and save the three right side air outlet bezel screws and remove the right air outlet bezel (Figure 7).

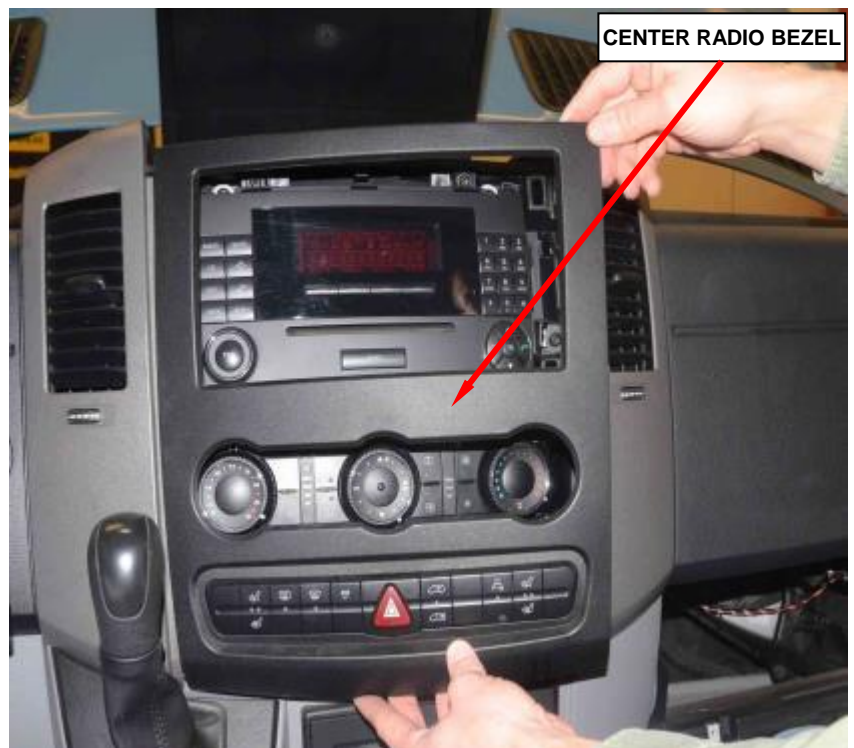
Figure 8 – Center Radio Bezel

11. Remove the center radio bezel and position to the side (Figure 8).

32. Position the center air outlet bezel to the instrument panel and install the two screws. Tighten the screws securely (Figure 9).
33. Install the center radio bezel (Figure 8).

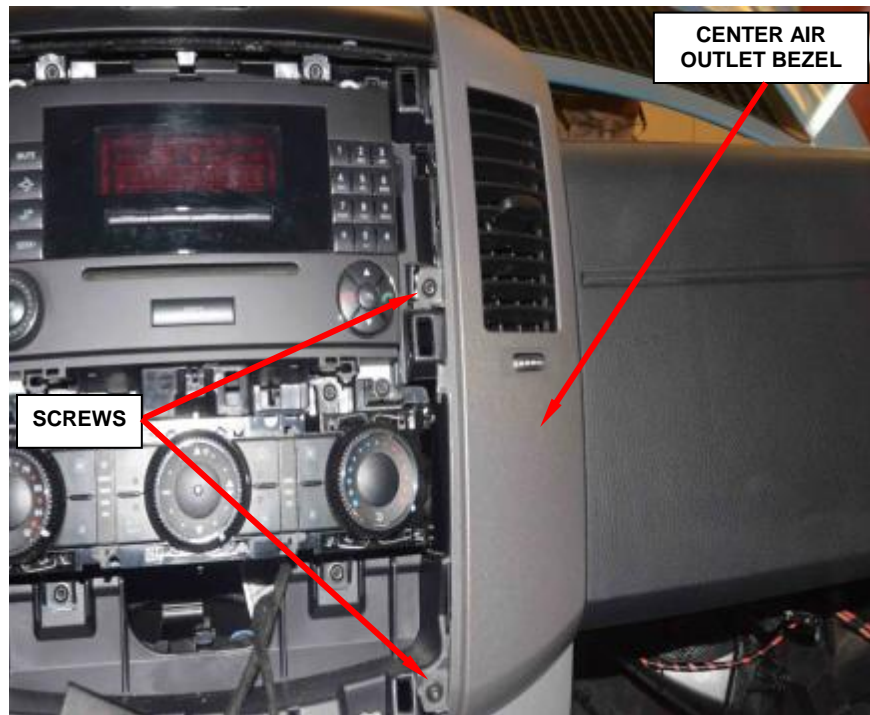
**Figure 9 – Center Air Outlet Bezel**

12. Remove and save the two center air outlet bezel screws and remove the bezel (Figure 9).

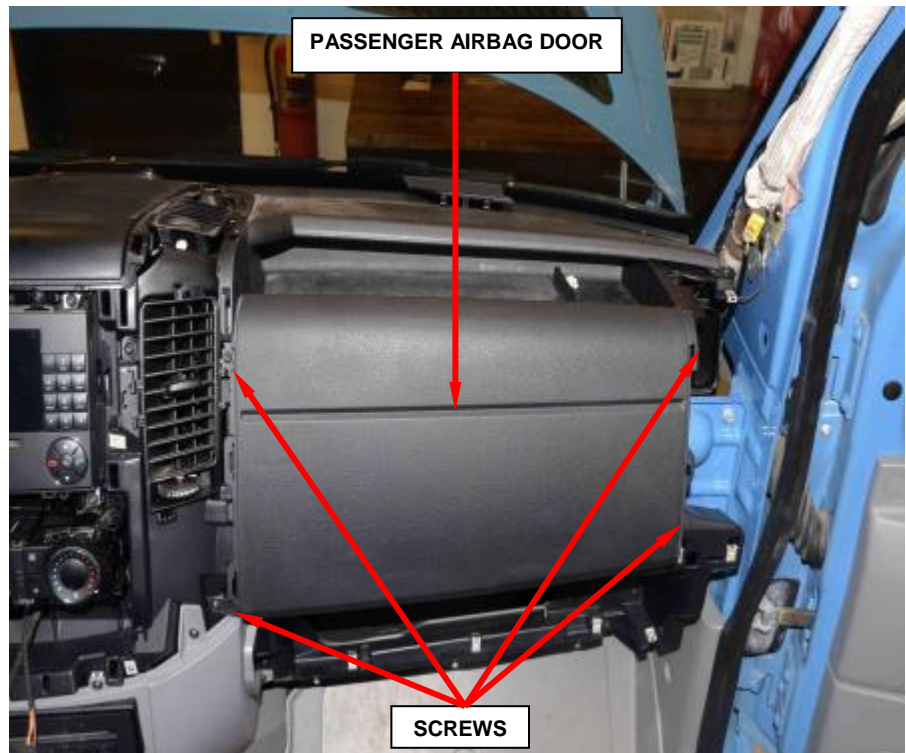
**Figure 10 – Passenger Airbag Door**

13. Remove and save the four screws that secure the tabs on the inboard and outboard ends of the passenger airbag door to the instrument panel base trim (Figure 10).

31. Install and tighten the four screws on the inboard and outboard ends of the passenger airbag door to the instrument panel base trim. Tighten the screws securely (Figure 10).

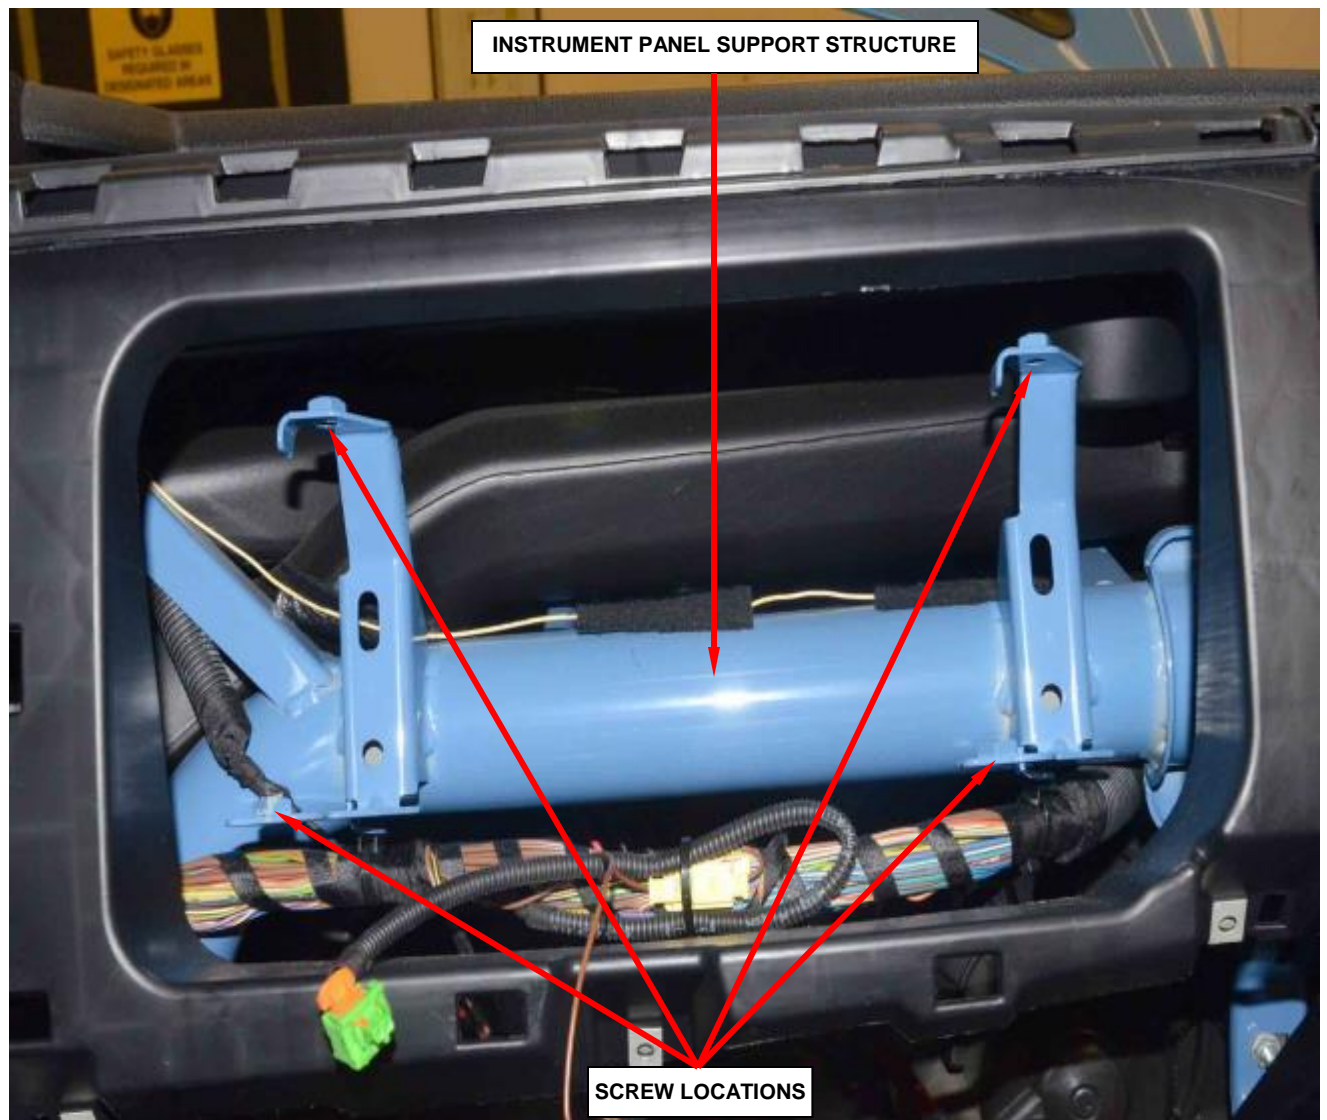
**Figure 11 – Mounting Screw Locations  
(Passenger Airbag Module Removed for Photographic Purposes)**

14. Reach up into the instrument panel glove box opening to access and remove the four screws that secure the stanchions on the back of the passenger airbag module to the brackets on the instrument panel support structure. **Discard the removed screws** (Figure 11).

29. Slide the passenger airbag module fully forward into the instrument panel opening.
30. Reach up into the instrument panel glove box opening to access, install and tighten the four **NEW** screws to secure the stanchions on the back of the passenger airbag housing to the brackets on the instrument panel support structure. **Never reuse the old screws.** Tighten the screws to 71 in. lbs. (8 N·m) (Figure 11).

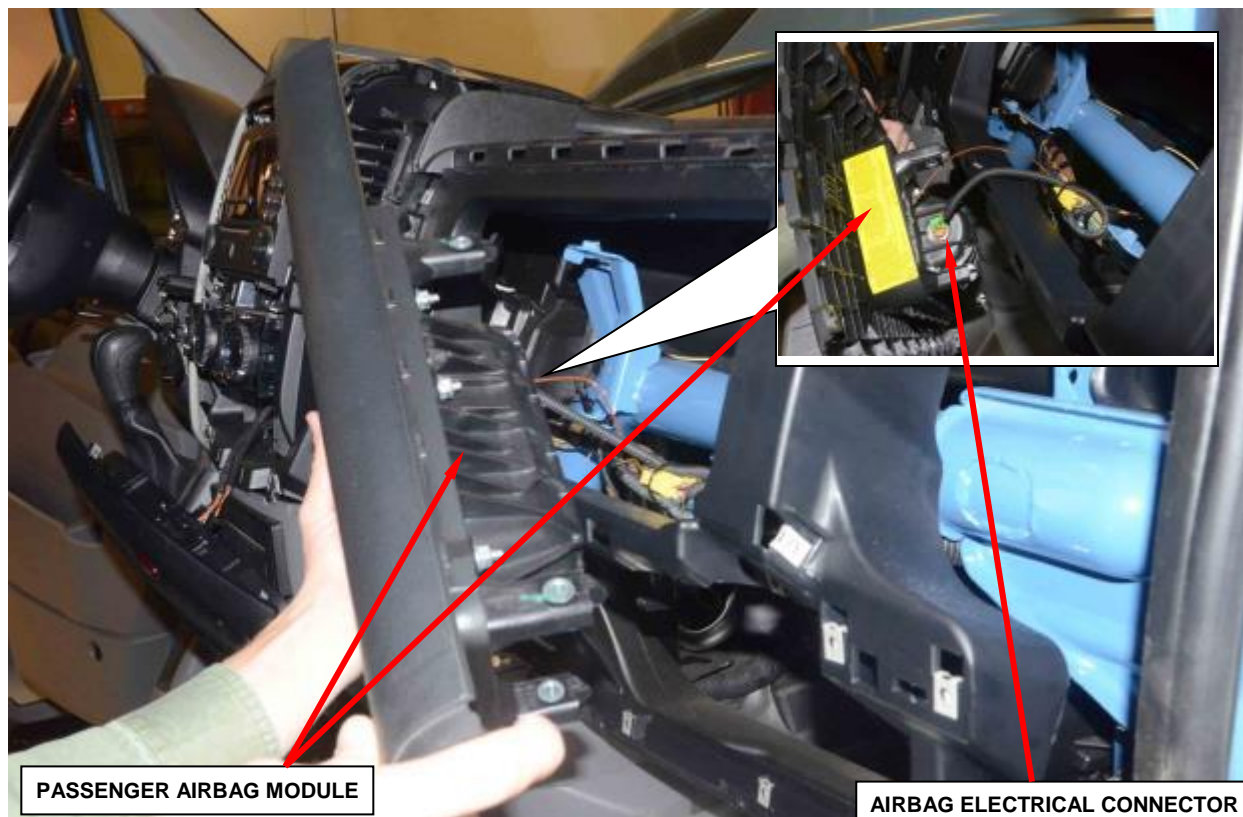
Figure 12 – Passenger Airbag Module

15. Pull the passenger airbag module rearward far enough to access the airbag electrical connector on the inboard end of the unit (Figure 12 and 13).

16. Disconnect the airbag electrical connector from the airbag inflator connector receptacle, which is located on the inboard end of the passenger airbag housing. To disconnect the connector:
  - a. Slide the orange Connector Position Assurance (CPA) lock on the connector toward the top of the connector.
  - b. Depress the connector latch tab and pull the connector straight away from the inflator initiator.

28. Connect the airbag electrical connector to the airbag inflator connector receptacle, which is located on the inboard end of the passenger airbag housing. Be certain that the latch on the connector and the orange Connector Position Assurance (CPA) lock are each fully engaged (Figure 12).

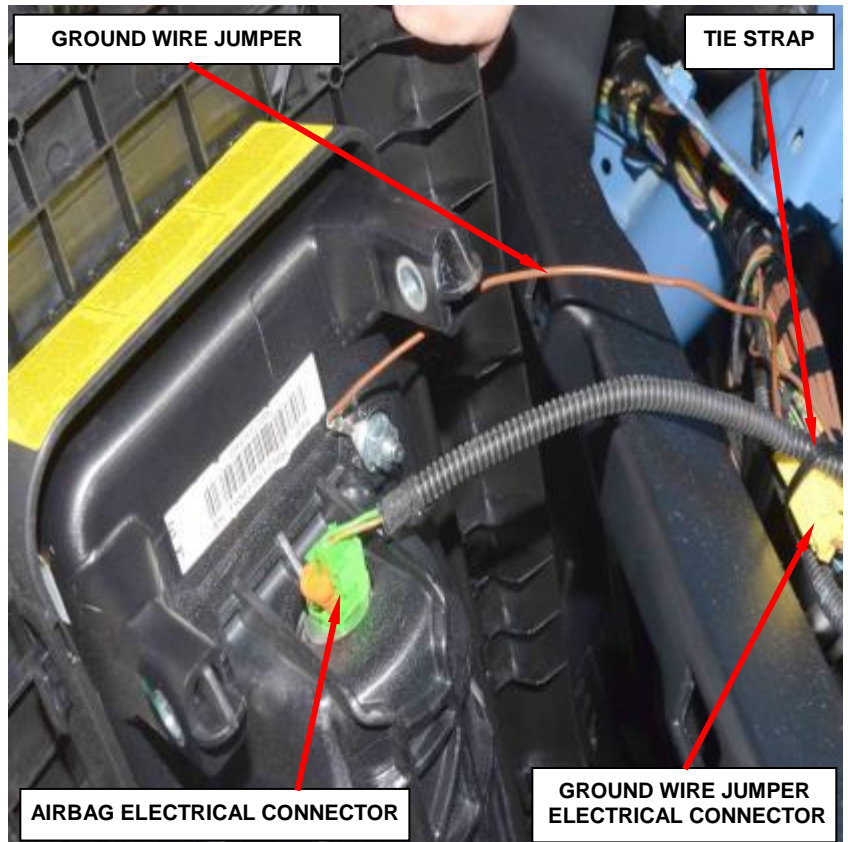
**Figure 13 – Ground Wire Jumper**

17. Remove and **discard** the tie strap securing the yellow ground wire jumper electrical connector to the instrument panel wire harness (Figure 13).

18. Disconnect the yellow ground wire jumper electrical connector from the instrument panel wire harness (Figure 13).

26. Connect the yellow ground wire jumper electrical connector to the instrument panel wire harness (Figure 13).

27. Secure the ground wire jumper electrical connector to the instrument panel wire harness using a **NEW** tie strap (Figure 13).

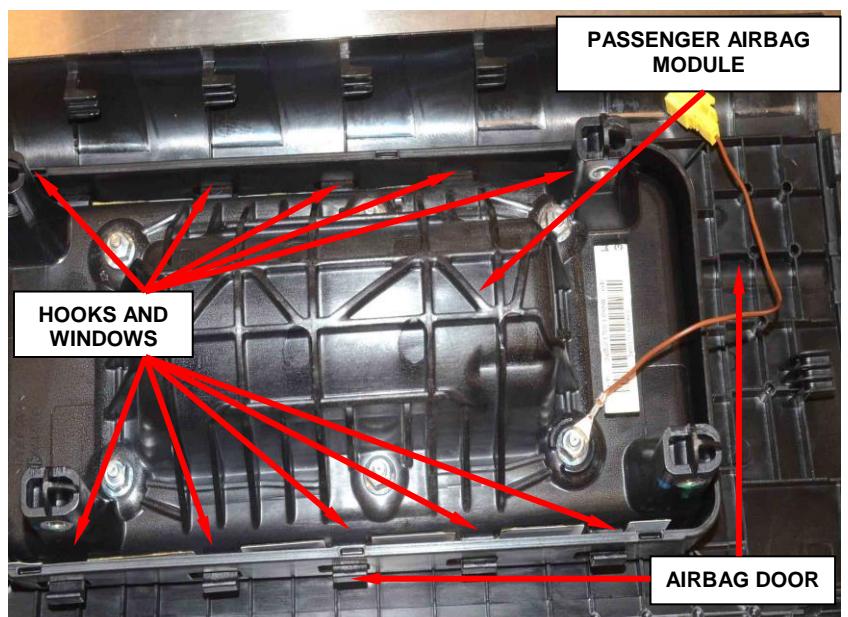
**Figure 14 – Release Passenger Airbag Module**

21. Release the passenger airbag module hooks from the airbag door windows (Figure 14).

22. Gently pull the passenger airbag module up slowly making sure that the hooks are clear from the windows on all sides.

23. Install the NEW passenger airbag module to the original airbag door cover by first inserting the bottom hooks into the windows (Figure 14).

24. Snap the remaining hooks on the opposite side into place (Figure 14).
