TO: Mercedes-Benz Dealer Principals, General Managers, Sales Managers, Service Managers, Parts Managers	FROM: Heike Scheuble, General Manager, Aftersales
RE: Recall Campaign 2018110007 MY12 Freightliner Sprinters Replace Takata Passenger-side Airbag	DATE: November 15, 2018

Campaign No. 2018110007, November 2018

SUBJECT: **Model 906 (Sprinter), Model Years 2012
Freightliner
Replace Front Passenger-side Air Bag**

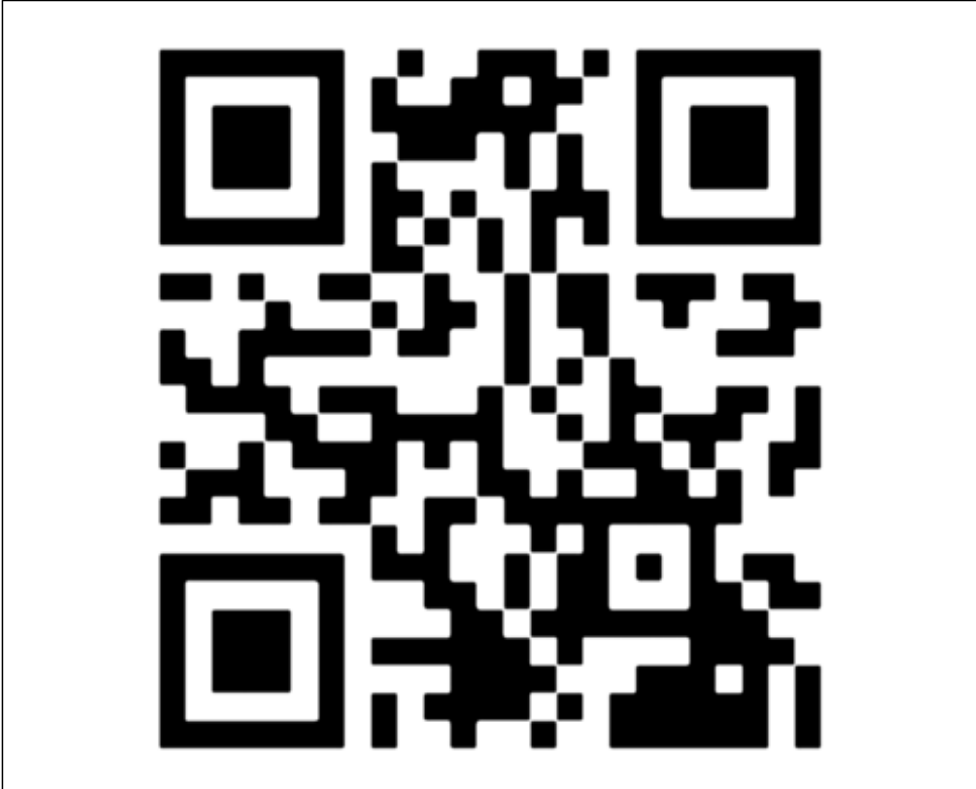
QR code for "Mercedes-Benz Part Scan" app

- The required QR code can be scanned here from the picture. Make sure that only authorized workshop personnel has access to the QR code!

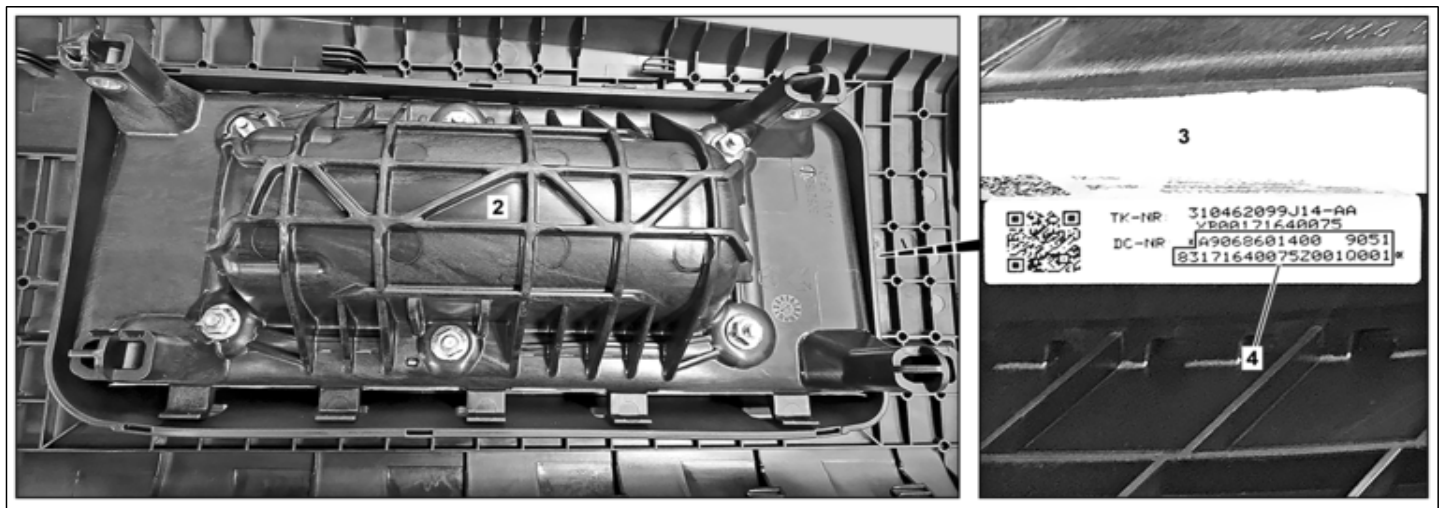
Shown on front passenger airbag (2)

2 Front passenger airbag

3 Adhesive label

4 Serial number

The serial number (4) consists of the following information:

- A-object number (e.g. A906860200005)
- Color number (e.g. 9051)
- Sequential number (e.g. 831716400752001)
- Q-status (e.g. Q001)

This information must be read off the adhesive label (3) and entered consecutively without spaces (e.g. A906860200005905183171640075001Q001) as the serial number (4).

1 Document the serial number (4) of the removed driver airbag (1) or of the removed front passenger airbag (2) using "Mercedes-Benz Part Scan".

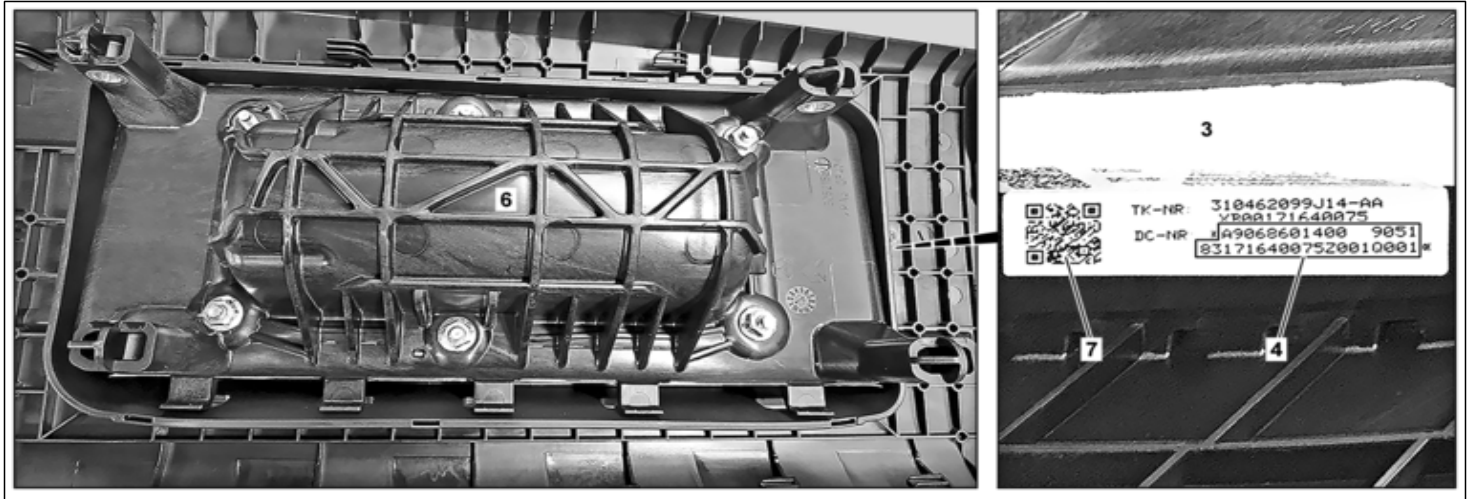
Shown on new front passenger airbag (6)

- 3 Adhesive label
- 4 Serial number

- 6 New front passenger airbag
- 7 QR code

Document the new driver airbag (5) or the new front passenger airbag (6) using "Mercedes-Benz Part Scan".

To do this, scan the serial number (4) on the adhesive label (3) with the QR code (7) on the new driver airbag (4) or the new front passenger airbag (6). If necessary, the serial number (4) of the new driver airbag (5) or of the new front passenger airbag (6) can also be documented manually using the keypad. To do this, read off the serial number (4) on the adhesive label (3) on the new driver airbag (5) or the new front passenger airbag (6) and enter it manually in the application using the keypad.
