| RE: <b>Recall Campaign 2016090005 UPDATE</b><br><b>MY 10-11 906 Mercedes-Benz and Freightliner</b><br><b>Sprinters</b><br><b>Replace Takata Passenger-side Airbag</b> | DATE: June 16, 2017 |

| <b>Campaign No. :</b> | <b>Replace Sprinter Takata Passenger-Side Airbag</b> |

SUBJECT: **Model 906 (Sprinter), Model Years 2007-2012**  
**Freightliner and Mercedes-Benz**  
**Replace Front Passenger-side Air Bag**

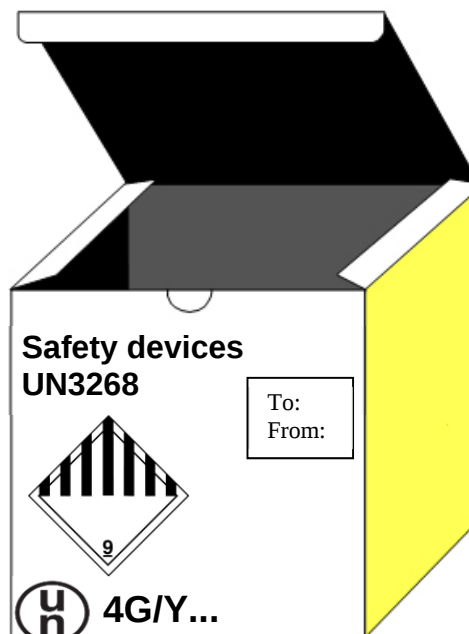
- A **Class 9 Miscellaneous** label must be clearly visible on one side of the box.

- The following words ("marking") must also be clearly visible on the same side of the box as the Class 9 label:  
**Safety devices**  
**UN3268** (font size must be  $\geq \frac{1}{2}$  inch)
- Affix **"To/From"** address label to same or adjacent packaging face as the hazardous markings/labels.
- The UN 4G code preprinted near the bottom edge of the box must also be clearly visible.

- Note:** The Packing Group and the EX# are no longer required to be printed on the HAZMAT bill of lading.
- Package example:**

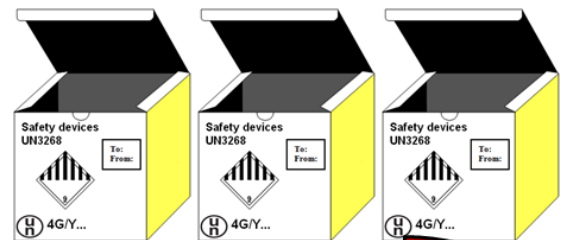
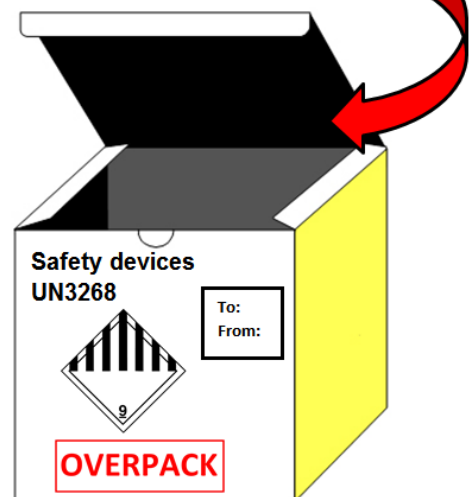
### Package example:

- Package each airbag in a separate UN spec box prepared with the labels/markings described above.
- Place each individual airbag box inside a larger non-UN spec box to keep the shipment together.
- This larger box is called an "OVERPACK."
- The OVERPACK must have the identical markings and label as the boxes contained inside.

- The OVERPACK must have the "OVERPACK" statement on the same face as the hazard markings and labels.
