T59 SAFETY RECALL CLAIM GUIDELINES

DOCUMENTATION NEEDED FOR UNCONFIRMED OR INCOMPLETE REPAIR
ON BRAKE BOOSTER WATER SHIELD FOR 11-14 GRAND CHEROKEE/DURANGO

BRAKE BOOSTER WATER SHIELD ON 11-14 GRAND CHEROKEE/DURANGO

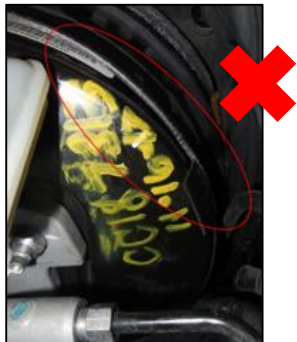
VIN/date written on the face of the brake booster instead of the top.

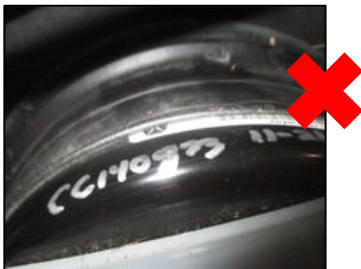
Picture does not show any tab locations and therefore unable to verify proper repair.

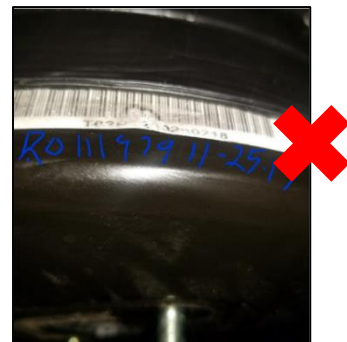
Picture has been altered to add VIN and date. This is warranty fraud and will not be accepted.
