UPDATE - T59 Safety Recall Claim Guidelines

UPDATED: T59 SAFETY RECALL CLAIM GUIDELINES

BRAKE BOOSTER WATER SHIELD ON 11-14 GRAND CHEROKEE/DURANGO

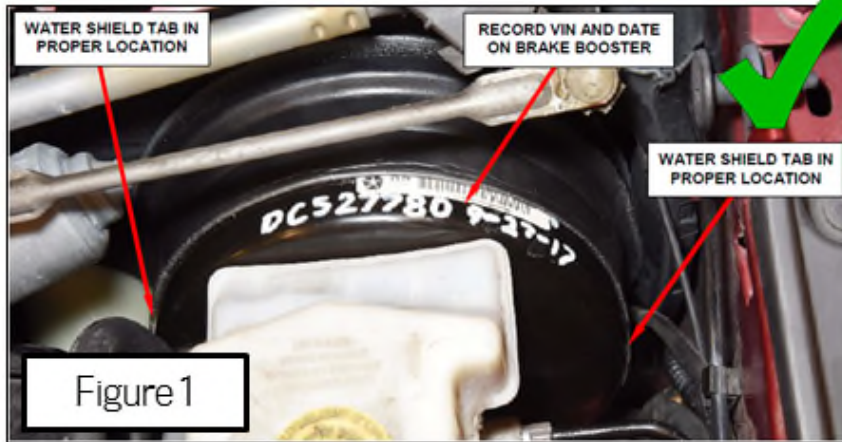
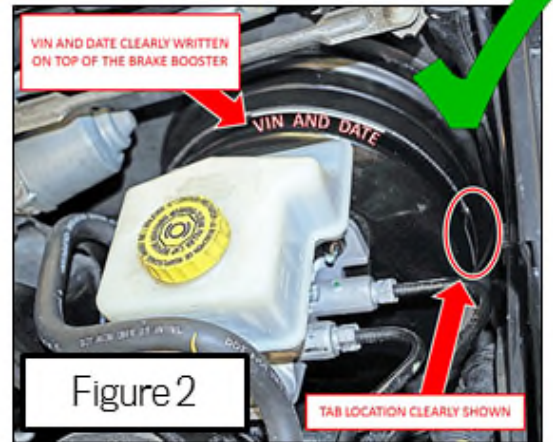
ACCEPTABLE PHOTO DOCUMENTATION

- Evidence of proper water shield tab alignment (as shown in figure 1 and 2)
- The VIN of the vehicle (written on top of the booster as shown in figure 1 and 2)
- The date of the inspection/repair, (written on top of the booster as shown in figure 1 and 2)

Below are some examples of acceptable and unacceptable photo documentation. *Please note that a picture of the side of the booster as shown in figure 2 below is acceptable and can provide sufficient evidence of proper water shield installation.* For further instruction please reference the T59 Brake Booster Safety Recall for details.

It is imperative that these instructions be followed to ensure the Brake Booster Water Shield is installed correctly with the tab edges flush with the edge of the brake booster and located at the three o'clock and nine o'clock positions.

- Proper positioning of the water shield on the brake booster (at least one water shield tab is visible). This is critical to ensure proper placement. **Claims with pictures that do not show the proper tab alignment will be returned.**
- The recorded VIN and date written on the outer circumference of the booster

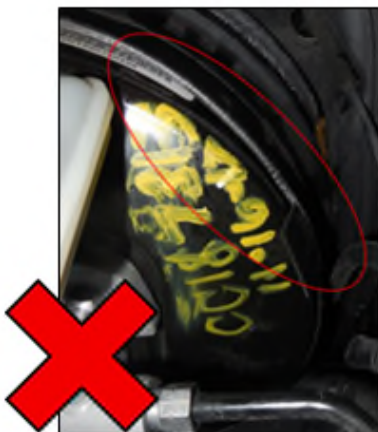
VIN/date written on the

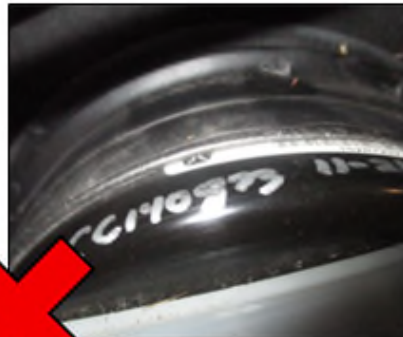
Picture does not show any tab

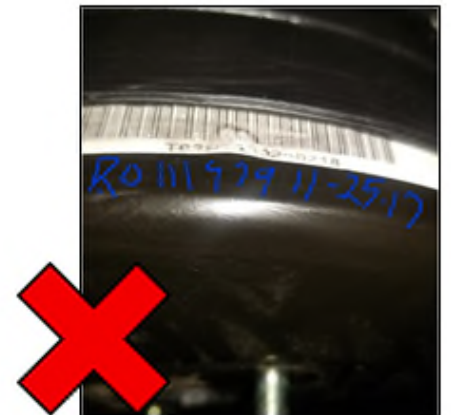
Picture has been altered to
