TO: Mercedes-Benz Dealer Principals, General Managers, Sales Managers, Service Managers, Parts Managers	FROM: Michael Scott, Vans Regulations and Certifications Gregory Gunther, Department Manager, Vehicle Compliance and Analysis, Engineering Services
RE: <b>Recall Campaign 2017120007</b> <b>Launch Notification</b> <b>MY16 906 (Sprinter)</b> <b>Check Left B-Pillar Label, Replace if Necessary</b>	DATE: December 8, 2017

# RECALL CAMPAIGN LAUNCH NOTIFICATION

**Check B-Pillar Label (Code: N3LHIWGEWI, Damage Code: 40 922 56)**

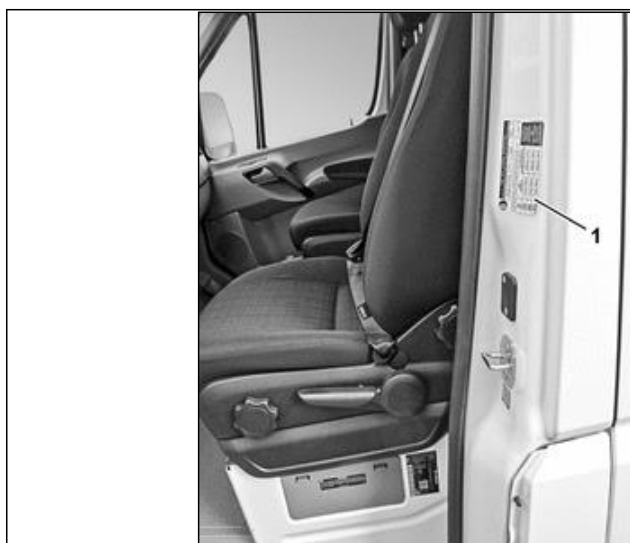
D40.10-1127-02

1 B-Pillar label

Step	Check	
1	Check to see if the vehicle is affected. If not, the repair is complete.  If so, proceed to workstep 2.	<b>i. For authorized MB Service only an EVA entry is needed. An additional check of the vehicle in WIS is not necessary.</b>
2	Check if the original label for the vehicle is available. If not, open a PTSS case for the vehicle.  If so, proceed to workstep 3.	<b>i. Label is VIN specific.</b>
3	Replace the B-pillar label	<b>i. The surface must be free of grease.</b>
4	Add protective foil.
