RE: **Recall Campaign 2017 110017**
Launch Notification
MY17 447 (Metris)
Check Wheel Bearing Retaining Rings

Campaign No. 2017110017, December 2017

SUBJECT: **Model 447 Model Year 2017
Wheel Bearing Retaining Ring**

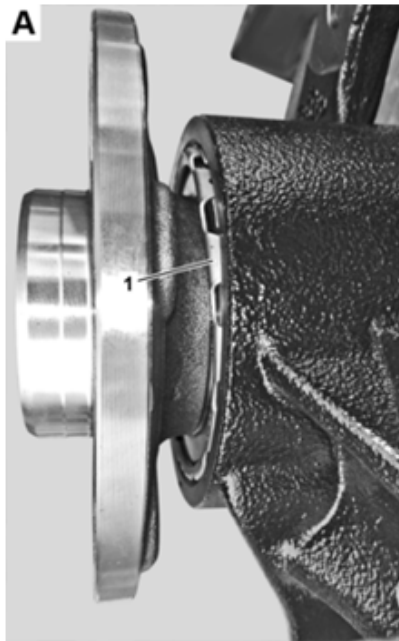
If installation position of retaining ring **(1)** on the front wheel bearing (left or right side) is **NOT OK (See picture A)** proceed to step 2.

Picture A: Shown on left side, retaining ring (1) **NOT** correctly inserted

2. **Insert retaining ring (1)** correctly with a flat head screwdriver **(2)** as shown in **(picture B)**, lever all way round the front wheel bearing till **flush-fitted**.
3. **Check retaining ring (1)** is correctly seated on wheel bearing. To do so, position suitable tool (e.g. screwdriver and plastic mallet), as shown, **(see arrow in picture B)**. By applying light hammer blows, check if the retaining ring **(1)** can be turned on the wheel bearing **(see picture B)**.

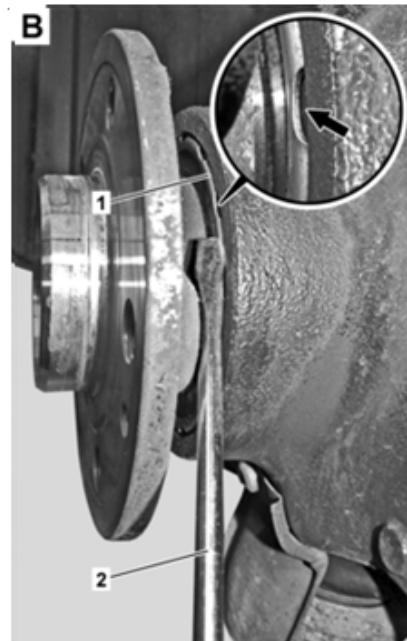
The retaining ring **(1) must be flush-fitted** all the way round the front wheel bearing (left and right side of the vehicle).

If installation position of retaining ring **(1)** on the front wheel bearing (left or right side) is **OK (See picture B)** proceed to step 3.

Picture B: Shown on left side, retaining ring (1) insert correctly.

If the retaining ring **(1)** on the wheel bearing can be turned. The retaining ring is not correctly inserted. Repeat operation step 2.

If the retaining ring **(1)** on the wheel bearing does not move the **procedure is complete.**
