**SUBJECT: NEW VEHICLE DEMONSTRATION / DELIVERY HOLD - Safety Recall 17S33 - Supplement #4**

Certain 2015-2017 Model Year F-150 and 2017 Model Year F-Super Duty Vehicles  
 Doors Will Not Close or Open While Driving

## CERTAIN 2015-2017 MODEL YEAR F-150 AND 2017 MODEL YEAR F-SUPER DUTY VEHICLES — DOORS WILL NOT CLOSE OR OPEN WHILE DRIVING

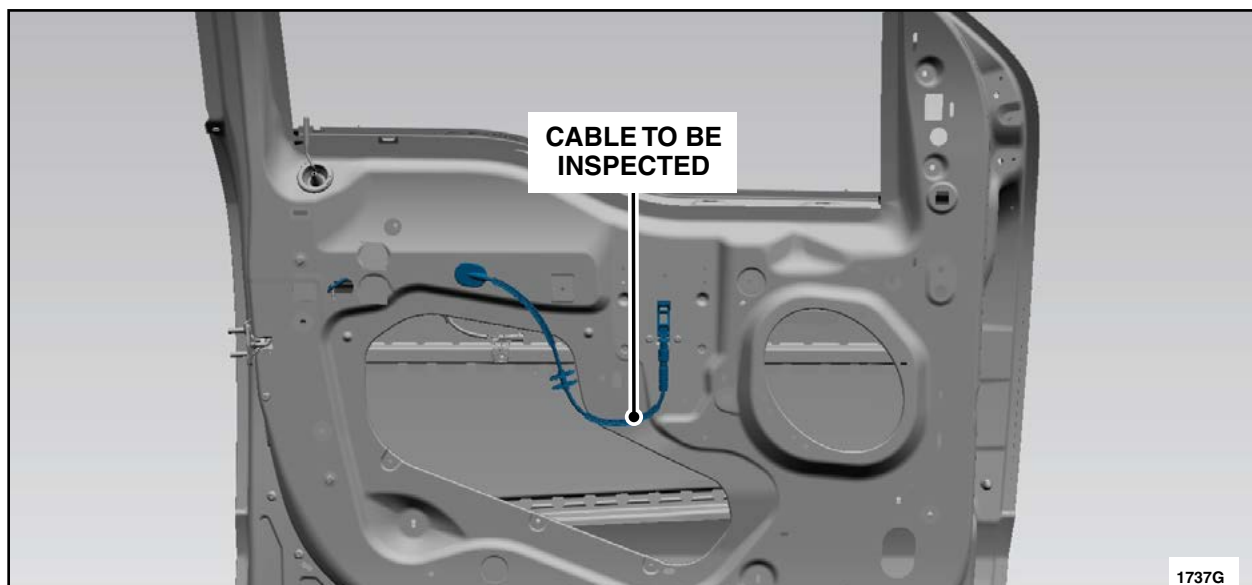
**FIGURE 1**

3. Inspect the interior door handle to latch release cable for kinking. See Figure 1.

4. Remove the front door latch and replace the interior door handle release cable. Please follow the WSM procedures in Section 501-14.

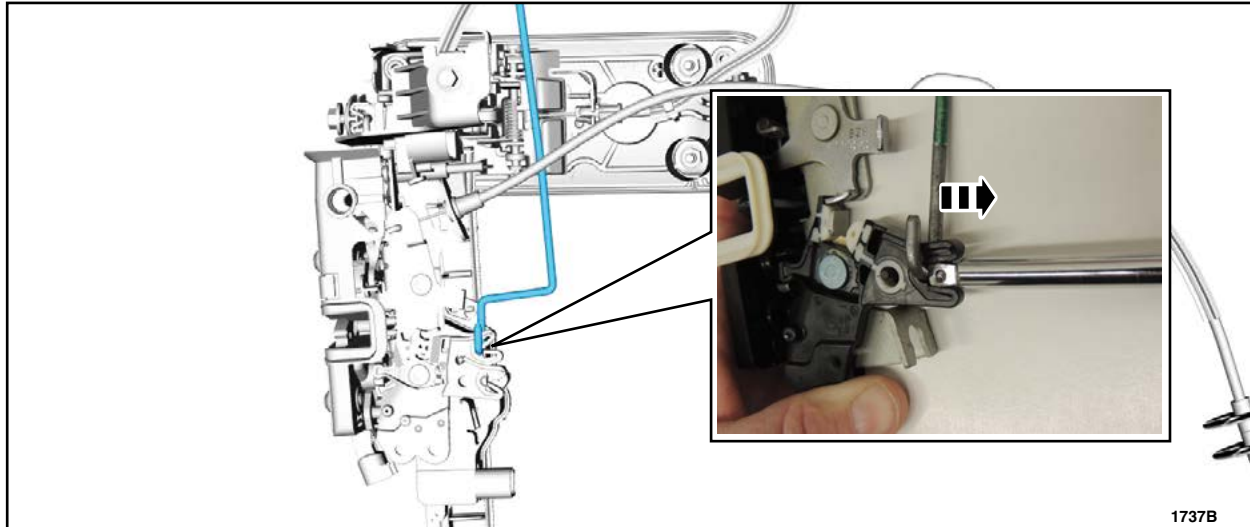
**FIGURE 2**

6. *If not already removed*, remove the lock rod assembly. See Figure 2.

- Use the male end of a 1/4" extension to spread apart the lock rod retainer and remove the rod from the door latch.

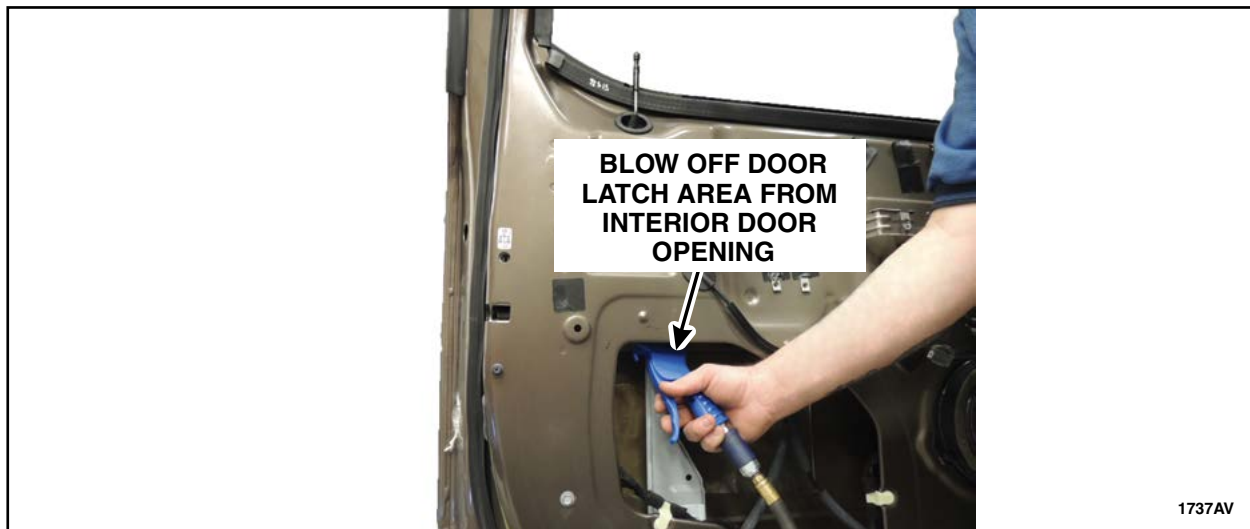
**FIGURE 3**

7. Using compressed air, blow out any debris or residual water from the door latch assembly, exterior door handle mechanism and cables for thirty seconds. Blow drying with compressed air for thirty seconds is critical to remove as much moisture as possible. See Figure 3.

**NOTE:** Driver door latch shown, all door latches similar.

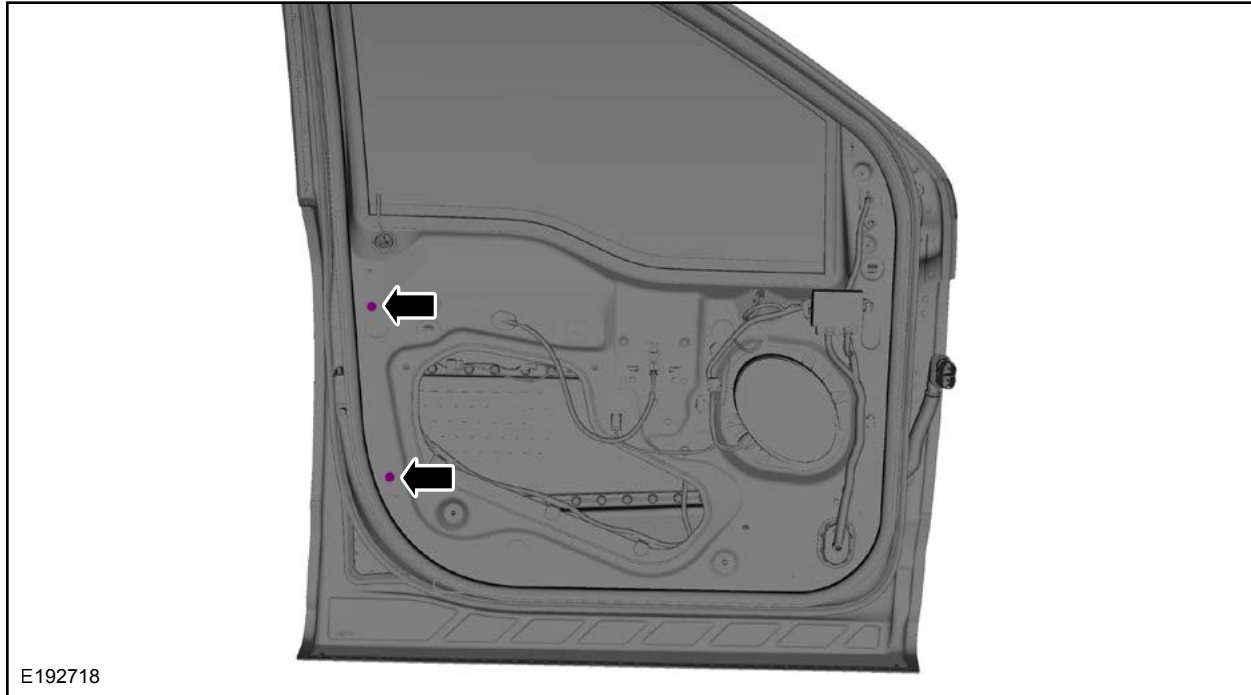
**FIGURE 4**

8. *If not previously left loose*, loosen but do not remove the two door glass run bolts. See Figure 4.

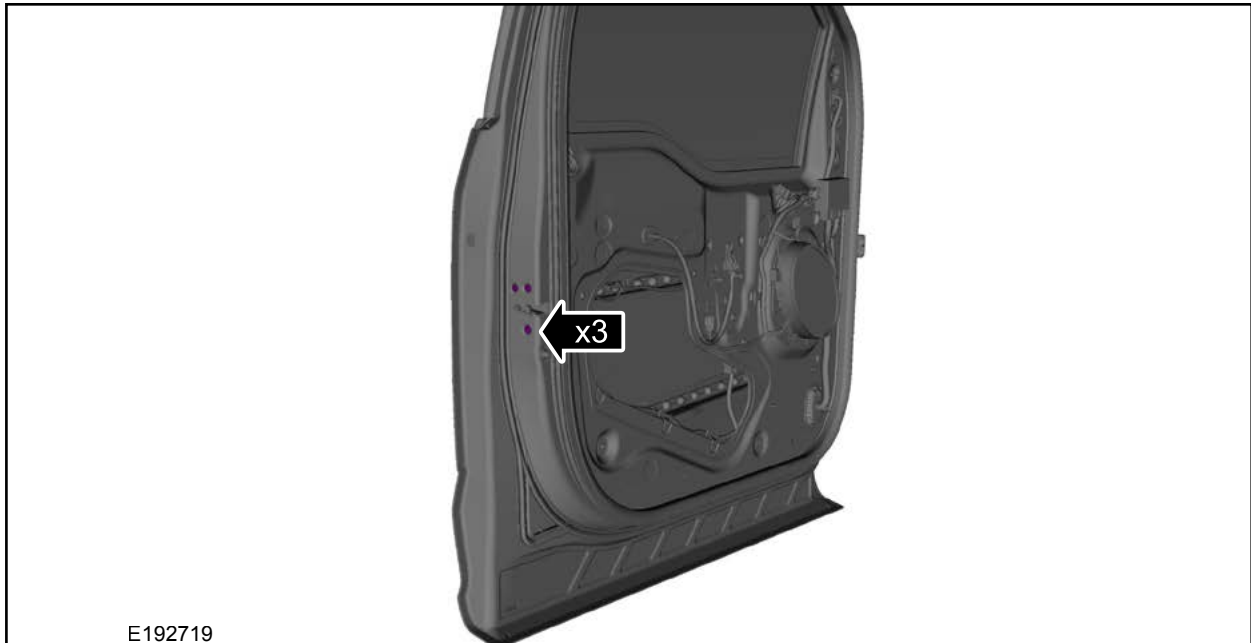
**FIGURE 5**

9. *If not previously left loose*, loosen but do not remove the 3 door latch bolts. See Figure 5.

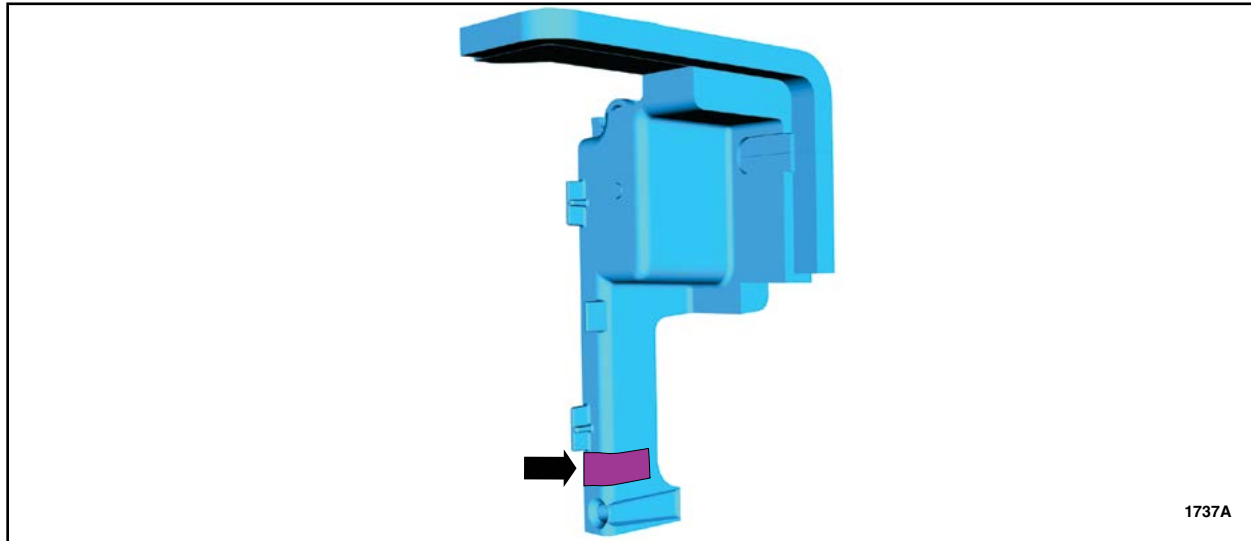
FIGURE 6

10. Apply supplied foam tape to the *new* shield in the highlighted area. See Figure 6.

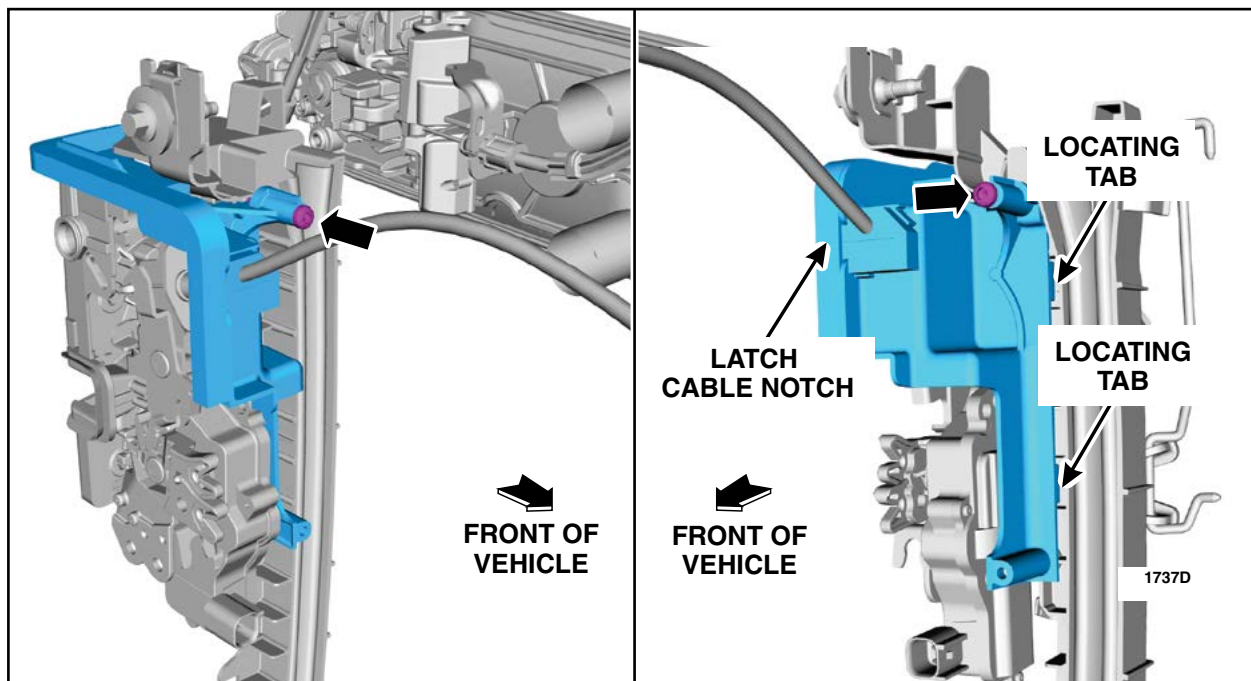
FIGURE 7

11. With the latch and door glass run assembly loose inside the door panel, install the door latch water shield into position. See Figure 7.

12. Install the *new* screw into the top hole of the shield. See Figure 7.

**NOTE:** The lower fastener hole of the shield is not used on the front water shields.

**NOTE:** Driver side door latch shown, passenger side door latch similar.

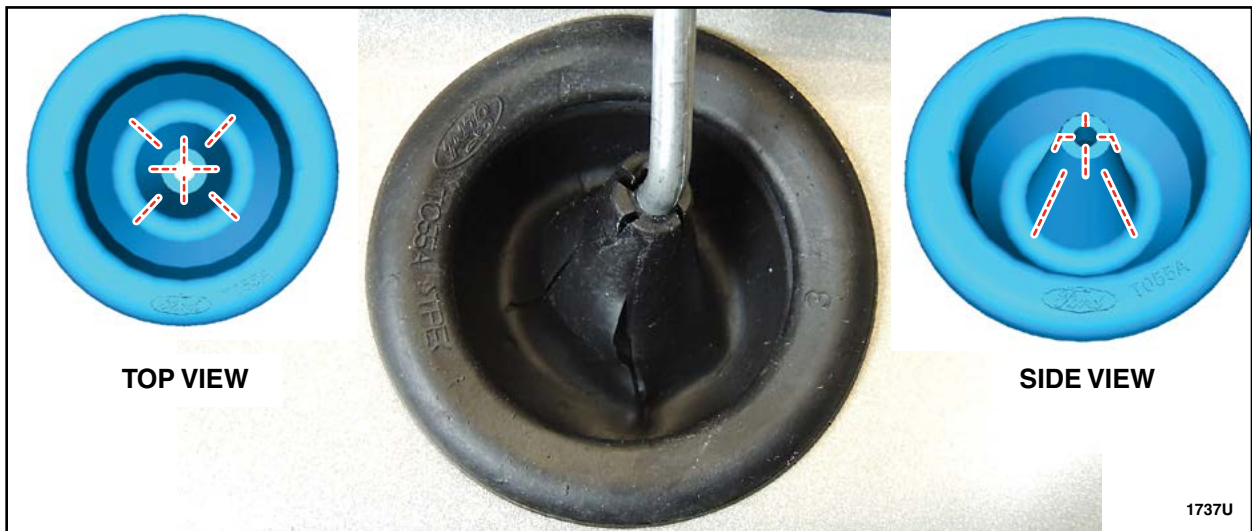
**FIGURE 10**

16. Modify the front door Lock Rod Grommet. See Figure 10.

- a. Using a utility knife, cut four 6 mm (.25 in) long slits approximately 90° apart into the top of the front door lock rod grommet where the lock rod exits the grommet.
- b. Cut four additional 13 mm (.5 in) long slits approximately 90° apart on the inner sides of the grommet 45° separated from the previously cut slits.

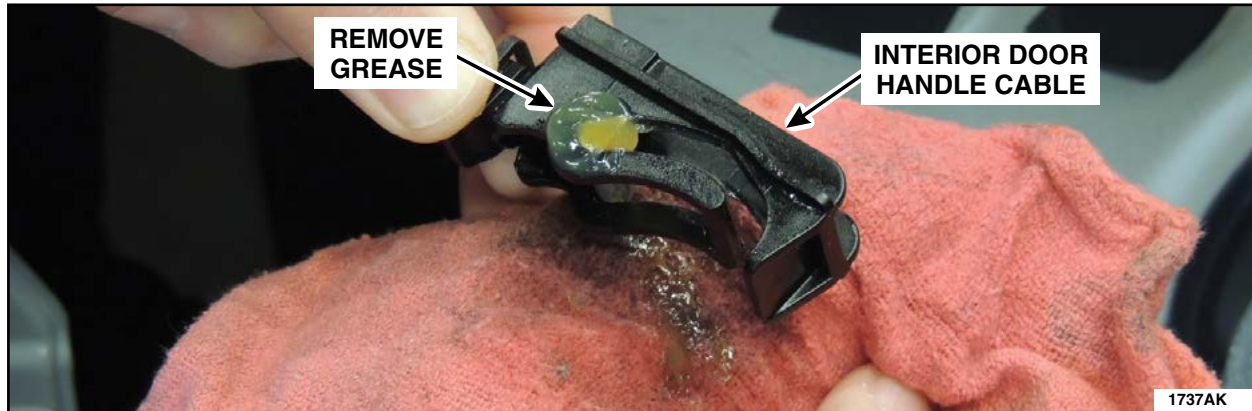
FIGURE 11

17. If equipped, disconnect the interior door handle cable retaining clips from the door sheet metal.
18. Using isopropyl alcohol and a clean shop towel, thoroughly remove grease from the interior door handle cable mechanism. See Figure 11.

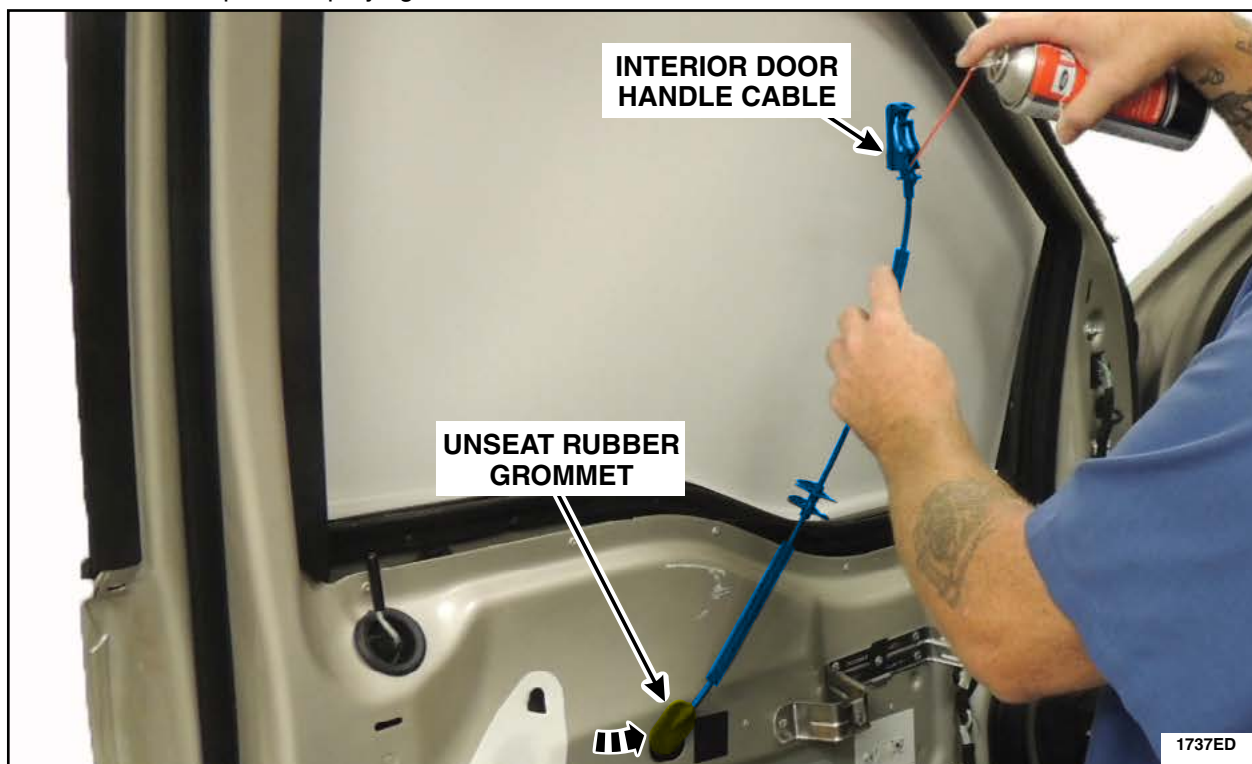
FIGURE 12

19. Unseat the interior door handle cable rubber grommet and while holding the end of the cable in an upward position, spray Motorcraft® XL-6 silicone lubricant down into the cable for five seconds. See Figure 12.

**NOTE:** If the Motorcraft® XL-6 Lubricant container is not equipped with an applicator nozzle that can accommodate a straw, swap the applicator nozzle from another Motorcraft® chemical such as: XL-5 Multi-Purpose Grease Spray, XL-5-A Multi-Purpose Grease Spray or ZC-30-A Silicone Gasket Remover so a straw can be used. Spray a small amount to clear the applicator nozzle and straw prior to spraying the cable.

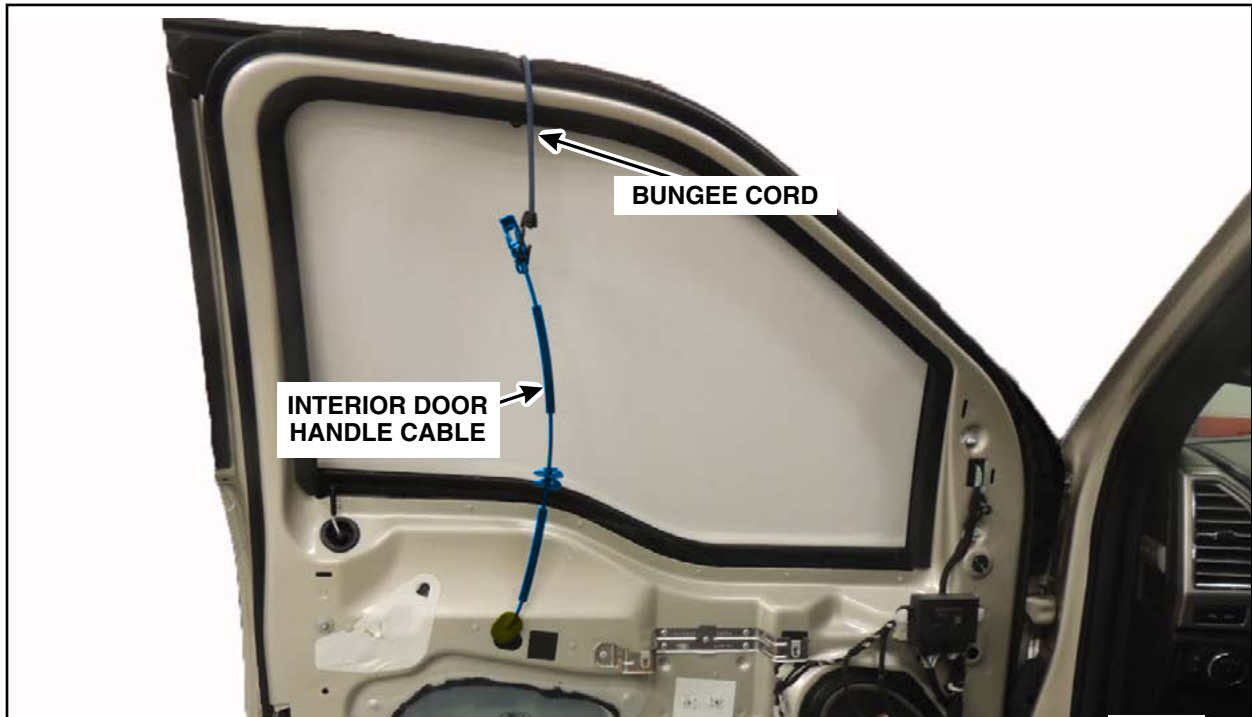
FIGURE 13

20. Using a bungee cord or other similar device, secure the interior door handle cable to the door in an upward position to allow the Motorcraft® XL-6 silicone lubricant time to run down into the cable, until the interior door panel is reinstalled later in this procedure. See Figure 13.

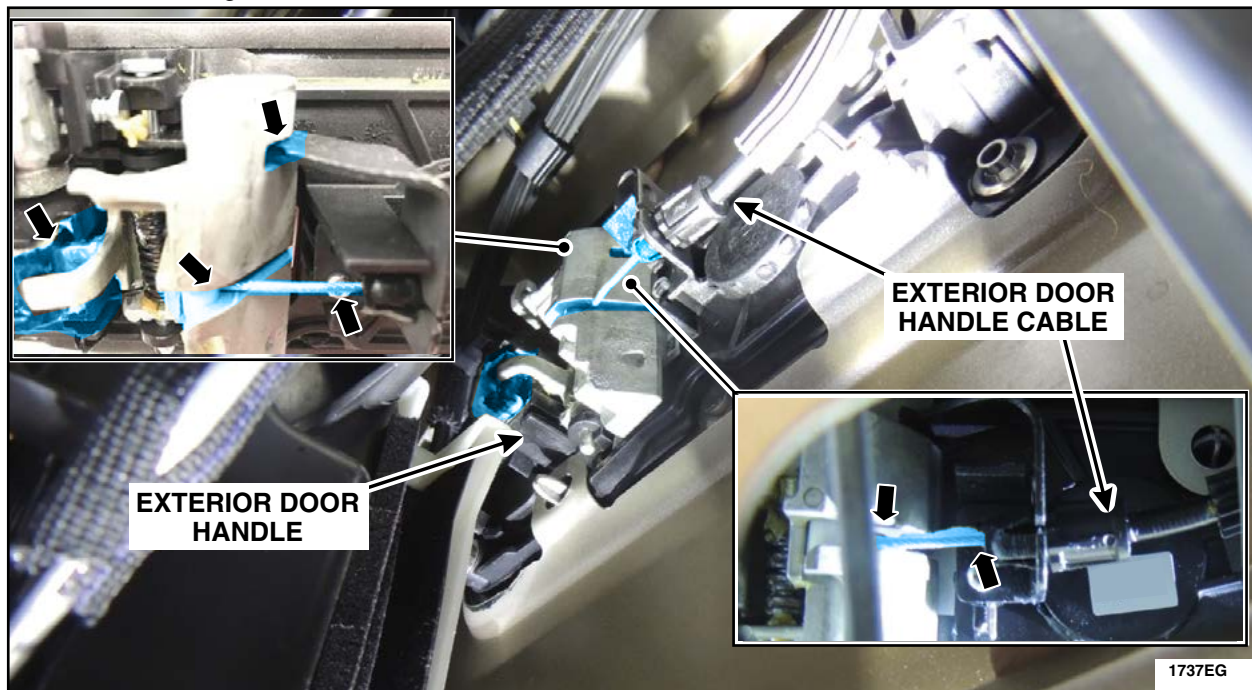
FIGURE 14a

21. Through the large door sheet metal opening, use a brush to apply a light film of Motorcraft® XG-16 low temperature grease to the exterior door handle cable end, and to the three additional highlighted areas. See Figures 14a and 14b.

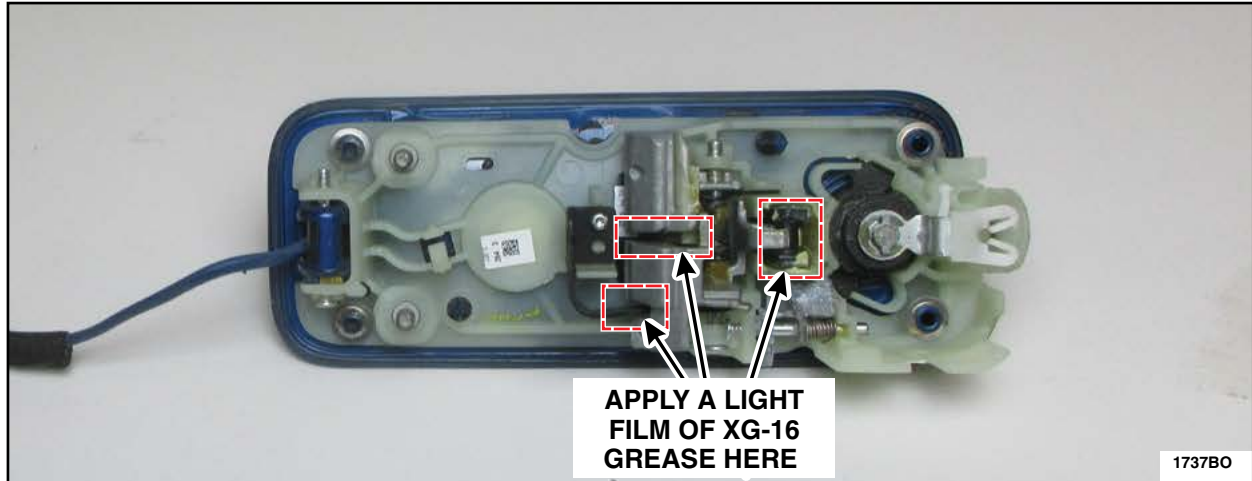
**FIGURE 14b**

**NOTE:** The exterior door handle is removed for clarity.

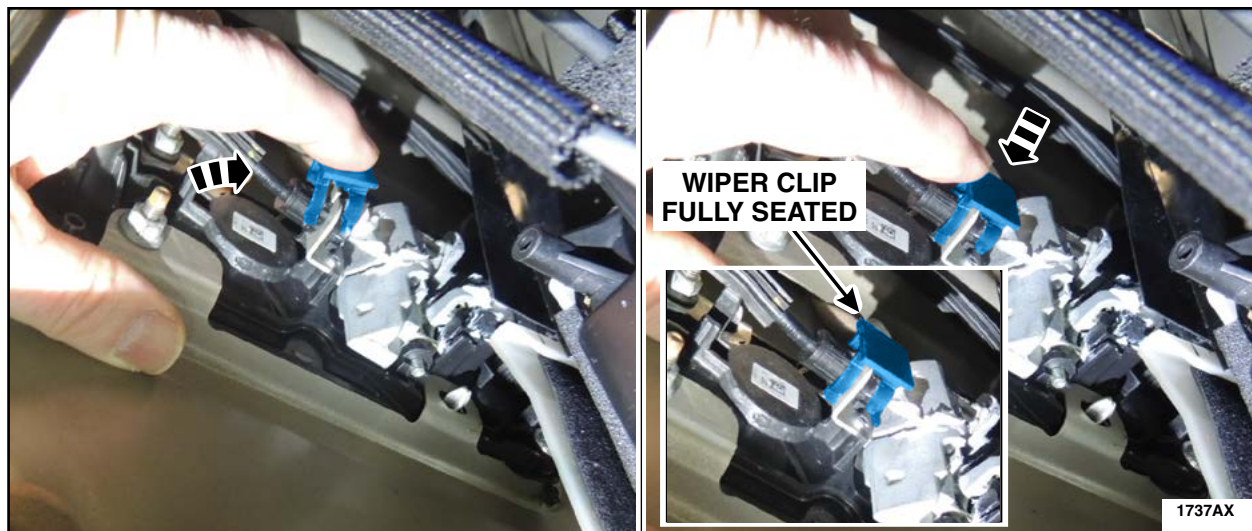
**FIGURE 15**

22. Install the handle cable wiper clip on the exterior door handle cable end. See Figure 15.

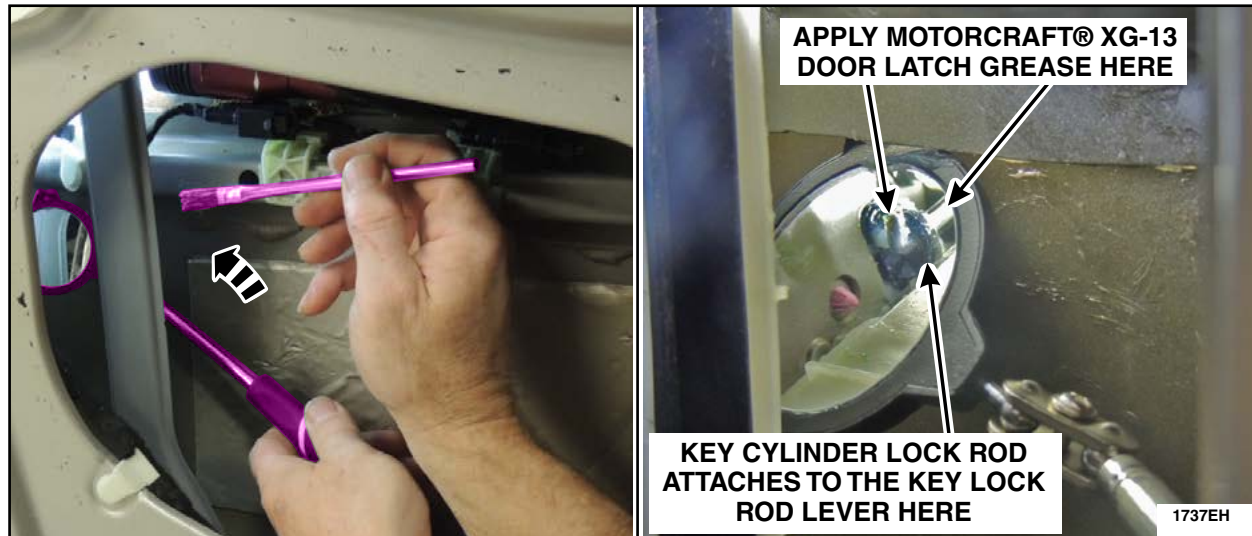
FIGURE 16

23. For driver side only, use an inspection mirror to locate and liberally apply Motorcraft® XG-13 door latch grease to the area where the key cylinder lock rod attaches to the key lock rod lever.  
See Figures 16 and 17.

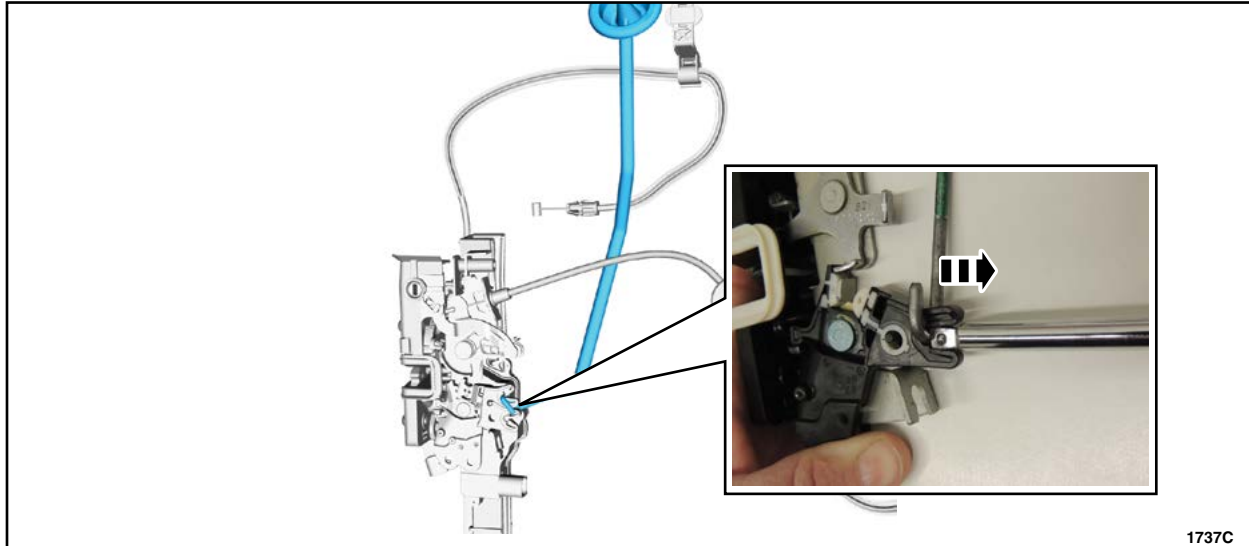
**FIGURE 19**

6. *If not already removed*, remove the lock rod assembly. See Figure 19.

- Use the male end of a 1/4" extension to spread apart the lock rod retainer and remove the rod from the door latch.

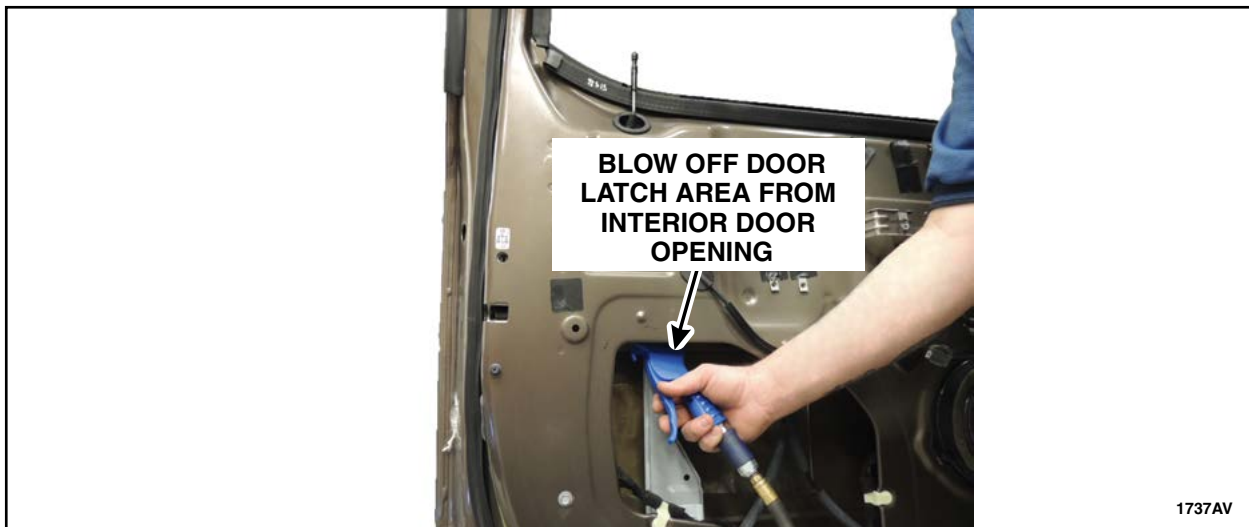
**FIGURE 20**

7. Using compressed air, blow out any debris or residual water from the door latch assembly, exterior door handle mechanism and cables for thirty seconds. Blow drying with compressed air for thirty seconds is critical to remove as much moisture as possible. See Figure 20.

**NOTE:** Driver door latch shown, all door latches similar.

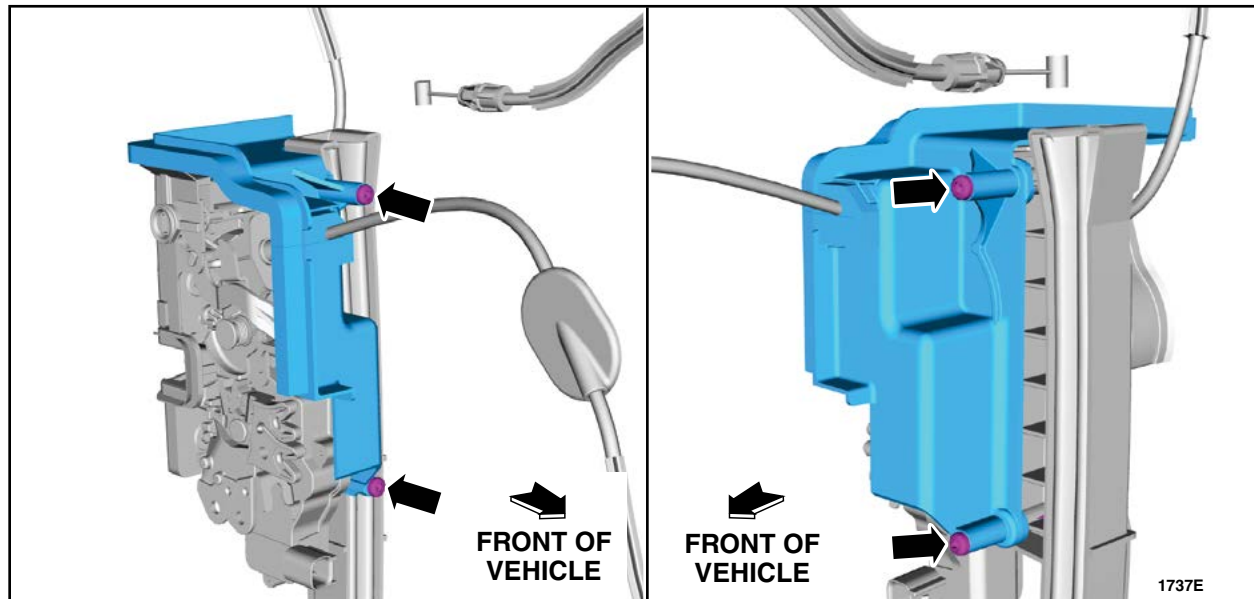
FIGURE 21

9. Install the *new* screws into the top and bottom holes of the shield. See Figure 21.

**NOTE:** Driver side door latch shown, passenger side door latch similar.

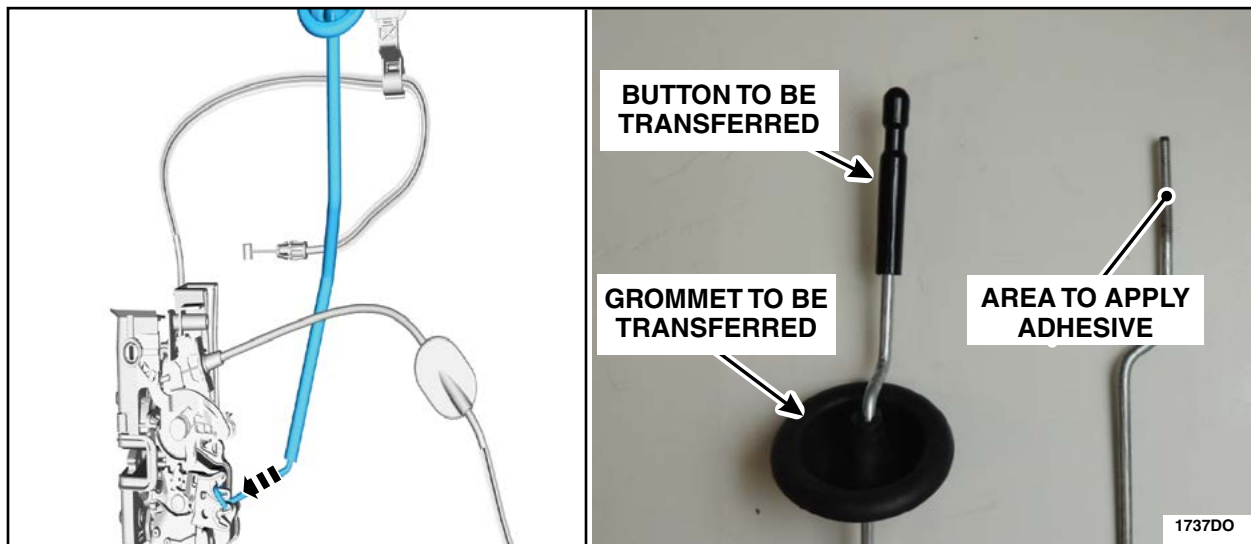
FIGURE 22

- For replacement lock rods only. Transfer the grommet, sleeve and button from the original lock rod to the *new*.
- Apply a bead of Motorcraft® instant gel adhesive TA-19-C (or equivalent) to the lock rod prior to threading the button into place.
- When threading the button onto the *new* lock rod, stop threading when some resistance is met.
- Ensure the right-hand and left-hand buttons are installed at similar heights.

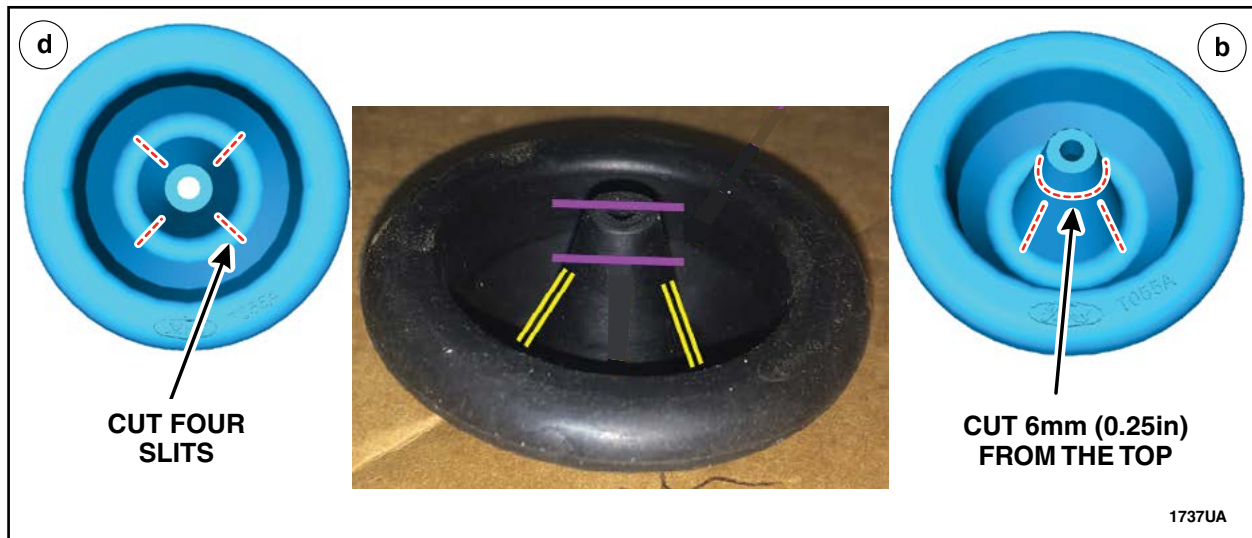
FIGURE 24

11. Modify the rear door lock rod grommet. See Figure 24.

- a. Remove the rear door lock rod grommet from the lock rod.
- b. Cut approximately 6 mm (0.25 in) off the top of the grommet.
- c. Install the rear door lock rod grommet back onto the lock rod.
- d. Using a utility knife, cut four 6 mm (0.25 in) long slits approximately 90° apart into the lower portion of the rear door lock rod grommet.

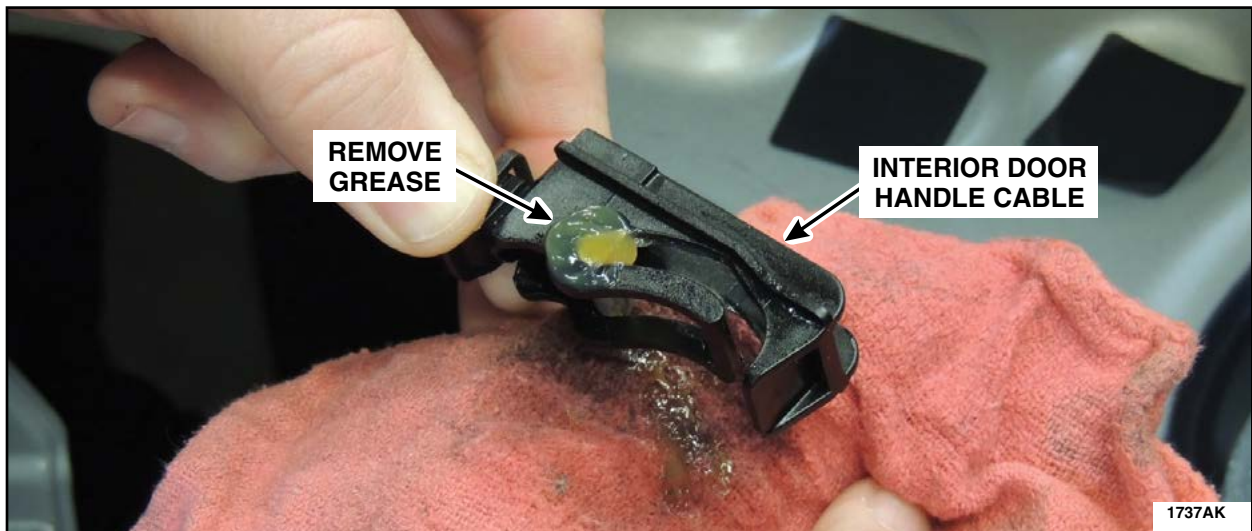
FIGURE 25

12. Using isopropyl alcohol and a clean shop towel, thoroughly remove grease from the interior door handle cable mechanism. See Figure 25.

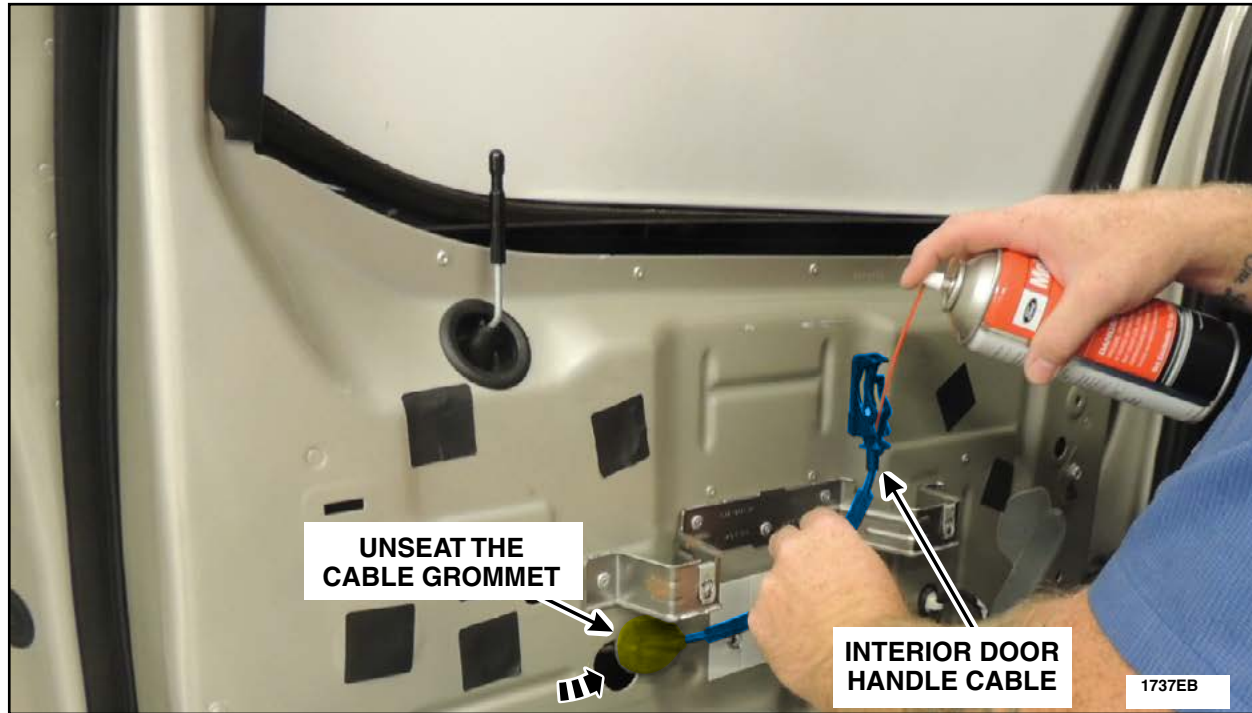
FIGURE 26

13. Unseat the interior door handle cable rubber grommet and while holding the end of the interior door handle cable in an upward position, spray Motorcraft® XL-6 silicone lubricant for five seconds down into the cable. See Figure 26.

**NOTE:** If the Motorcraft® XL-6 Lubricant container is not equipped with an applicator nozzle that can accommodate a straw, swap the applicator nozzle from another Motorcraft® chemical such as: XL-5 Multi-Purpose Grease Spray, XL-5-A Multi-Purpose Grease Spray or ZC-30-A Silicone Gasket Remover so a straw can be used. Spray a small amount to clear the applicator nozzle and straw prior to spraying the cable.

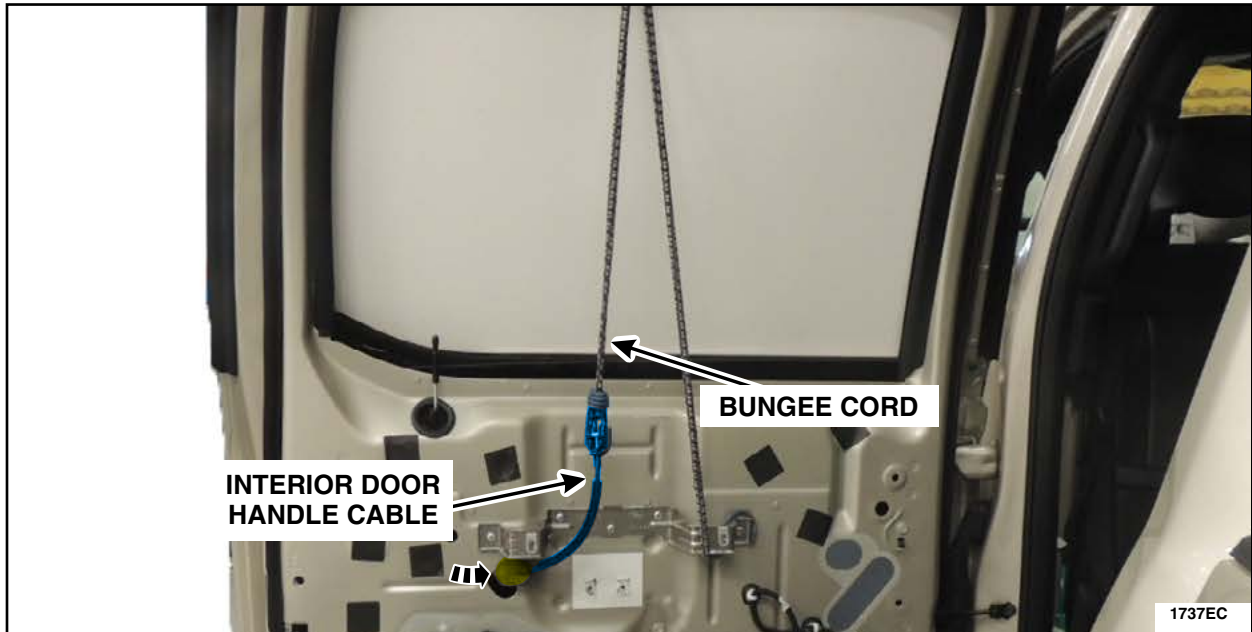
FIGURE 27

14. Using a bungee cord or other similar device, secure the interior door handle cable to the door in an upward position to allow the lubricant time to run down into the cable, until the interior door handle cable is reinstalled later in this procedure. See Figure 27.

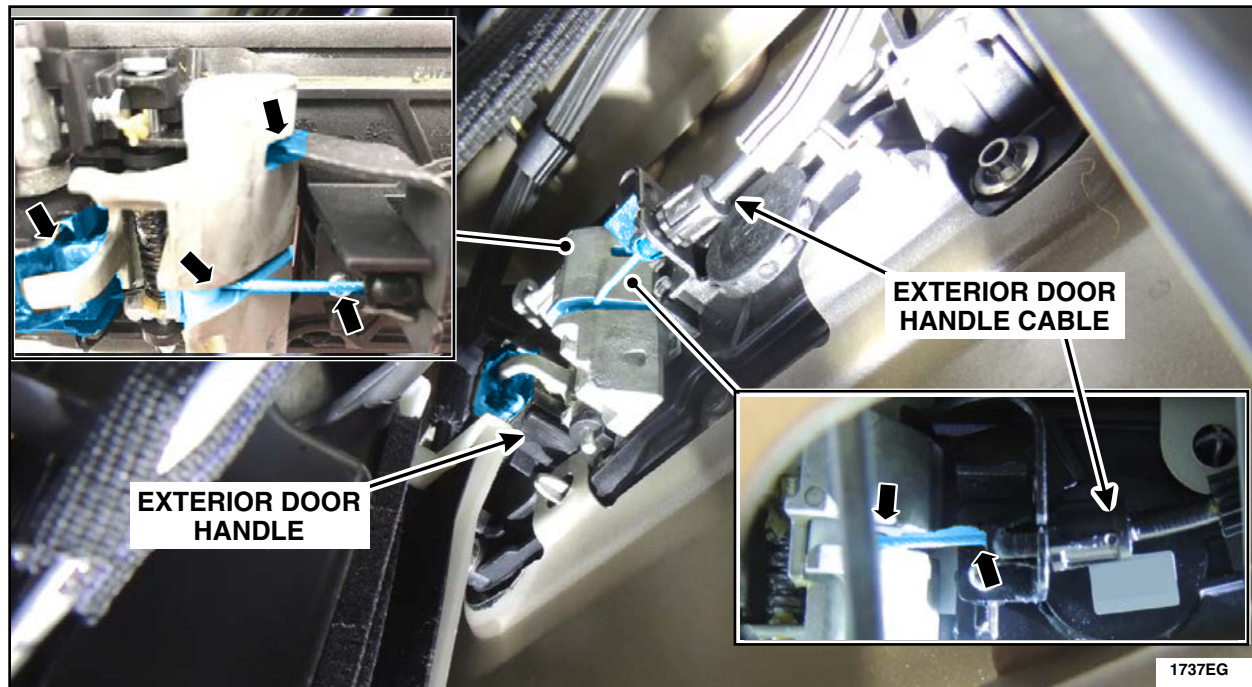
FIGURE 28a

15. Through the large door sheet metal opening, use a brush to apply a light film of Motorcraft® XG-16 low temperature grease to the exterior door handle cable end, and to the three additional highlighted areas. See Figures 28a and 28b.

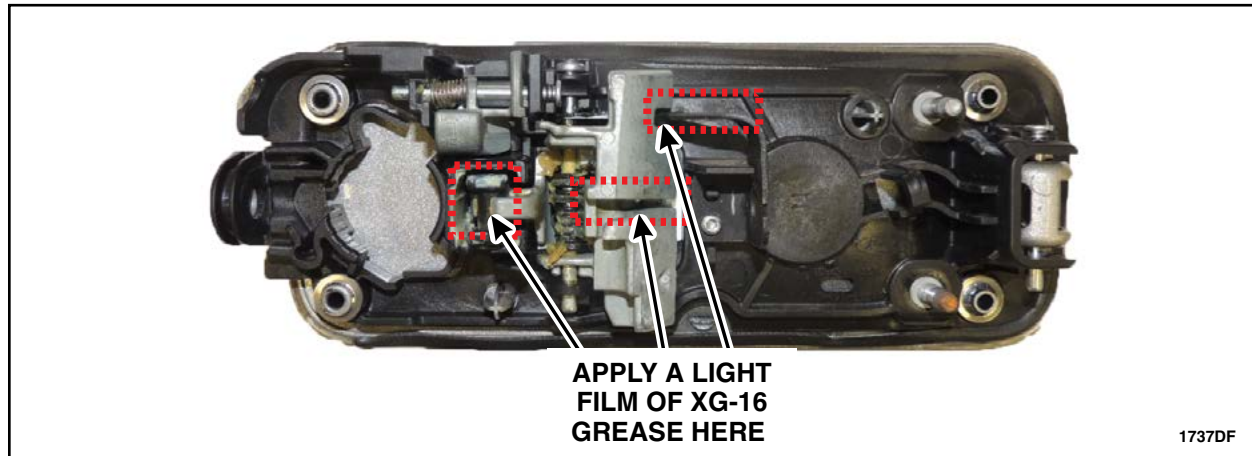
**FIGURE 28b**

**NOTE:** The exterior door handle is removed for clarity.

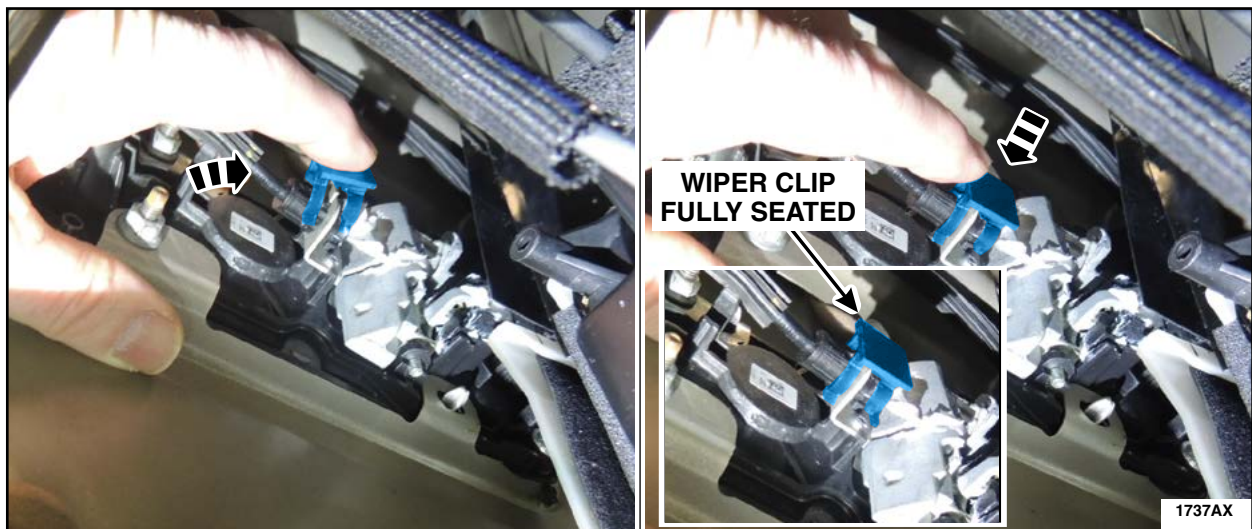
**FIGURE 29**

16. Install the handle cable wiper clip on the exterior door handle cable end. See Figure 29.

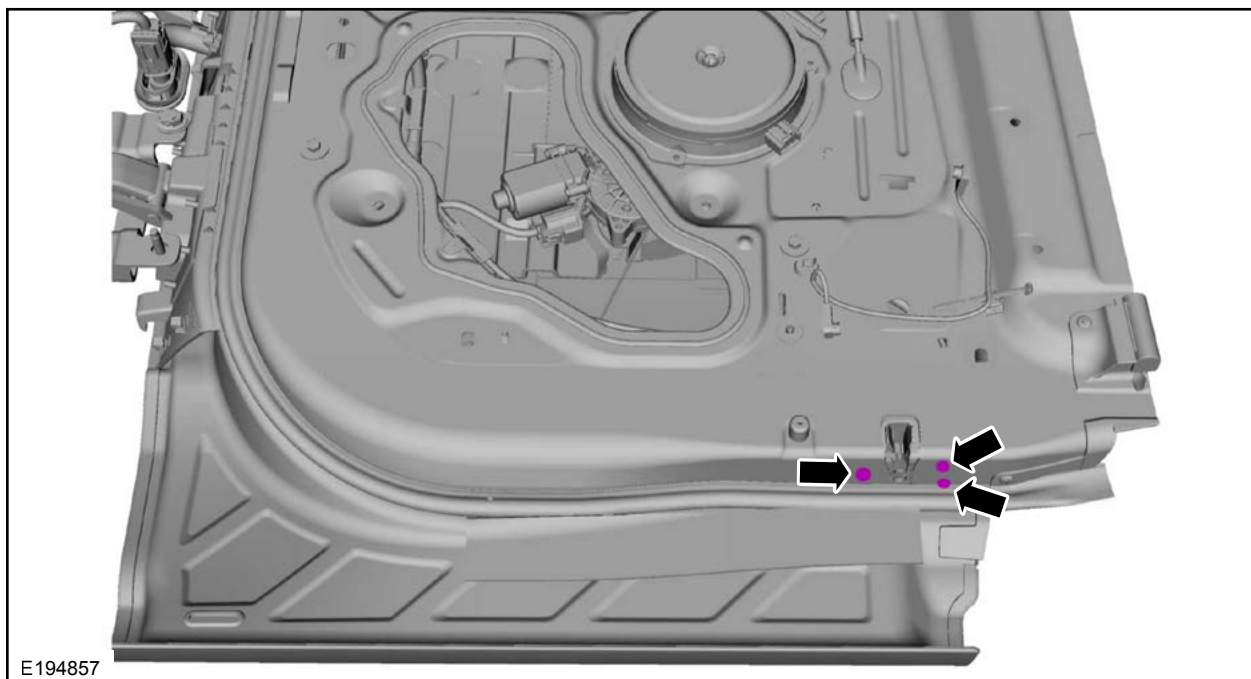
**FIGURE 30**

1. Remove the rear door interior trim panels. Please follow the WSM procedures in Section 501-05.
2. Remove the door panel weather shields for access.
3. Inspect the interior door handle to latch cable for kinking. See Figure 31.
  - Correct any kinks found in the cable by straightening the cable by hand as required.
4. Remove the three lower door latch bolts. See Figure 30.

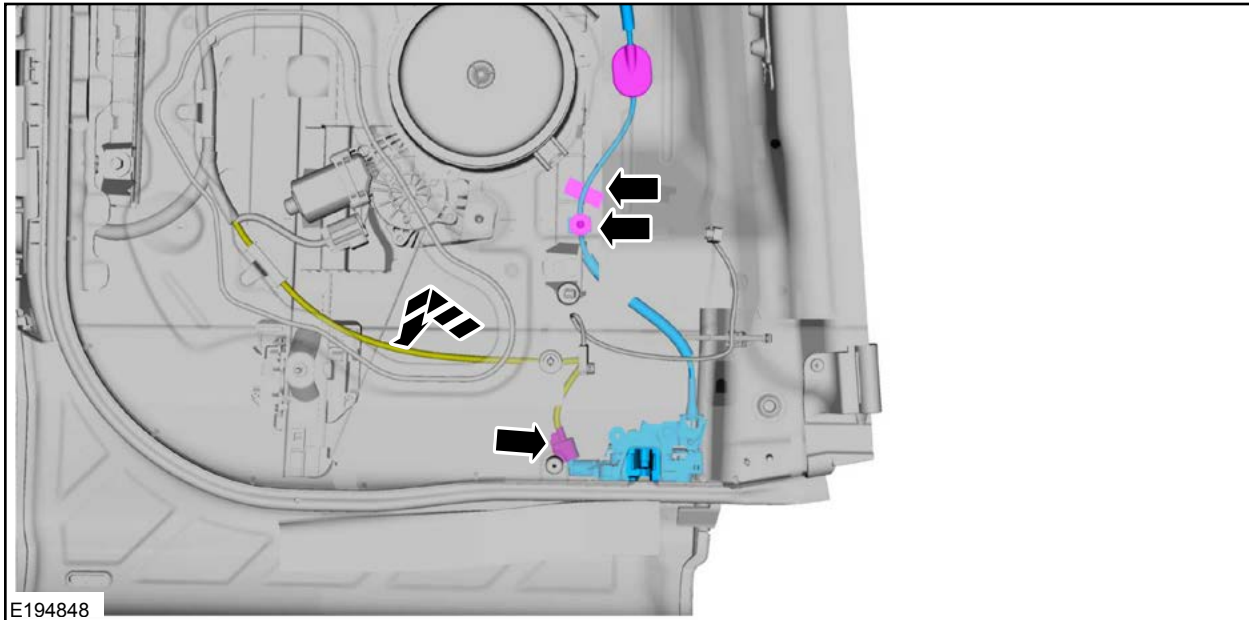
FIGURE 31

5. Detach the cable retainers and disconnect the electrical connector. Position the rear door latch outside of the door. See Figure 31.

9. Position the rear door lower latch back into the door. Attach the cable retainers and connect the electrical connector. See Figure 31.
10. Install the three lower door latch bolts. See Figure 30.
  - 106 lb.in (12 Nm).
11. Install the door panel weather shields.
12. Install the rear door interior trim panels. Please follow the WSM procedures in Section 501-05.
