**SUBJECT: NEW VEHICLE DEMONSTRATION / DELIVERY HOLD - Safety Recall 17S33 - Supplement #4**

Certain 2015-2017 Model Year F-150 and 2017 Model Year F-Super Duty Vehicles  
 Doors Will Not Close or Open While Driving

## CERTAIN 2015-2017 MODEL YEAR F-150 AND 2017 MODEL YEAR F-SUPER DUTY VEHICLES — DOORS WILL NOT CLOSE OR OPEN WHILE DRIVING

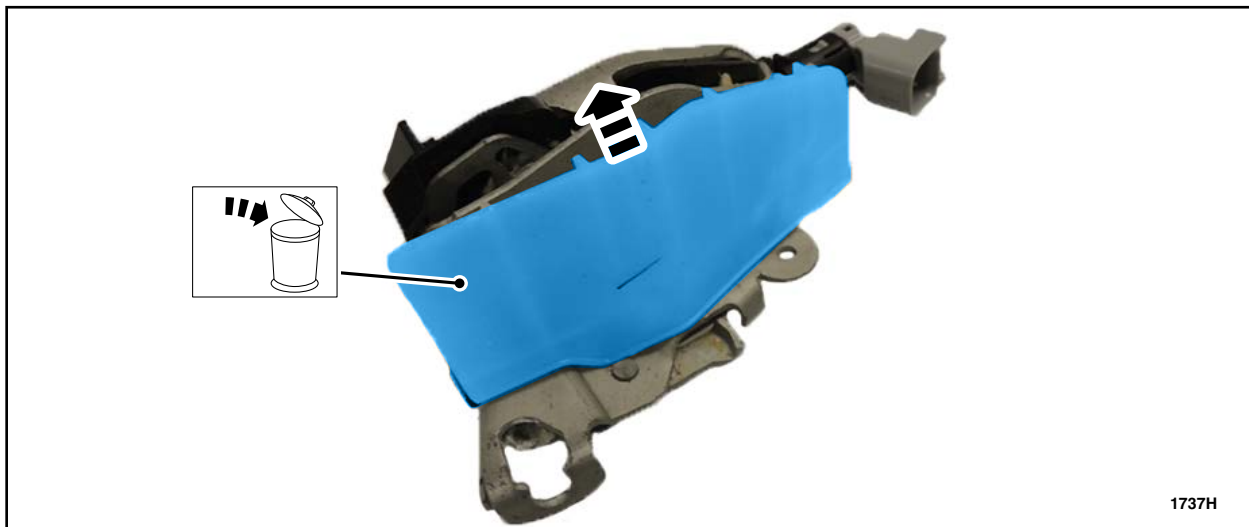
FIGURE 32

**NOTE:** Some F-150 SuperCab vehicles may be equipped with a smaller water shield than what is being installed in this safety recall. The smaller shields must be removed and replaced. See Figure 32.

6. If equipped with small water shields, remove and discard the existing lower door latch water shields. See Figure 32.

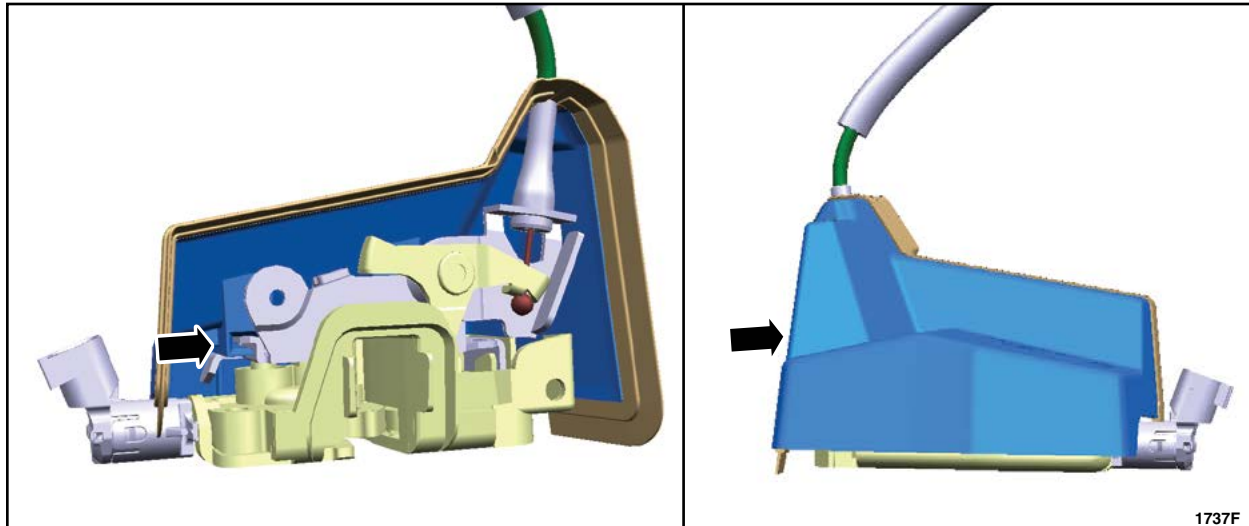
**FIGURE 33**

7. Using compressed air, blow out any debris or residual water from the latch assembly area.
8. Install a *new* door latch water shield onto the lower rear door latch. See Figure 33.

**NOTE:** If the vehicle has previously had a rear lower door latch replaced, it may already have the latest level door latch water shield installed. If the Super Cab rear lower door latch has a large water shield installed as shown in Figure 33, then installation of a new water shield is not required.
