**SUBJECT:** **NEW VEHICLE DEMONSTRATION / DELIVERY HOLD - Safety Recall 17S33 - Supplement #2**  
 Certain 2015-2017 Model Year F-150 and 2017 Model Year F-Super Duty Vehicles  
 Doors Will Not Close or Open While Driving

## CERTAIN 2015-2017 MODEL YEAR F-150 AND 2017 MODEL YEAR F-SUPER DUTY VEHICLES — DOORS WILL NOT CLOSE OR OPEN WHILE DRIVING

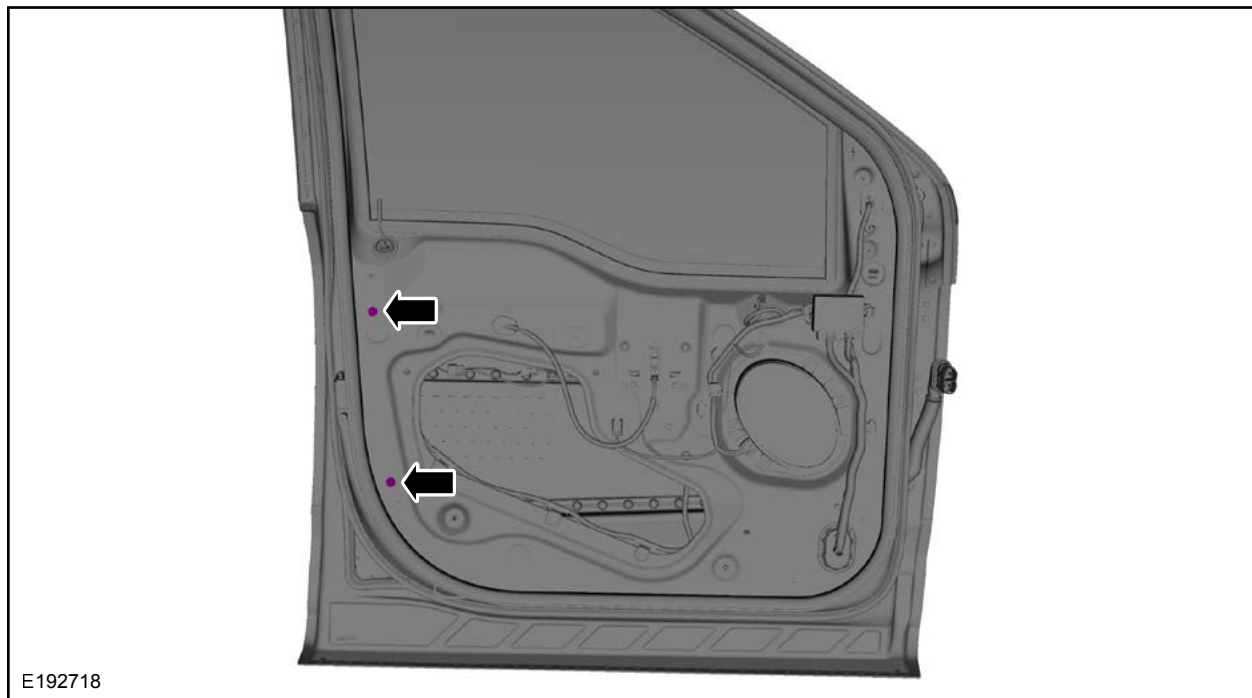
**FIGURE 3**

6. Loosen but do not remove the two door glass run bolts. See Figure 3.

11. Tighten the two door glass run bolts. See Figure 3.

- 71 lb.in (8 Nm).

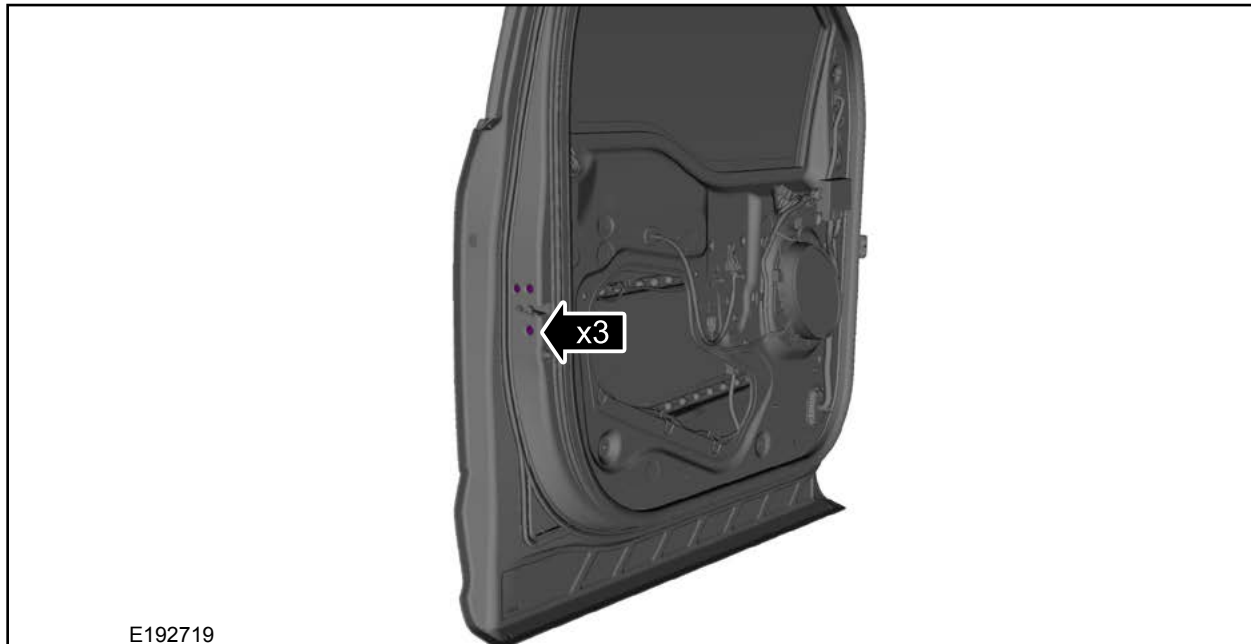
**FIGURE 4**

7. Loosen but do not remove the 3 door latch bolts. See Figure 4.

12. Tighten the three door latch bolts. See Figure 4.

- 71 lb.in (8 Nm).

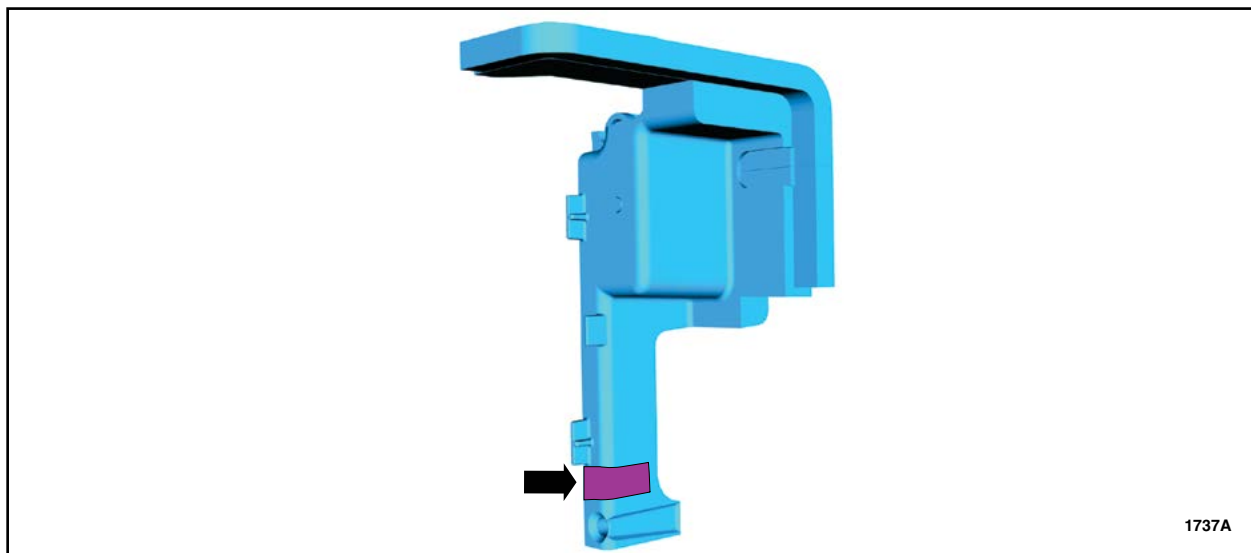
**FIGURE 5**

8. Apply supplied foam tape to the *new* shield in the highlighted area. See Figure 5.

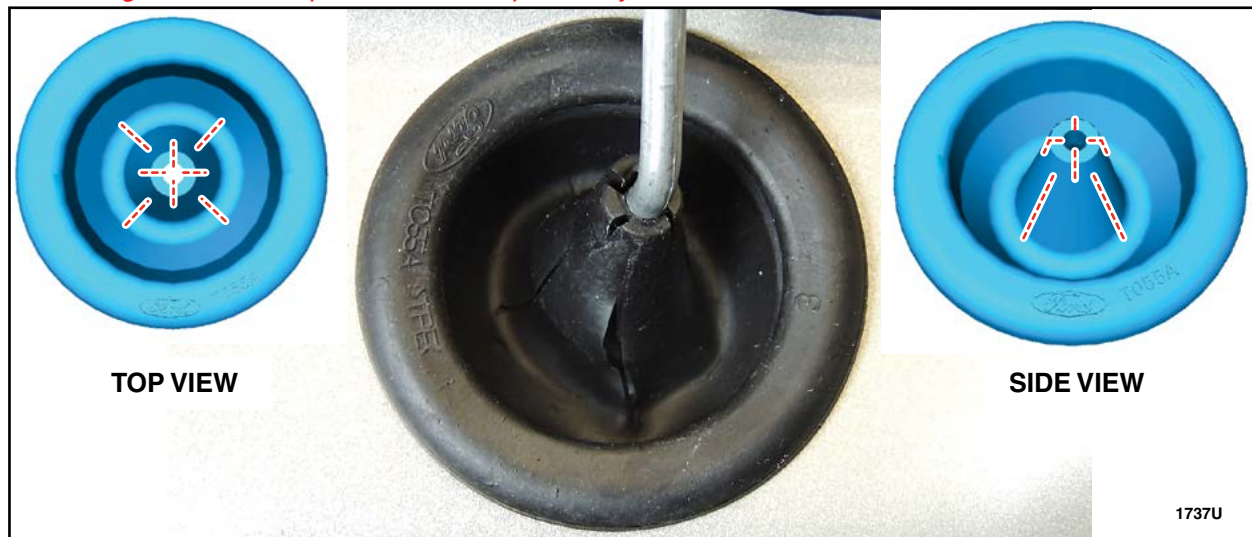
**FIGURE 9**

14. Modify the front door Lock Rod Grommet. See Figure 9.

- a. Using a utility knife, cut four 6 mm (.25 in) long slits approximately 90° apart into the top of the front door lock rod grommet where the lock rod exits the grommet.
- b. Cut four additional 13 mm (.5 in) long slits approximately 90° apart on the inner sides of the grommet 45° separated from the previously cut slits.

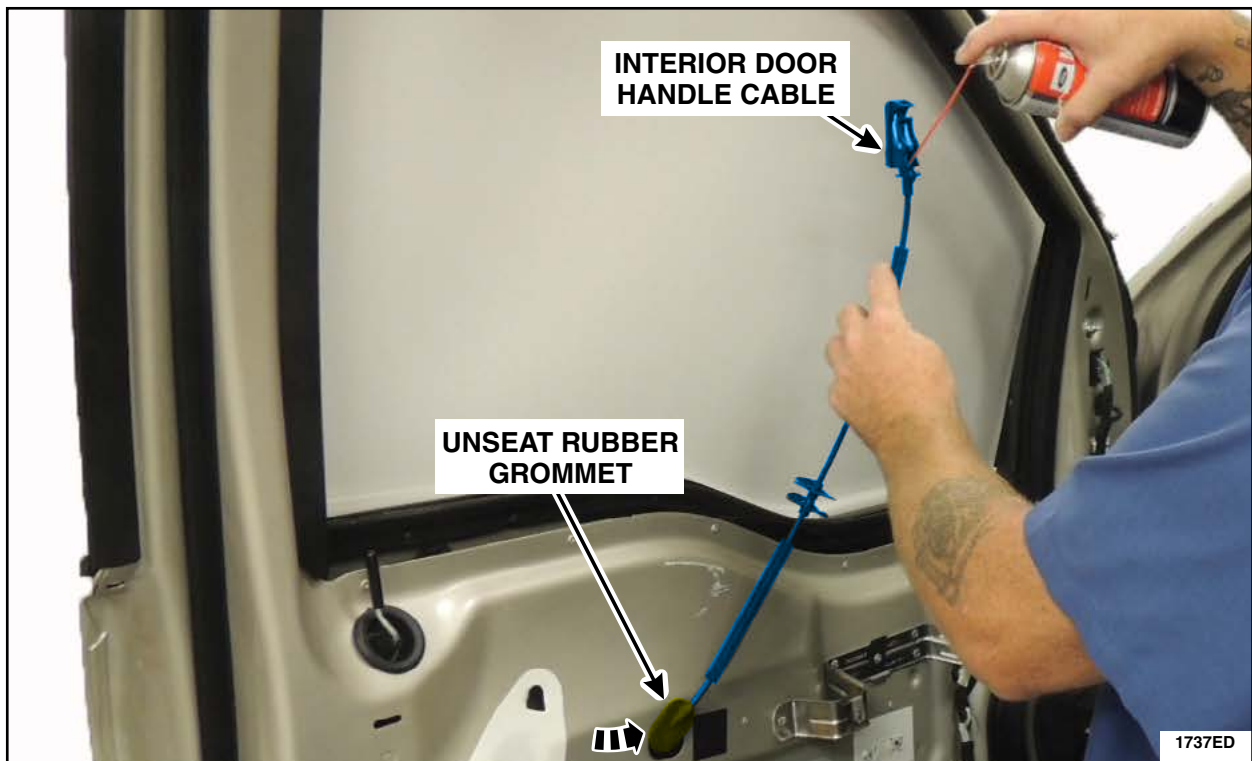
**FIGURE 11**

17. Unseat the interior door handle cable rubber grommet and while holding the end of the cable in an upward position, spray Motorcraft® XL-6 silicone lubricant down into the cable for five seconds. See Figure 11.

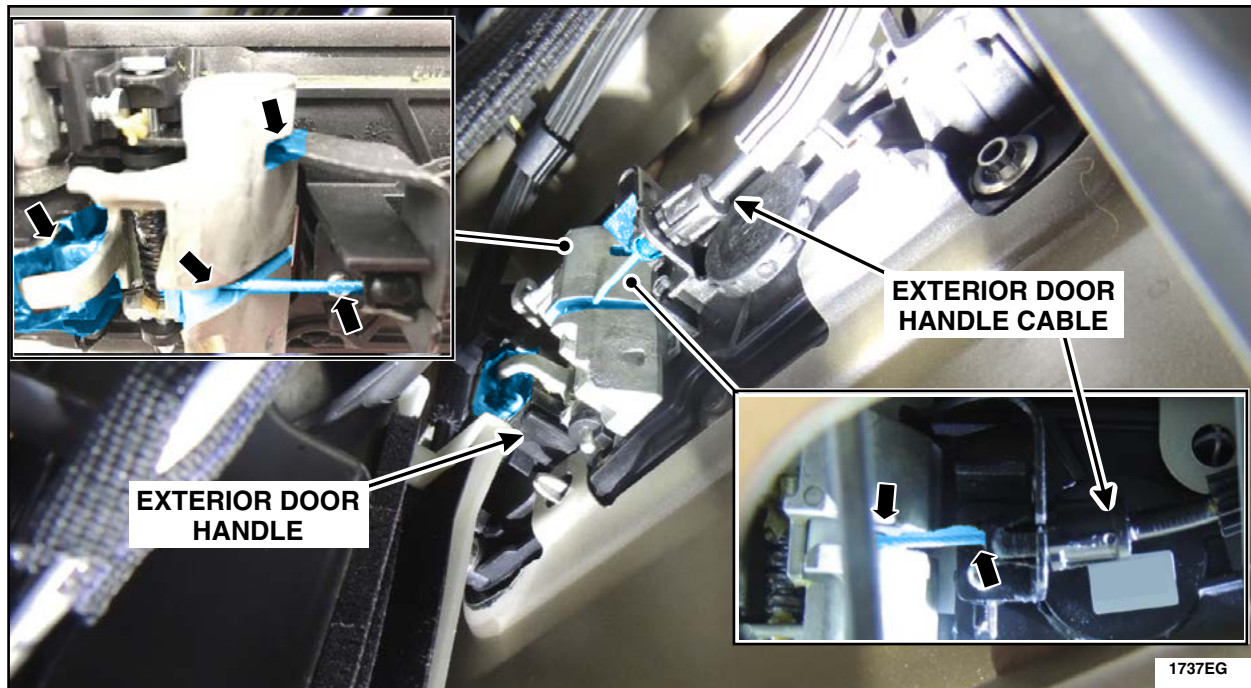
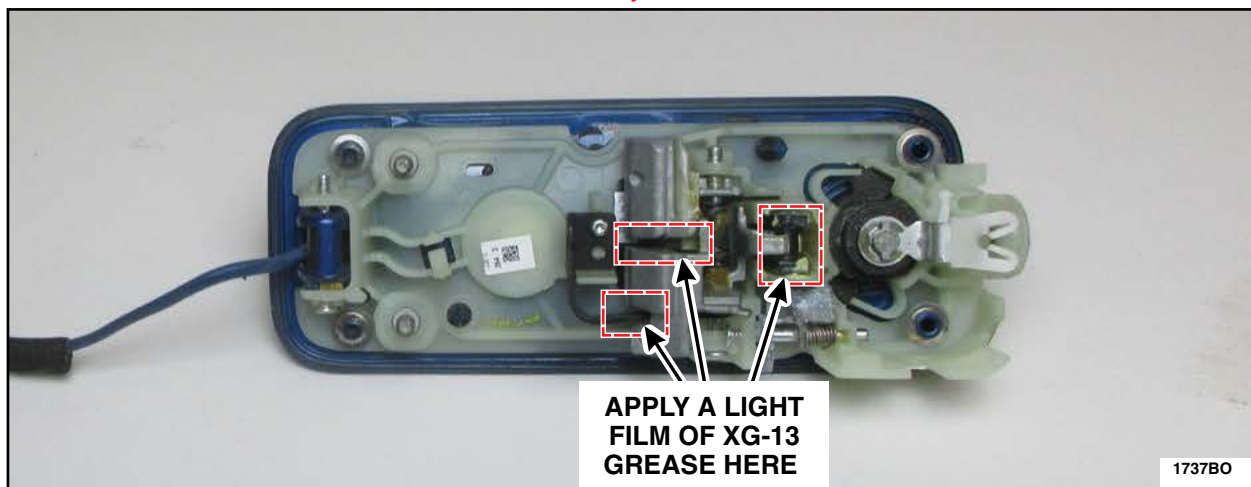
19. Through the large door sheet metal opening, use a brush to apply a light film of Motorcraft® XG-13 door latch grease to the exterior door handle cable end, and to the three additional highlighted areas. See Figures 13a and 13b.

**NOTE:** The exterior door handle is removed for clarity.

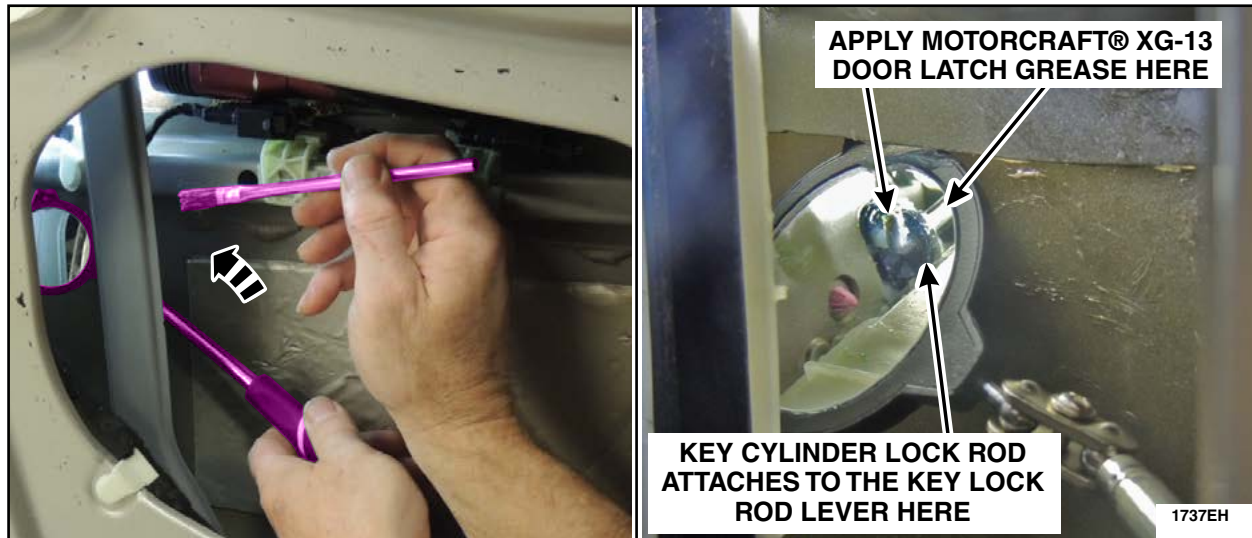
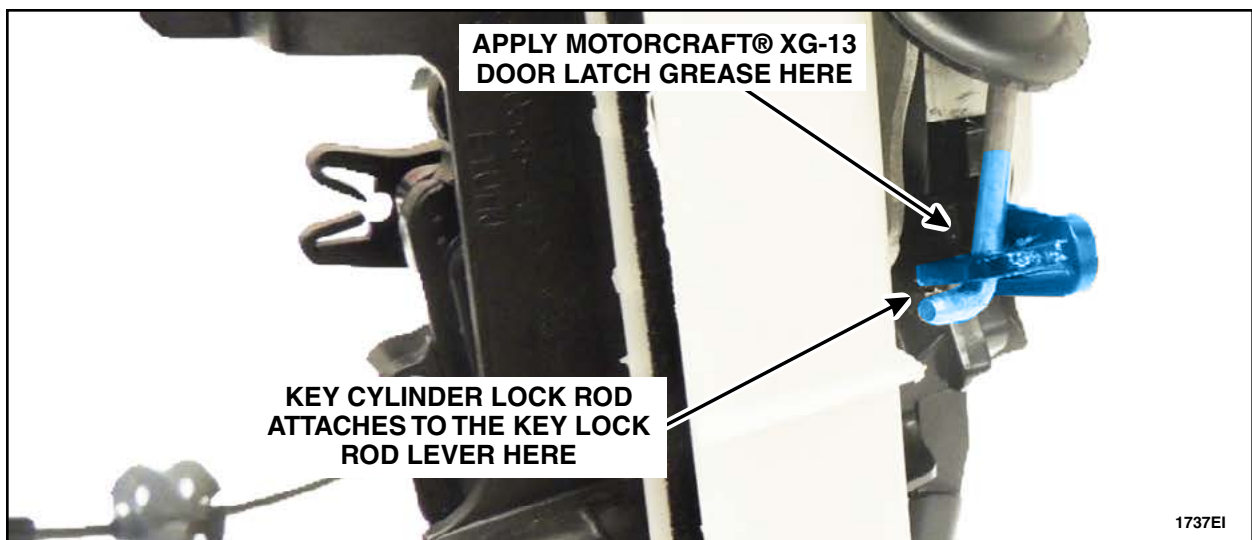
20. For driver side only, use an inspection mirror to locate and liberally apply Motorcraft® XG-13 door latch grease to the area where the key cylinder lock rod attaches to the key lock rod lever.  
See Figures 14 and 15.

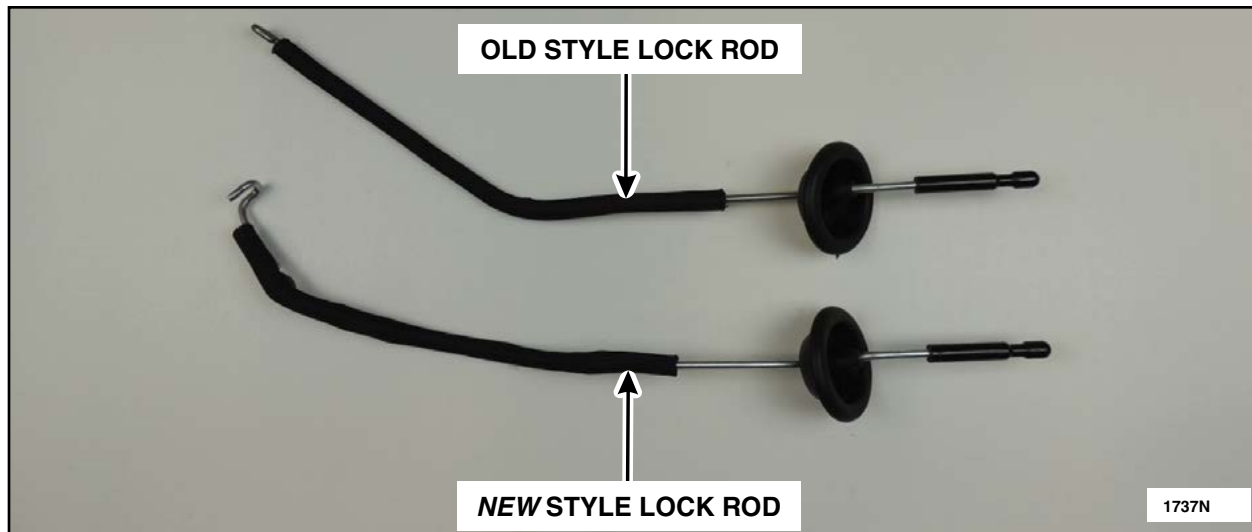
Yes - Install a *new* lock rod to accommodate the *new* water shield. See Figure 19 and 20.

No - Verify the vehicle has the updated lock rod shown in Figure 20 and proceed to Step 9.

- For replacement lock rods only. Transfer the grommet , sleeve and button from the original lock rod to the *new*.
- Apply a bead of Motorcraft® instant gel adhesive TA-19-C (or equivalent) to the lock rod prior to threading the button into place.
- When threading the button onto the *new* lock rod, stop threading when some resistance is met.
- Ensure the right-hand and left-hand buttons are installed at similar heights.

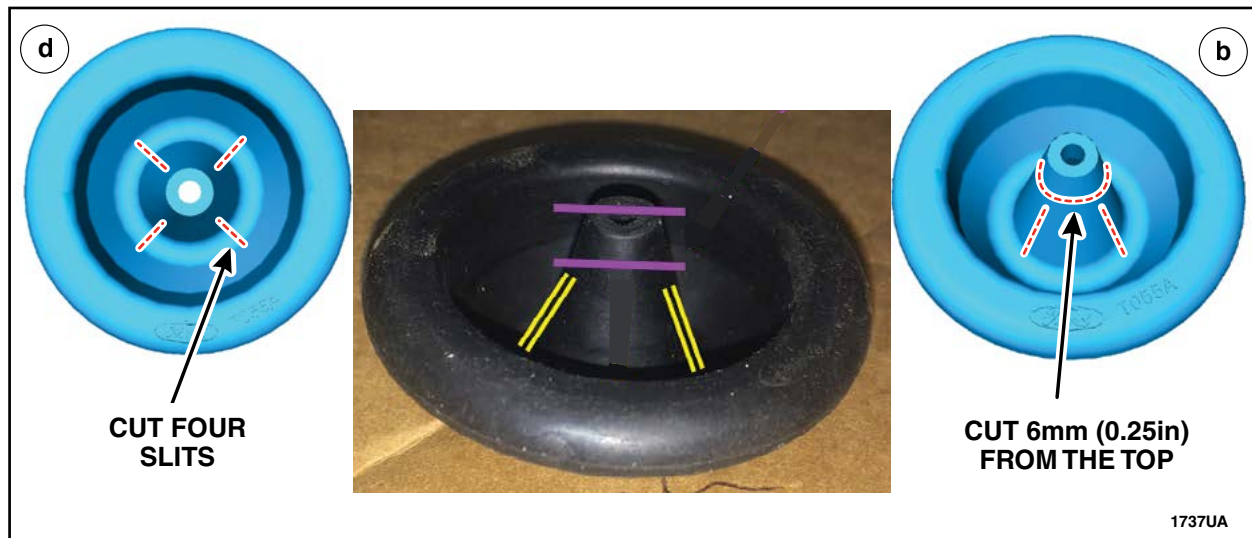
**FIGURE 21**

9. Modify the rear door lock rod grommet. See Figure 21.

- Remove the rear door lock rod grommet from the lock rod.
- Cut approximately 6 mm (0.25 in) off the top of the grommet.
- Install the rear door lock rod grommet back onto the lock rod.
- Using a utility knife, cut four 6 mm (0.25 in) long slits approximately 90° apart into the lower portion of the rear door lock rod grommet.

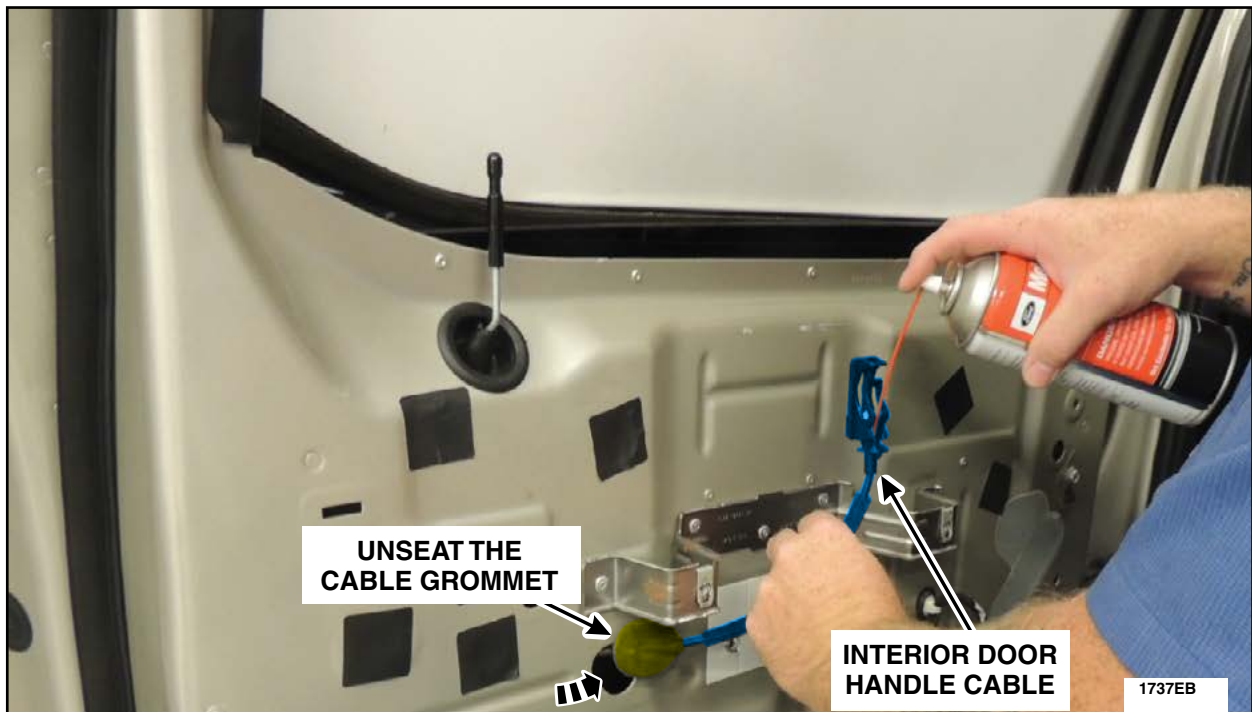
**FIGURE 23**

11. Unseat the interior door handle cable rubber grommet and while holding the end of the interior door handle cable in an upward position, spray Motorcraft® XL-6 silicone lubricant for five seconds down into the cable. See Figure 23.

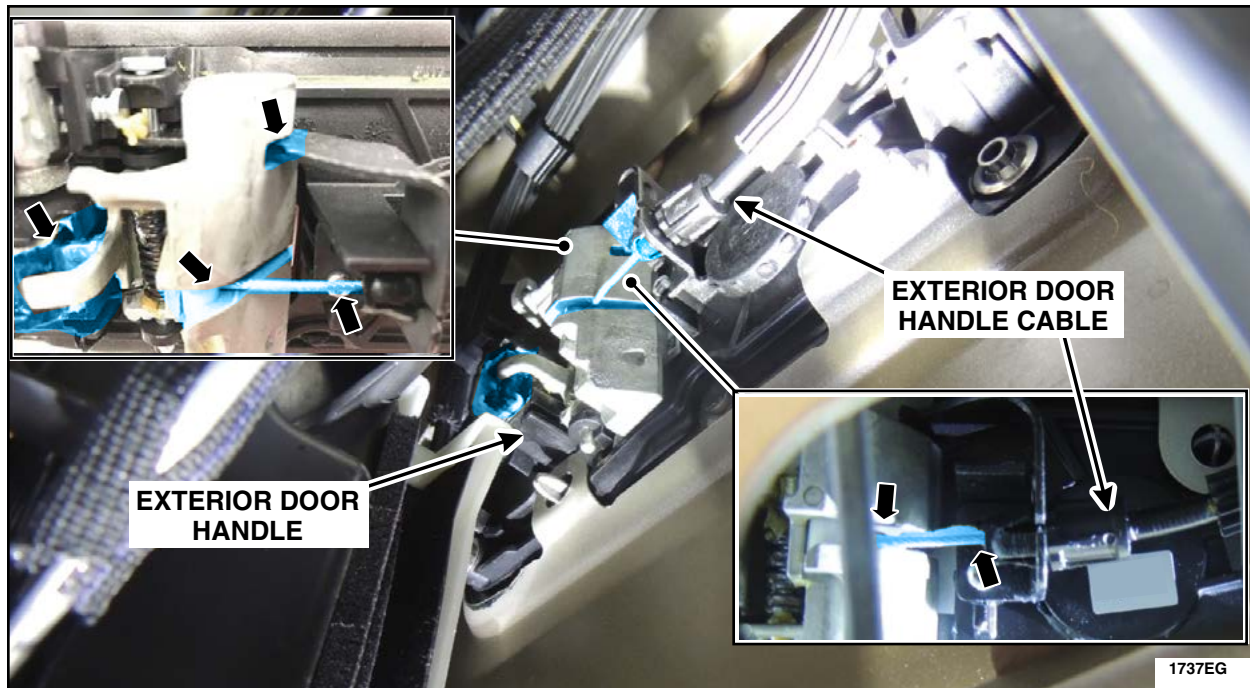
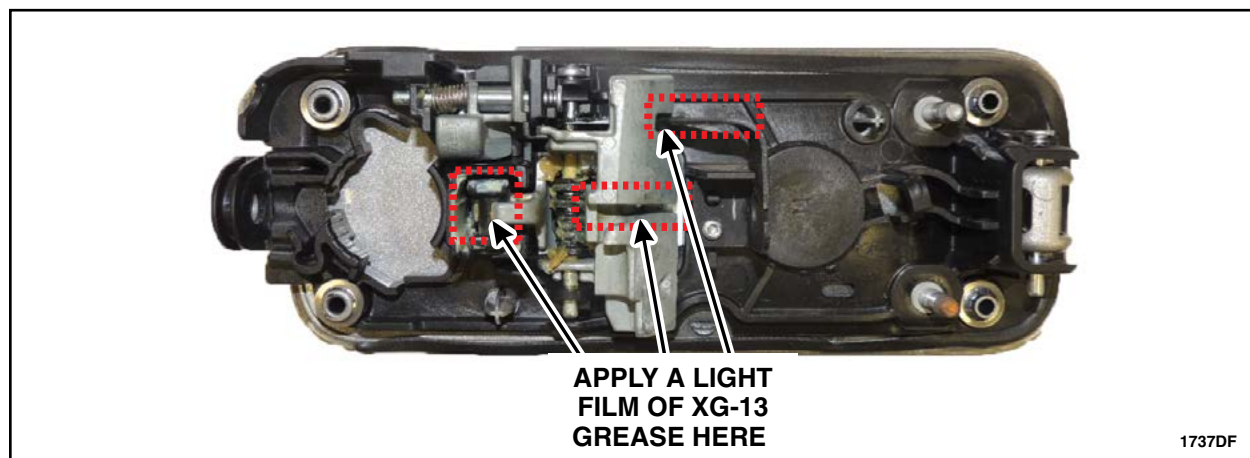
13. Through the large door sheet metal opening, use a brush to apply a light film of Motorcraft® XG-13 door latch grease to the exterior door handle cable end, and to the three additional highlighted areas. See Figures 25a and 25b.

**NOTE:** The exterior door handle is removed for clarity.
