**IMPORTANT SAFETY RECALL**  
**NHTSA Recall# 17V-603**

**Subject:** Counterbalance Tube Weld Campaign  
**Date:** 9/21/2017      **Rev.-Date:** FR      **No.:** B17005  
**Re.:** Welded Repair      **Type:** Safety  
**Priority:** Immediate  
**Units Affected:** See attached VIN listing.

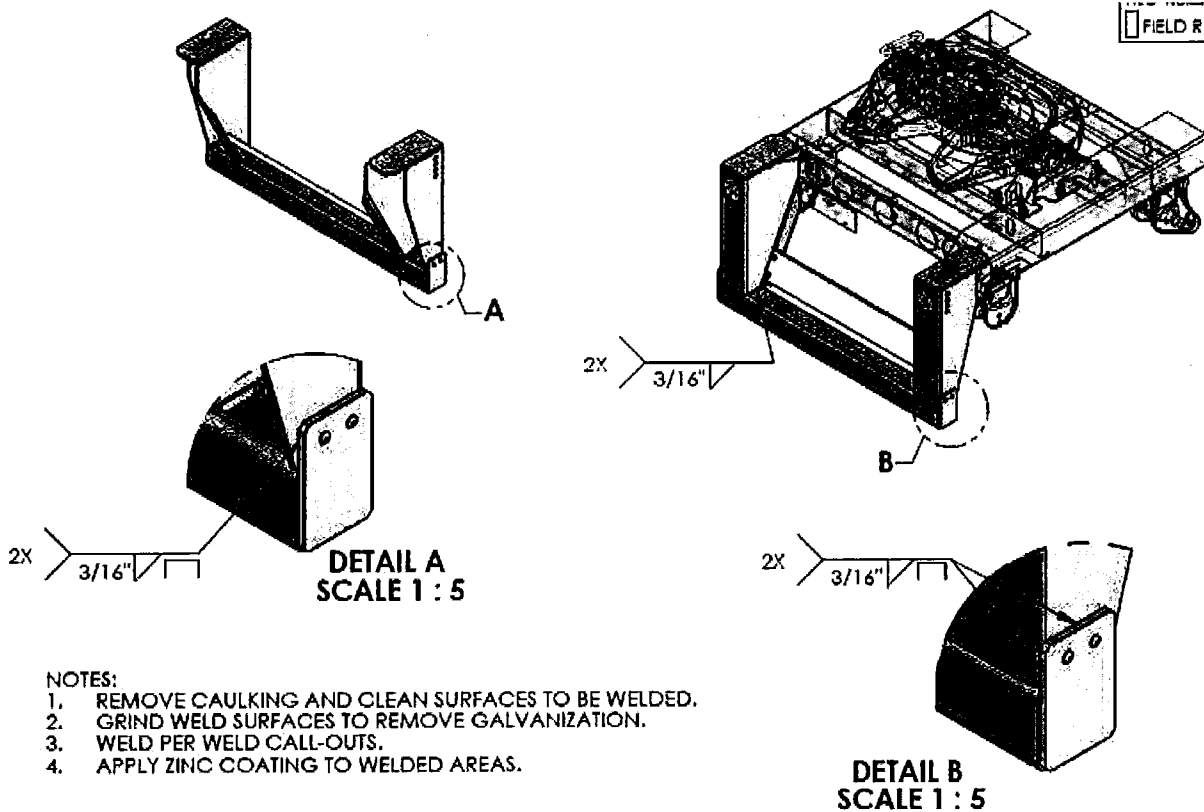
**Step 3:** Add all needed welds per the attached print directly below.

- NOTES:**
1. REMOVE CAULKING AND CLEAN SURFACES TO BE WELDED.
  2. GRIND WELD SURFACES TO REMOVE GALVANIZATION.
  3. WELD PER WELD CALL-OUTS.
  4. APPLY ZINC COATING TO WELDED AREAS.
