**TECHNICAL INSTRUCTIONS  
FOR  
SAFETY RECALL HLA  
FRONT PASSENGER AIRBAG MODULE  
CERTAIN 2007 – 2009 MY ES 350  
UPDATED 1-9-2018**

Update 1-9-2018

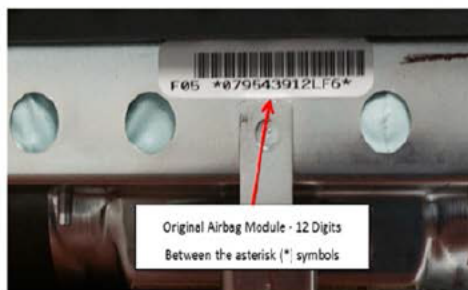
Record Airbag Serial Number

#### How to Identify an Airbag module Assembly number?

The Airbag module Assembly serial number is a 12 digit code. It can be found along with a bar code on opening the Airbag assembly unit. To manually enter these details into the application, the technician has to identify the 12 digit code between two Asterisks (\*) inside the Airbag assembly unit. The first seven characters of this 12 digit code are numbers and the 10<sup>th</sup> digit is either 'K' or 'L' always.

- The airbag serial number is **ALWAYS** the 12 **DIGITS** located between the asterisks.
- The 3 digits before the asterisk **ARE NOT** part of the serial number, and **SHOULD NOT** be entered or an inaccurate response may be returned.

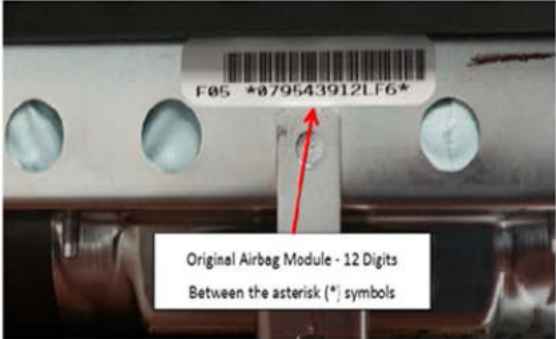
a) If the airbag serial number cannot be scanned or is not present check the box as shown below.

**Check this box if the label is damaged or missing**
