## TECHNICAL INSTRUCTIONS FOR SAFETY RECALL G0P FRONT PASSENGER AIRBAG INFLATOR MODULE CERTAIN 2010-2013 MY 4Runner

### UPDATE 7-17-18

## II. BACKGROUND

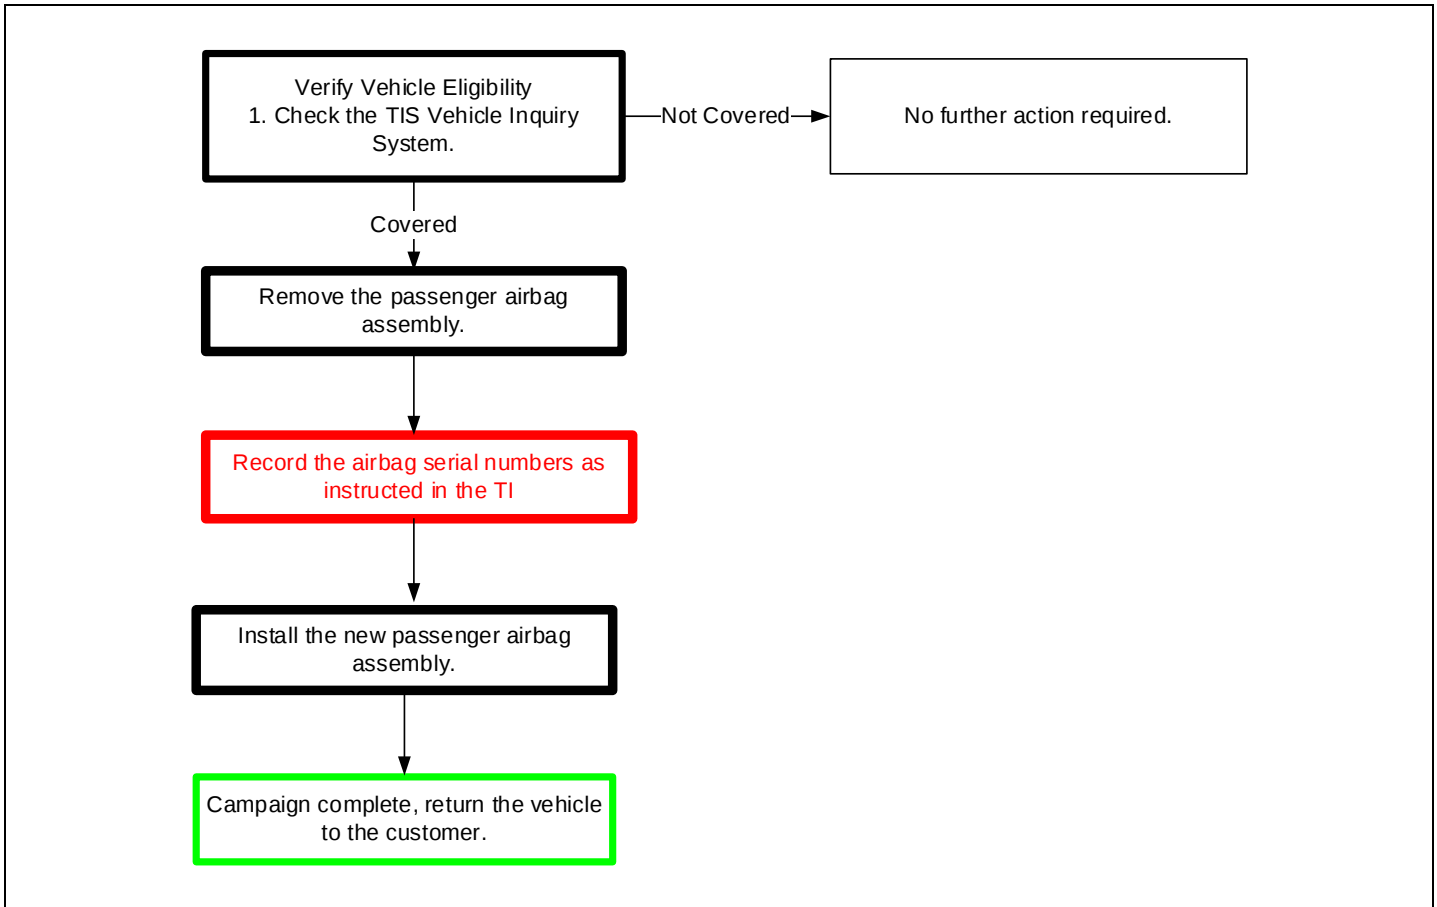
## I. OPERATION FLOW CHART

The flow chart is for reference only. **DO NOT** use it in place of the full technical instructions. Follow **ALL** steps as outlined in the full technical instructions to confirm the campaign is completed correctly.

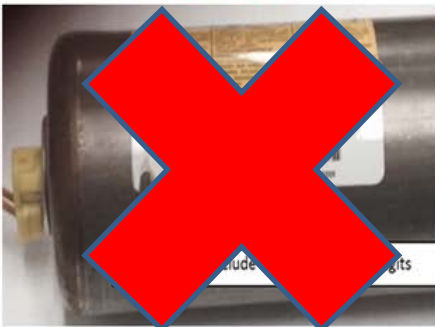
**Original Inflator**

How to Identify the Inflator serial code on the Original and Replacement Inflator can?

The Inflator serial code is an 11 digit code on the Inflator can. It can be found with a bar code on removing the Inflator can from the Airbag Assembly unit.

The first two characters of the Original Inflator Serial code will be from [AA, AB, AJ, FD or JD].

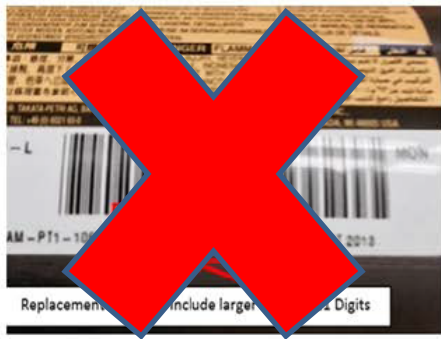
**Replacement Inflator**

The first two characters of the Replacement Inflator Serial code will be either 'LT' or 'LR'.

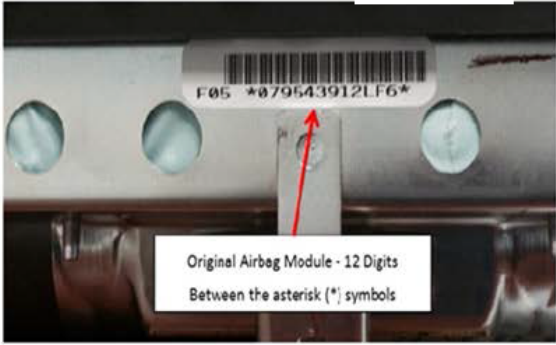
Original Airbag Module - 12 Digits  
Between the asterisk (\*) symbols

Check this box if the label is damaged or missing

a) If the airbag serial number cannot be scanned or is not present check the box as shown below.
