## TECHNICAL INSTRUCTIONS FOR SAFETY RECALL GLH FRONT PASSENGER AIRBAG INFLATOR REPLACEMENT CERTAIN 2007 – 2010 MY ES 350

**UPDATED 4-18-2018**

The subject vehicles are equipped with front passenger airbag inflators produced by Takata. The propellant in these inflators may degrade after prolonged exposure to high absolute humidity and fluctuating high temperatures. Degraded propellant can cause inflator rupture during airbag deployment. In the event of an inflator rupture, metal fragments could pass through the airbag cushion material, striking the vehicle occupants, and result in serious injury or death.

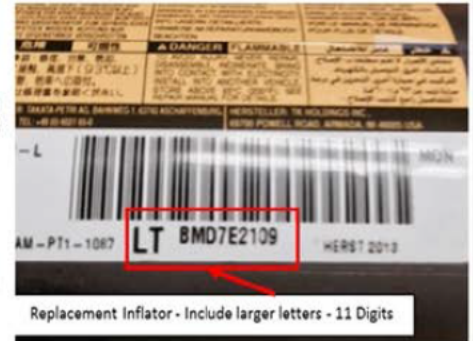
### Replacement Inflator

The first two characters of the Replacement Inflator Serial code will be either 'LT' or 'LR'.
