## TECHNICAL INSTRUCTIONS FOR SAFETY RECALL GLG FRONT PASSENGER AIRBAG MODULE CERTAIN 2010-2013 MY GX 460 **UPDATED 4-18-2018**

The subject vehicles are equipped with front passenger airbag inflators produced by Takata. The propellant in these inflators may degrade after prolonged exposure to high absolute humidity and fluctuating high temperatures. Degraded propellant can cause inflator rupture during airbag deployment. In the event of an inflator rupture, metal fragments could pass through the airbag cushion material, striking the vehicle occupants, and result in serious injury or death.

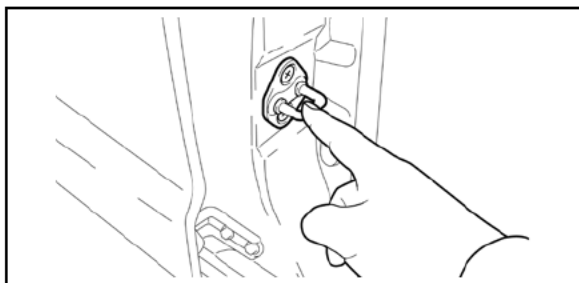
#### 1. ELIMINATE STATIC ELECTRICITY

- Before starting work and periodically while working on the vehicle, touch a metallic part of the vehicle to discharge static electricity in the body.

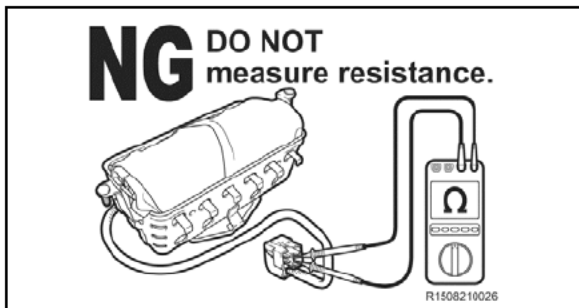
#### 2. DO NOT MEASURE RESISTANCE

- NEVER** measure the resistance of an airbag, this may cause accidental activation.

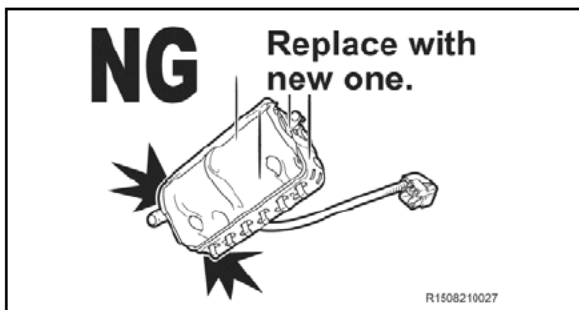
#### 3. HANDLE THE AIRBAG CAREFULLY

- If the airbag is dropped, replace it with a **NEW** one.

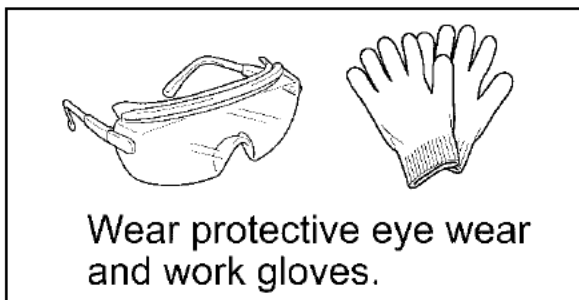
#### 4. WEAR PROTECTIVE EQUIPMENT

- Always wear appropriate protective equipment when working on the SRS.

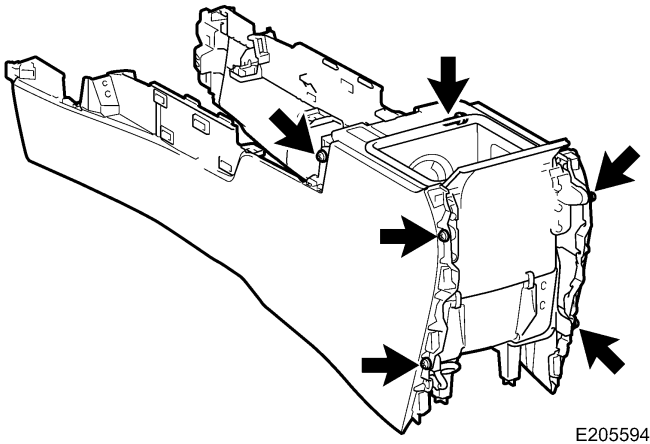
for LH side:

for RH side:

- c) Reengage the 6 claws on each side of the console as shown.
