## TECHNICAL INSTRUCTIONS FOR SAFETY RECALL HLA FRONT PASSENGER AIRBAG INFLATOR REPLACEMENT CERTAIN 2007 – 2009 MY ES 350

**UPDATED 4-18-2018**

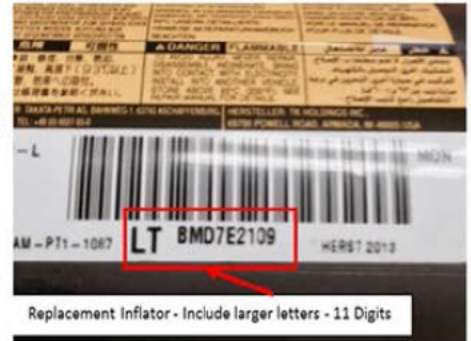
### Replacement Inflator

The first two characters of the Replacement Inflator Serial code will be either 'LT' or 'LR'.

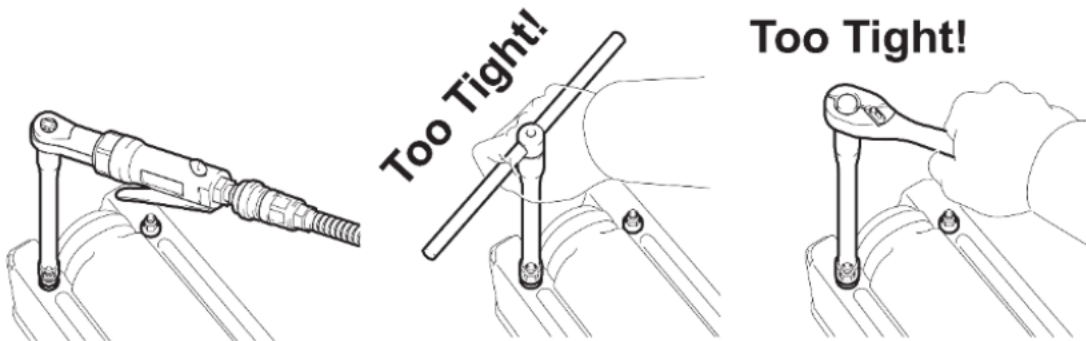
R1701260011Z01

- There will be some resistance when tightening the nuts because they are self-locking, confirm the nuts are tightened correctly.
- **DO NOT** use a power tool, T-handle, or ratchet when tightening the nuts to avoid over torqueing and deforming the studs.
- You may need to slide the airbag to the left or right with in the mounting bracket to access the center nut.

**OK**

**These tools cause overtightening !**
