TECHNICAL INSTRUCTIONS
FOR
SAFETY RECALL HLA
FRONT PASSENGER AIRBAG INFLATOR REPLACEMENT
CERTAIN 2007 – 2008 MY ES 350

I. OPERATION FLOW CHART

II. BACKGROUND

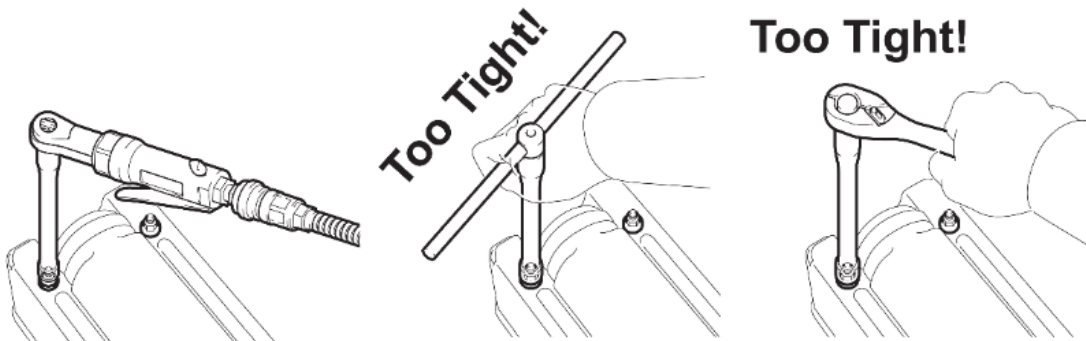
R1701260011Z01

Torque: 35 in. lbf (3.9N·m)

- There will be some resistance when tightening the nuts because they are self-locking, confirm the nuts are tightened correctly.
- **DO NOT** use a power tool, T-handle, or ratchet when tightening the nuts to avoid over torqueing and deforming the studs.
- You may need to slide the airbag to the left or right with in the mounting bracket to access the center nut.

These tools cause overtightening !
