**TECHNICAL INSTRUCTIONS**  
**FOR**  
**SAFETY RECALL HLA**  
**FRONT PASSENGER AIRBAG MODULE**  
**CERTAIN 2007 – 2008 MY ES 350**

## II. BACKGROUND

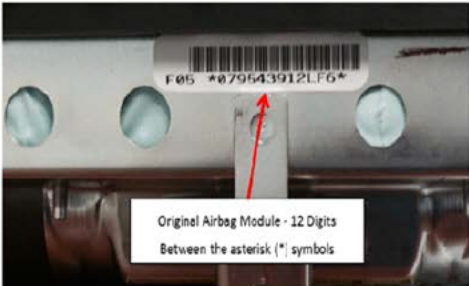
#### Airbag Serial Number Label Example

### AIRBAG SERIAL NUMBER IDENTIFICATION

- The airbag serial number is **ALWAYS** the 12 **DIGITS** located between the asterisks.
- The 3 digits before the asterisk **ARE NOT** part of the serial number, and **SHOULD NOT** be entered or an inaccurate response may be returned.

Original Airbag Module - 12 Digits  
Between the asterisk (\*) symbols

The Airbag module Assembly serial number is a 12 digit code. It can be found along with a bar code on opening the Airbag assembly unit. To manually enter these details into the application, the technician has to identify the 12 digit code between two Asterisks (\*) inside the Airbag assembly unit. The first seven characters of this 12 digit code are numbers and the 10<sup>th</sup> digit is either 'K' or 'L' always.
