# IMPORTANT UPDATE

## TECHNICAL INSTRUCTIONS FOR SAFETY RECALL G0P FRONT PASSENGER AIRBAG INFLATOR MODULE CERTAIN 2009 –2013 MODEL YEAR MATRIX

**Updated 1-9-18**

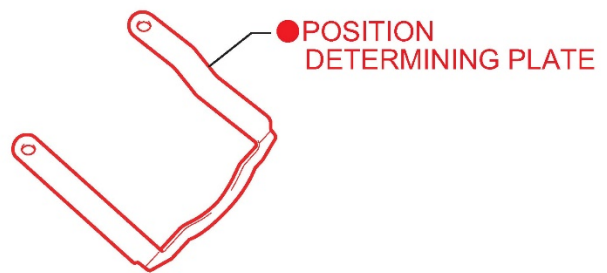
R1702270035

for MATRIX:

● : Replacement part

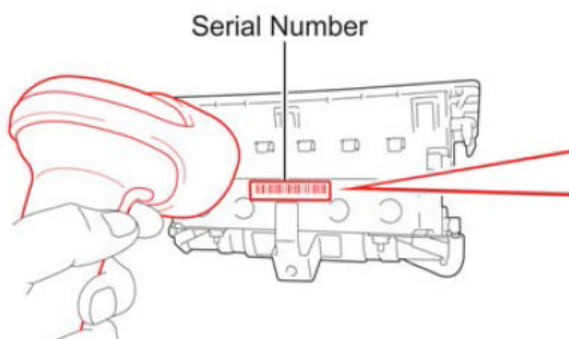
**Airbag Serial Number Label Example**

**AIRBAG SERIAL NUMBER IDENTIFICATION**

- The airbag serial number is **ALWAYS** the 12 **DIGITS** located between the asterisks.
- The 3 digits before the asterisk **ARE NOT** part of the serial number, and **SHOULD NOT** be entered or an inaccurate response may be returned.

The **AIRBAG ASSEMBLY** serial number and the **INFLATOR** serial number are **DIFFERENT**. The **AIRBAG ASSEMBLY** serial number **MUST** be recorded prior to replacement.

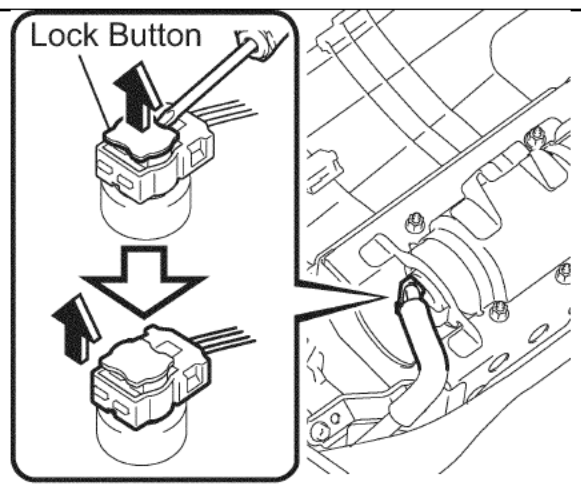
Lock Button

### 2. AIRBAG PREPARATION

- Use a screwdriver to release the lock button.
- Disconnect the connector.
- Disconnect the wire harness clamps.

**NOTE:** Disconnect the connector where the fixed stop plate is located.

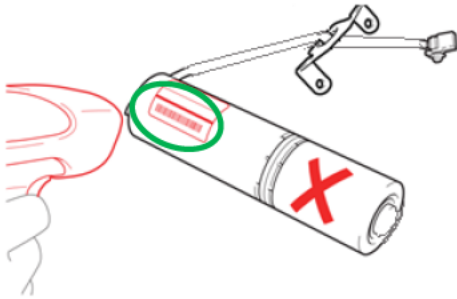
**Step a) Old Inflator (bar code)**

- Scan the **OLD** inflator bar code.
- Scan the **NEW** inflator QR code.

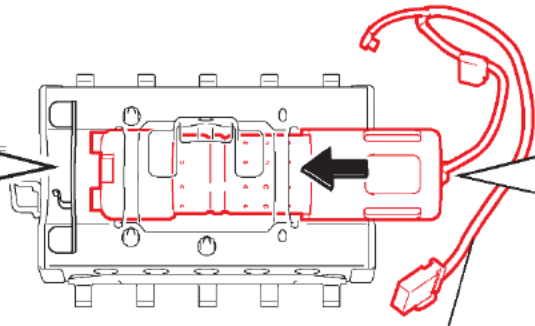
R1702270040

- a) Carefully slide the new inflator into the airbag assembly and align as shown.

- DO NOT** connect the inflator harness at this time. It is **CRITICAL** to first confirm that the inflator is installed in the correct position before connecting the harness.

**DO NOT** insert fully.

Check orientation

Upper side

Bottom
