TECHNICAL INSTRUCTIONS FOR SAFETY RECALL GLG/GLH/HLA FRONT PASSENGER AIRBAG INFLATOR REPLACEMENT CERTAIN 2007 – 2012 MY ES 350

UPDATE 1-15-2019

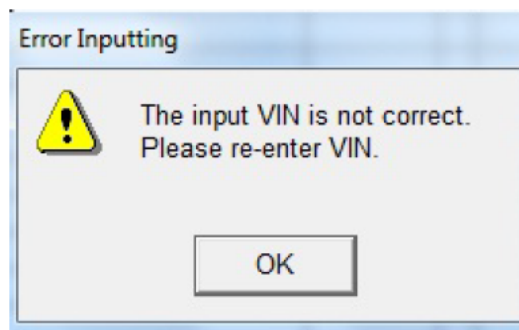
NOTE: If the VIN was not entered in ALL CAPS when Techstream was launched, an error will be displayed and there will be a prompt to reenter the VIN

- Enter the vehicle mileage and repair order information, then click the 'report' button.

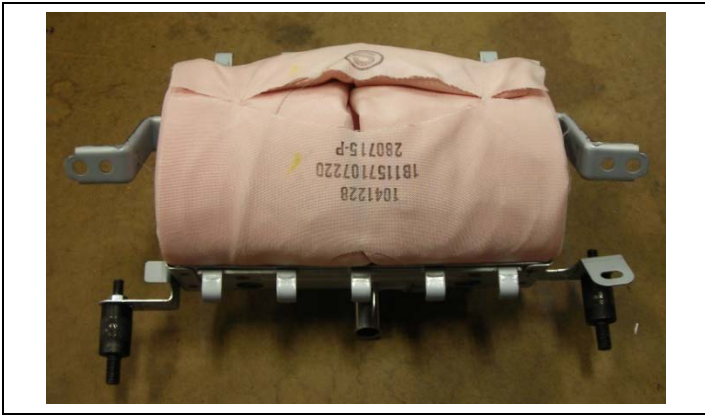
a) Mark the 5 self locking nuts to prevent reuse.

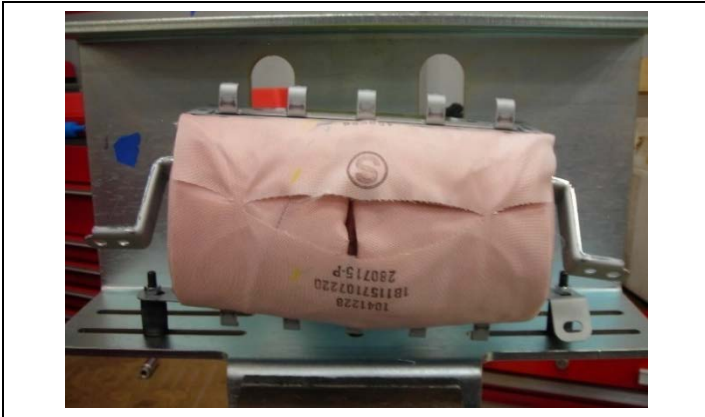
- b) Mount the adaptors (579943-3R3) to the airbag as shown.

NOTE: The 6mm stud mounts to the airbag.

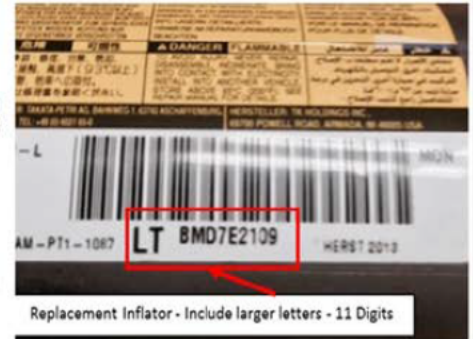
The first two characters of the Replacement Inflator Serial code will be either 'LT' or 'LR'.

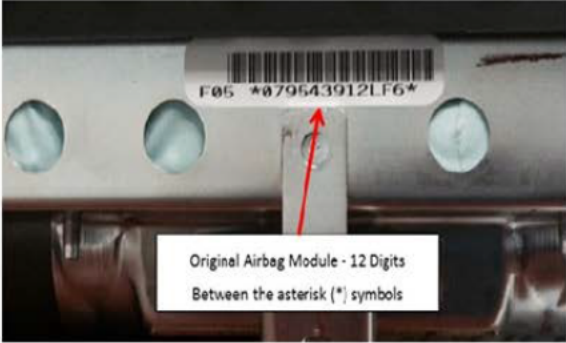
The Airbag module Assembly serial number is a 12 digit code. It can be found along with a bar code on opening the Airbag assembly unit. To manually enter these details into the application, the technician has to identify the 12 digit code between two Asterisks (*) inside the Airbag assembly unit. The first seven characters of this 12 digit code are numbers and the 10th digit is either 'K' or 'L' always.

Original Airbag Module - 12 Digits
Between the asterisk (*) symbols

How to Identify an Airbag module Assembly number?

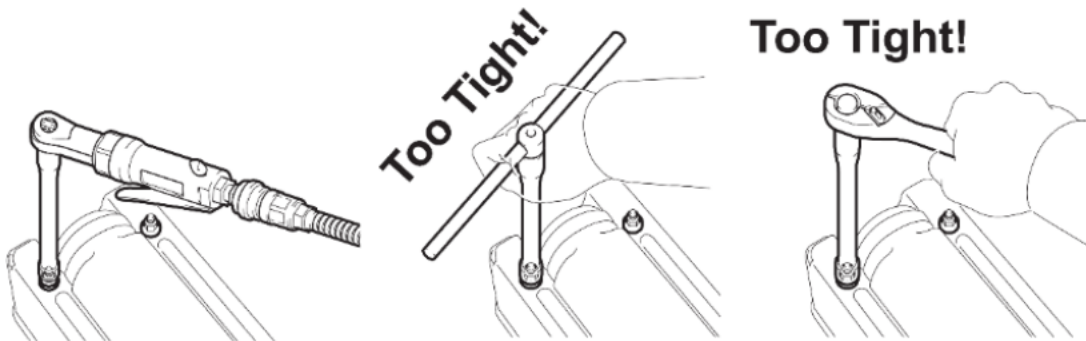
R1701260011Z01

NG

These tools cause overtightening !
