# IMPORTANT UPDATE

## TECHNICAL INSTRUCTIONS FOR SAFETY RECALL GLG/GLH/HLA FRONT PASSENGER AIRBAG MODULE CERTAIN 2010-2017 MY GX 460 **UPDATED 1-15-2019**

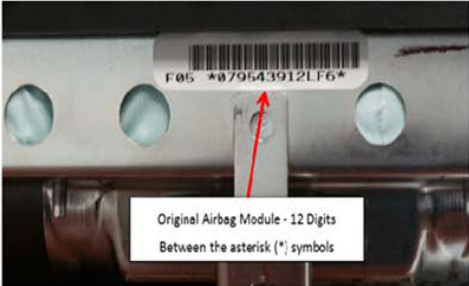
#### Airbag Serial Number Label Example

- The airbag serial number is **ALWAYS** the 12 **DIGITS** located between the asterisks.
- The 3 digits before the asterisk **ARE NOT** part of the serial number, and **SHOULD NOT** be entered or an inaccurate response may be returned.

The Airbag module Assembly serial number is a 12 digit code. It can be found along with a bar code on opening the Airbag assembly unit. To manually enter these details into the application, the technician has to identify the 12 digit code between two Asterisks (\*) inside the Airbag assembly unit. The first seven characters of this 12 digit code are numbers and the 10<sup>th</sup> digit is either 'K' or 'L' always.

Original Airbag Module - 12 Digits  
Between the asterisk (\*) symbols
