### SAFETY RECALL GLG/GLH and HLA

### FRONT PASSENGER AIRBAG MODULE

**CERTAIN 2006 – 2013 MY IS 250/350 and 2008 – 2013 MY IS F**

**Updated 6-14-18**

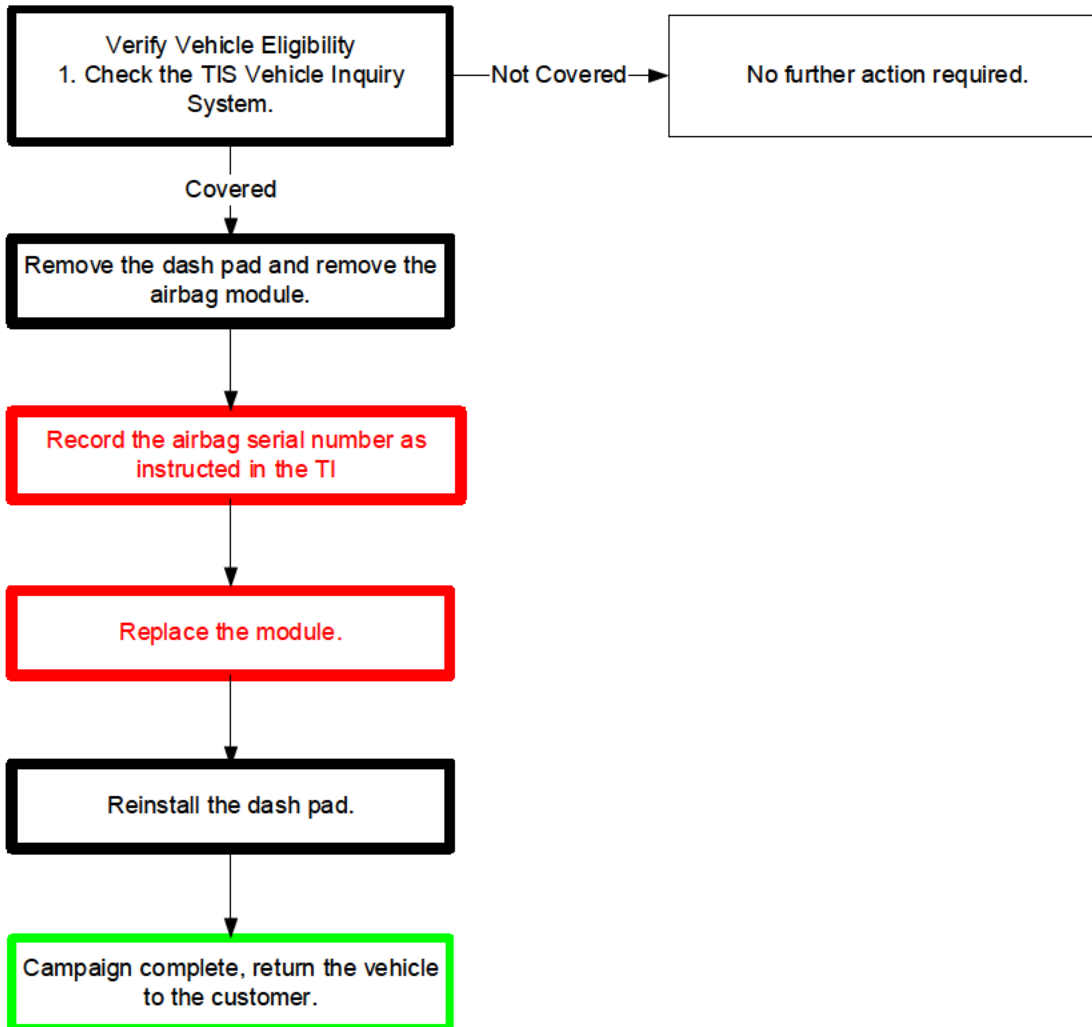
## I. OPERATION FLOW CHART

The flow chart is for reference only. **DO NOT** use it in place of the full technical instructions. Follow **ALL** steps as outlined in the full technical instructions to confirm the campaign is completed correctly.

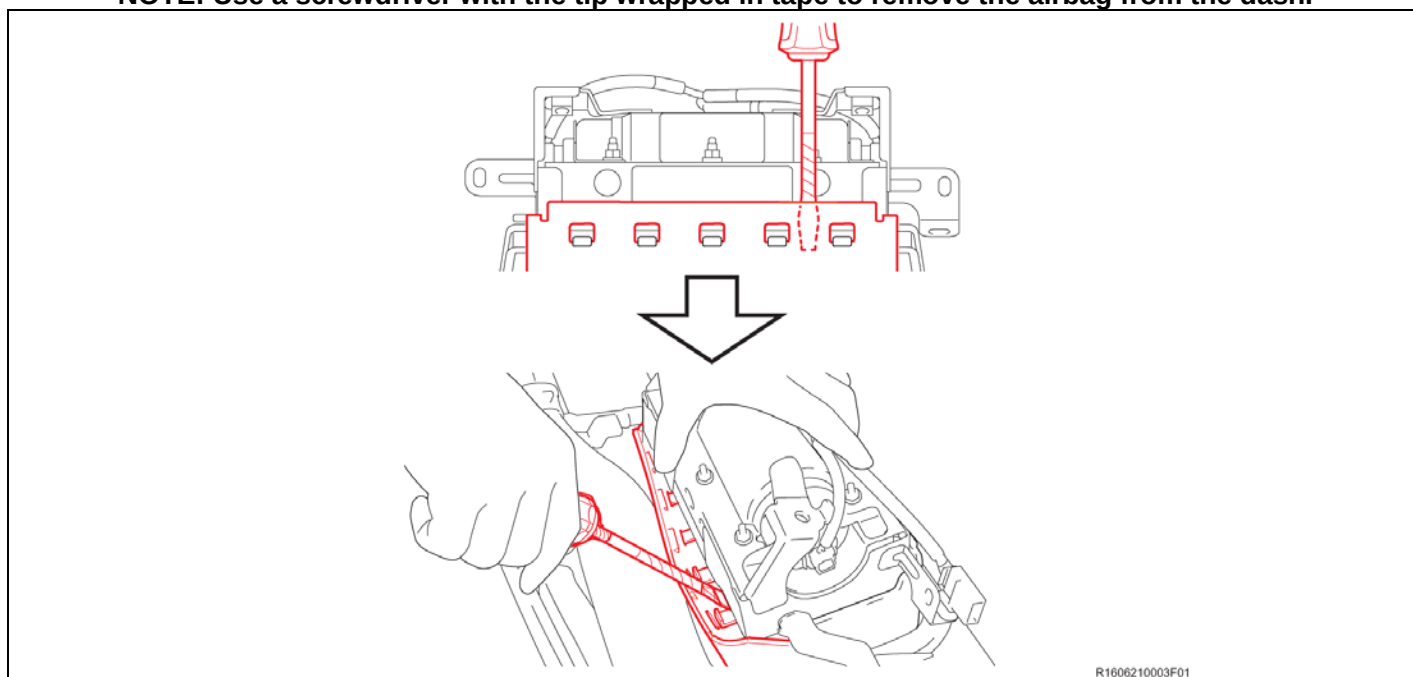
- Remove the 4 bolts, disengage the straps, and then remove the airbag assembly.

**NOTE: Use a screwdriver with the tip wrapped in tape to remove the airbag from the dash.**

- a) Position the airbag assembly in the instrument panel, engage the straps, and then install the 4 bolts.

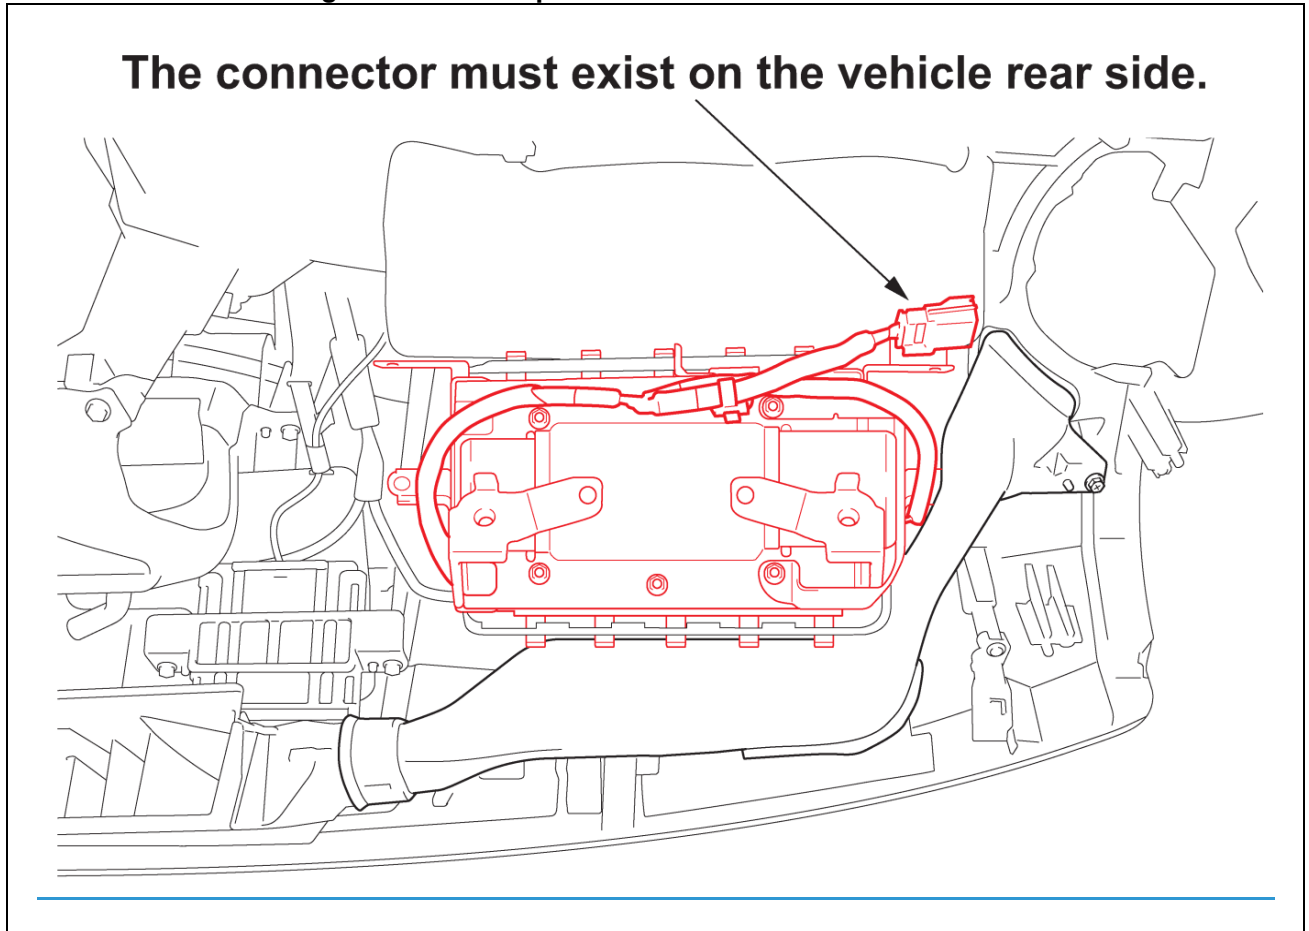
**NOTE:** Ensure the airbag connectors is positioned as shown
