# IMPORTANT UPDATE

## TECHNICAL INSTRUCTIONS FOR SAFETY RECALL G0P FRONT PASSENGER AIRBAG INFLATOR MODULE CERTAIN 2008 – 2013 MY SCION xB

**Updated 4-18-2018**

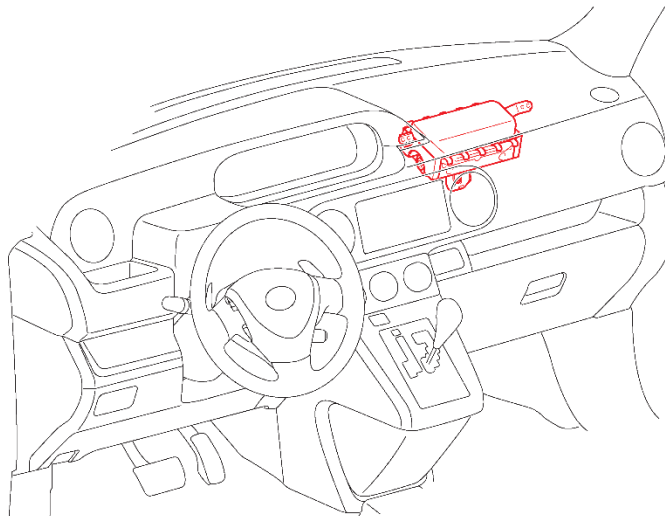
C162294

The subject vehicles are equipped with front passenger airbag inflators produced by Takata. According to Takata, the propellant in these inflators may degrade after prolonged exposure to high absolute humidity and fluctuating high temperatures. Degraded propellant can cause inflator rupture during airbag deployment. In the event of an inflator rupture, metal fragments could pass through the airbag cushion material, striking the vehicle occupants, and result in serious injury or death.

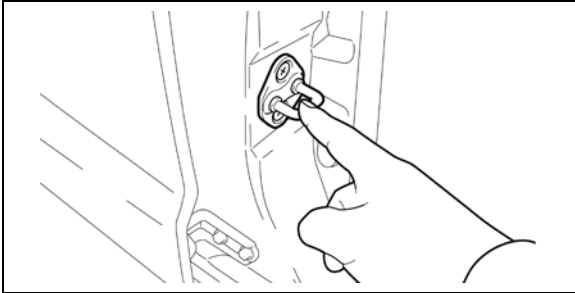
#### 1. ELIMINATE STATIC ELECTRICITY

- Before starting work and periodically while working on the vehicle, touch a metallic part of the vehicle to discharge static electricity in the body.

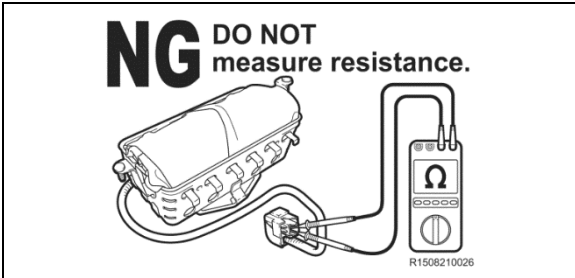
#### 2. DO NOT MEASURE RESISTANCE

- DO NOT** measure resistance of airbag components, this may cause accidental activation.

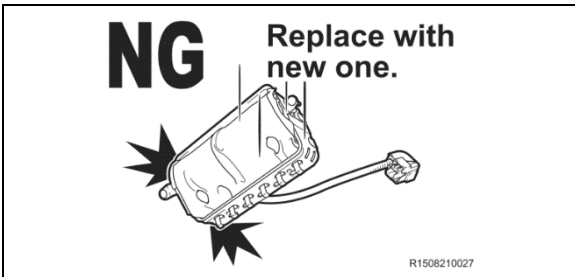
#### 3. HANDLE THE AIRBAG CAREFULLY

- If an airbag is dropped, replace it with a **NEW** one.

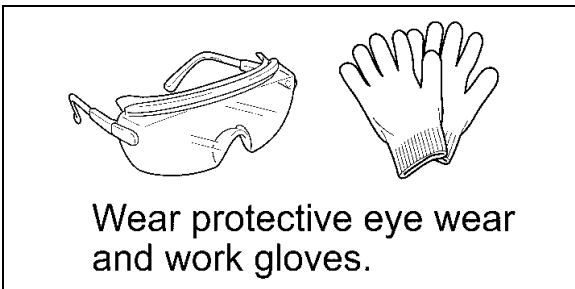
#### 4. WEAR PROTECTIVE EQUIPMENT

- Always wear appropriate protective equipment when working on the SRS.

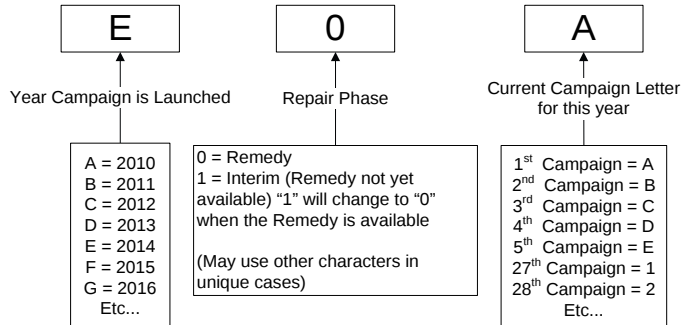
### A. CAMPAIGN DESIGNATION DECODER

Examples:

A0D = Launched in 2010, Remedy Phase, 4<sup>th</sup> Campaign Launched in 2010

B1E = Launched in 2011, Interim Phase, 5<sup>th</sup> Campaign Launched in 2011

C1C = Launched in 2012, Interim Phase, 3<sup>rd</sup> Campaign Launched in 2012
