# IMPORTANT UPDATE

## TECHNICAL INSTRUCTIONS FOR SAFETY RECALL G0P FRONT PASSENGER AIRBAG INFLATOR MODULE CERTAIN 2009 – 2013 MODEL YEAR COROLLA

**Updated 4-18-18**

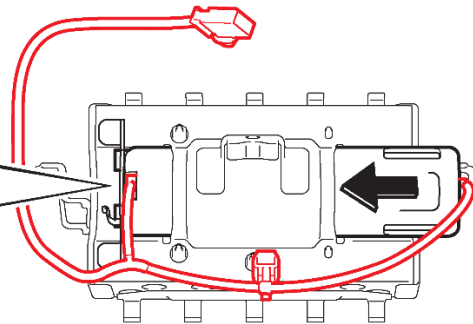
R1702270042

- d) Fully insert the inflator and ensure that the inflator is correctly oriented as shown.  
**NOTE: DO NOT pinch the wiring between the bracket and the inflator.**

**OK**

**NG**

**DO NOT**  
pinch the wire

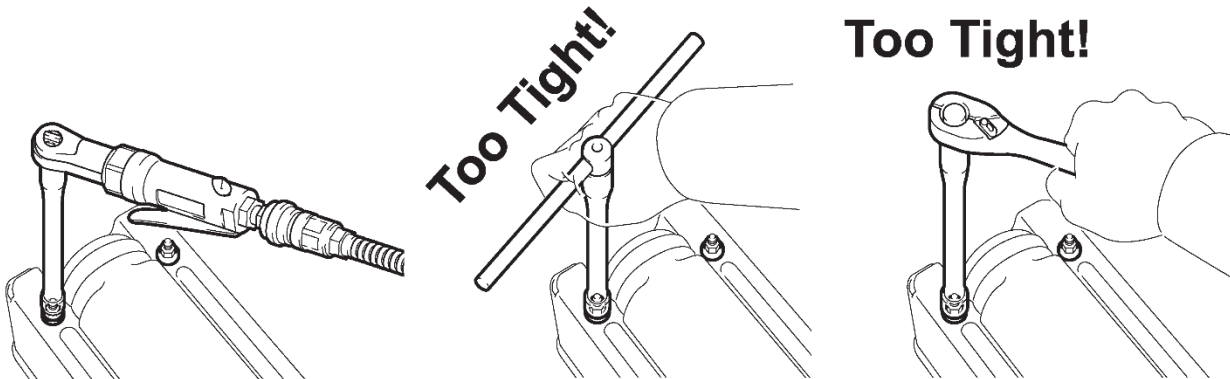
- a) Tighten the 5 nuts evenly in several increments in the sequence shown. Use a socket driver or torque wrench to tighten the nuts.

Torque: 35in. lbf (3.9N·m)

- There will be some resistance when tightening the nuts because they are self-locking, confirm the nuts are tightened correctly.
- **DO NOT** use a power tool, T-handle, or ratchet when tightening the nuts to avoid over torqueing and deforming the studs.
- You may need to turn the airbag to the left or right with in the mounting bracket to access the center nut.

# OK

# NG

## These tools cause overtightening !
